# STREAM BIOLOGICAL CONDITIONS ENVIRONMENTAL AUDITOR REPORT

<b>Stream ID:</b> S-B9	<b>Crossing Start Date:</b> 10/30/2023	<b>Crossing Completion Date:</b> 11/01/2023
<b>Milepost:</b> 297.4	<b>Pre-Con Assessment Date:</b> 10/16/2023	<b>Post-Con Assessment Date:</b> 11/01/2023
<b>Station:</b> 15712+41	<b>Stream Classification:</b> Perennial (Perennial, Intermittent, Ephemeral)	<b>Bankfull Width (ft.):</b> 7
<b>County:</b> Pittsylvania	<b>303(d) Impairment Listing:</b> Not Impaired	<b>Riffle:Pool Complexes Present?</b> No

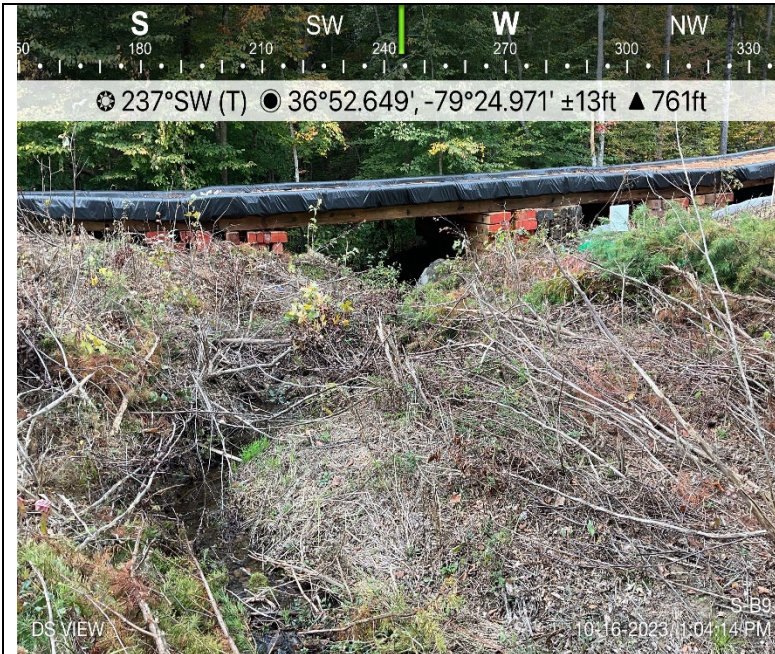
**Photo Description:** Downstream view of permitted impact area during pre-construction assessment.

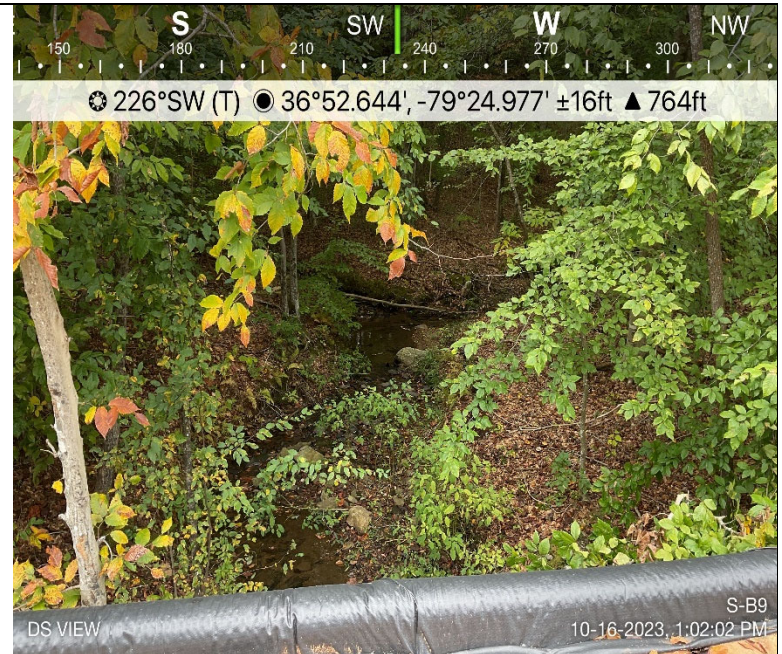
**Photo Description:** Conditions of the downstream area outside the ROW during pre-construction assessment.

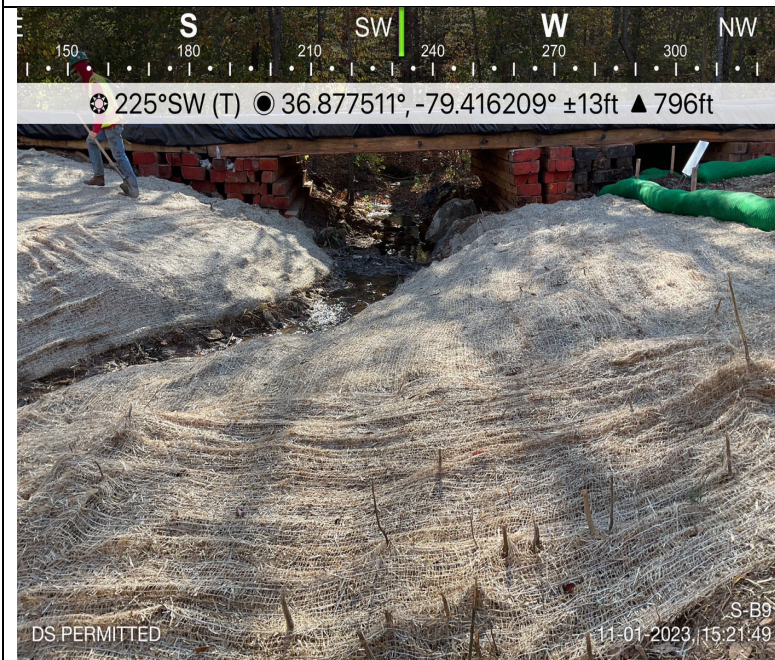
**Photo Description:** Downstream view of permitted impact area during post-construction assessment.

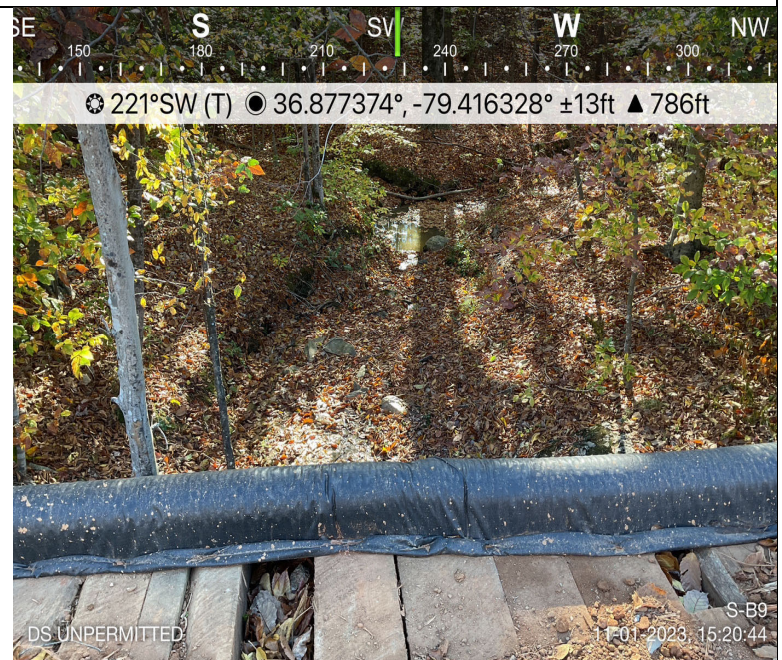
**Photo Description:** Conditions of the downstream area outside the ROW during post-construction assessment.

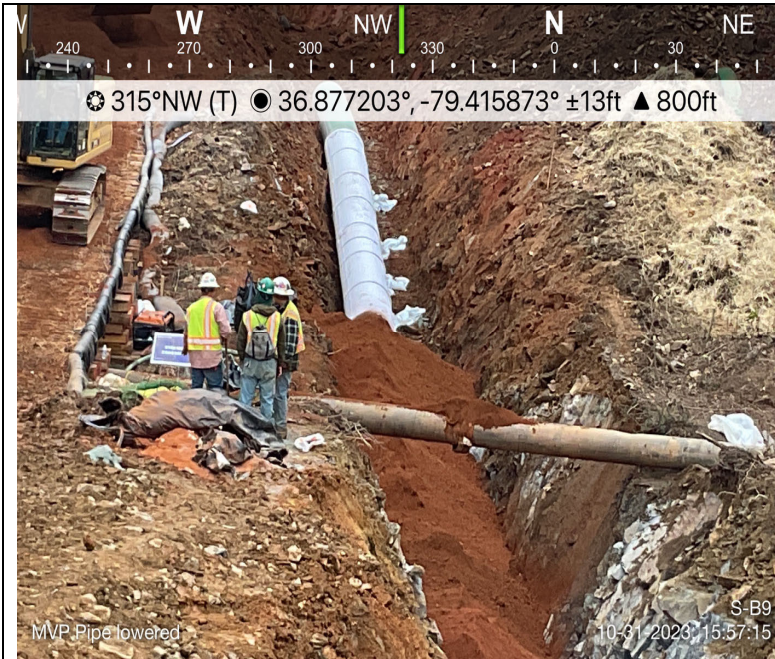
**Photo Description:** Padding and backfilling of the trench.

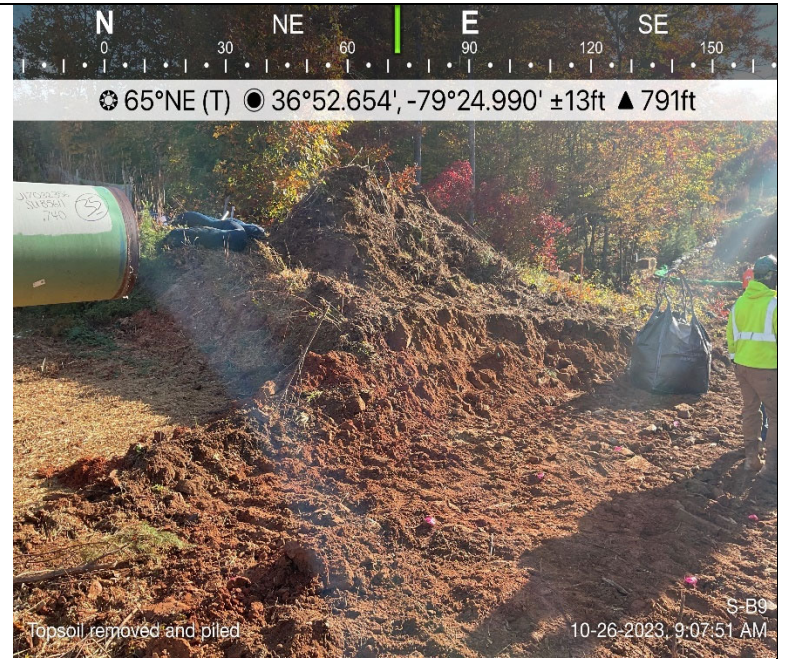
**Photo Description:** Topsoil that has been stored separately. Straw mulch was applied to the stockpile.

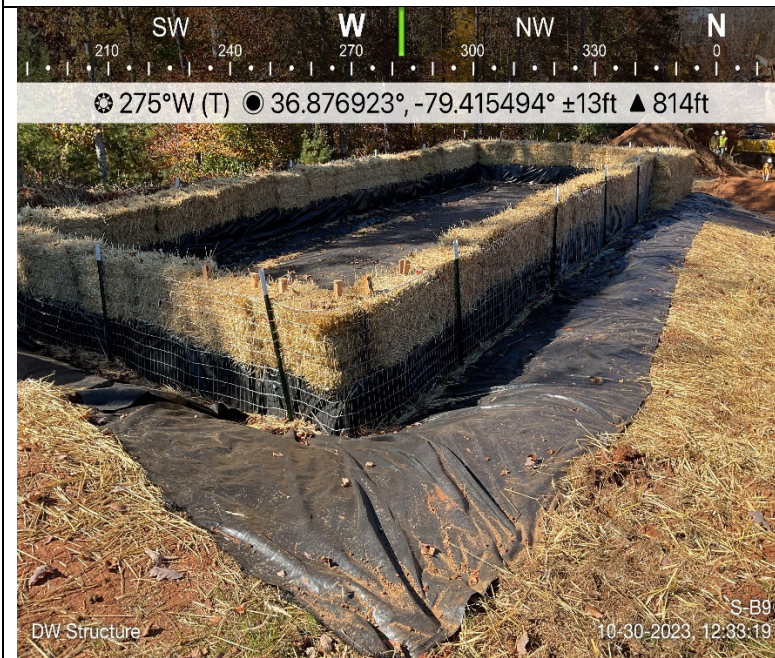
**Photo Description:** An overview of the dewatering structure.

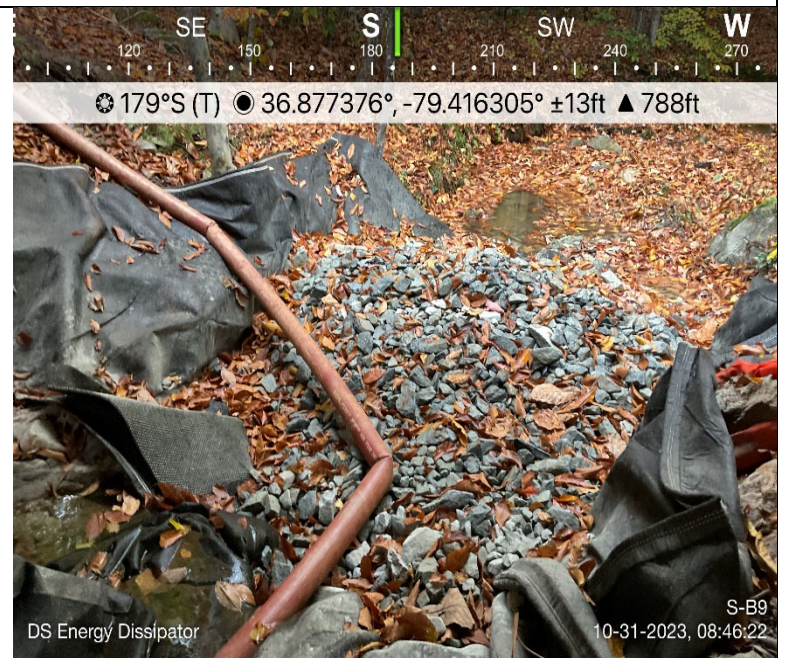
**Photo Description:** The energy dissipater for pump around operation.
