# STREAM BIOLOGICAL CONDITIONS ENVIRONMENTAL AUDITOR REPORT

<b>Stream ID:</b> S-C14	<b>Crossing Start Date:</b> 10/09/2023	<b>Crossing Completion Date:</b> 10/13/2023
<b>Milepost:</b> 261.8	<b>Pre-Con Assessment Date:</b> 10/06/2023	<b>Post-Con Assessment Date:</b> 10/13/2023
<b>Station:</b> 13823+04	<b>Stream Classification:</b> Perennial (Perennial, Intermittent, Ephemeral)	<b>Bankfull Width (ft.):</b> 50
<b>County:</b> Franklin	<b>303(d) Impairment Listing:</b> Impaired	<b>Riffle:Pool Complexes Present?</b> No

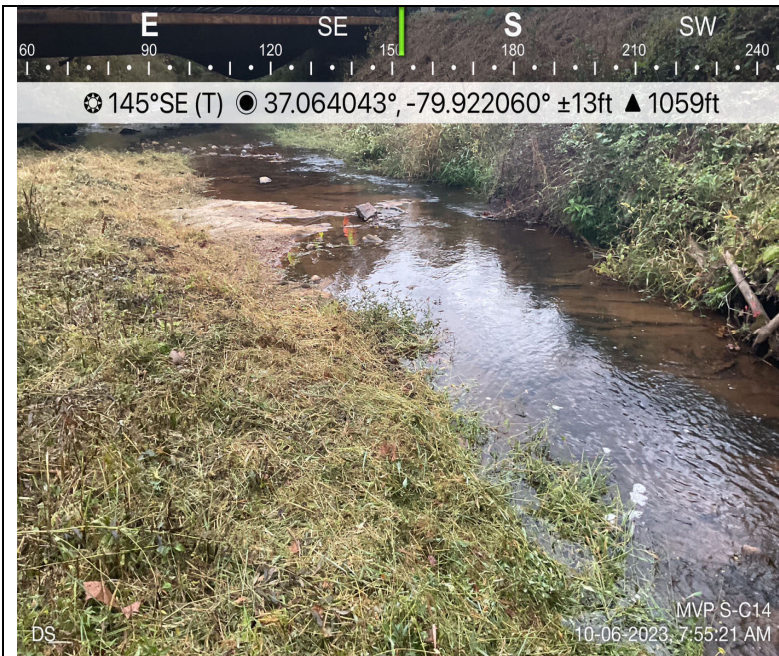
**Photo Description:** Downstream view of permitted impact area during pre-construction assessment.

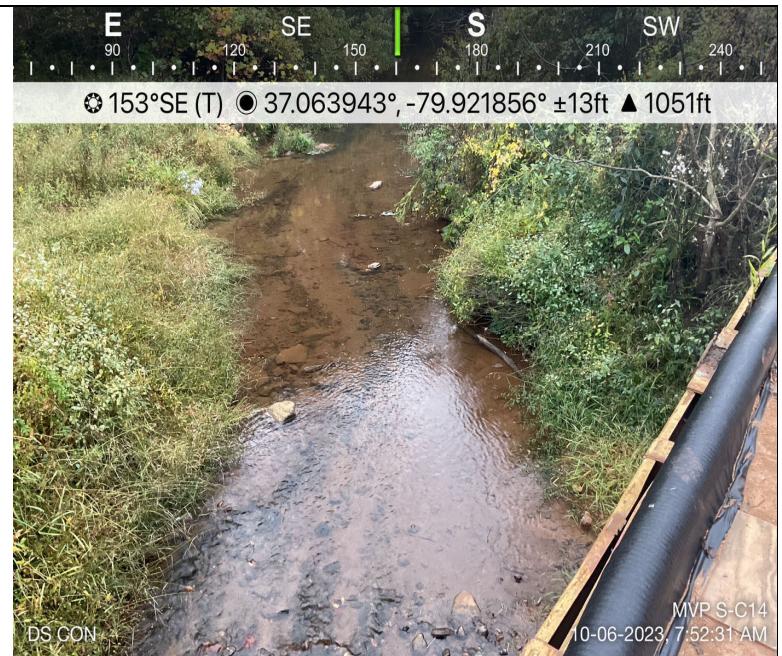
**Photo Description:** Conditions of the downstream area outside the ROW during pre-construction assessment.

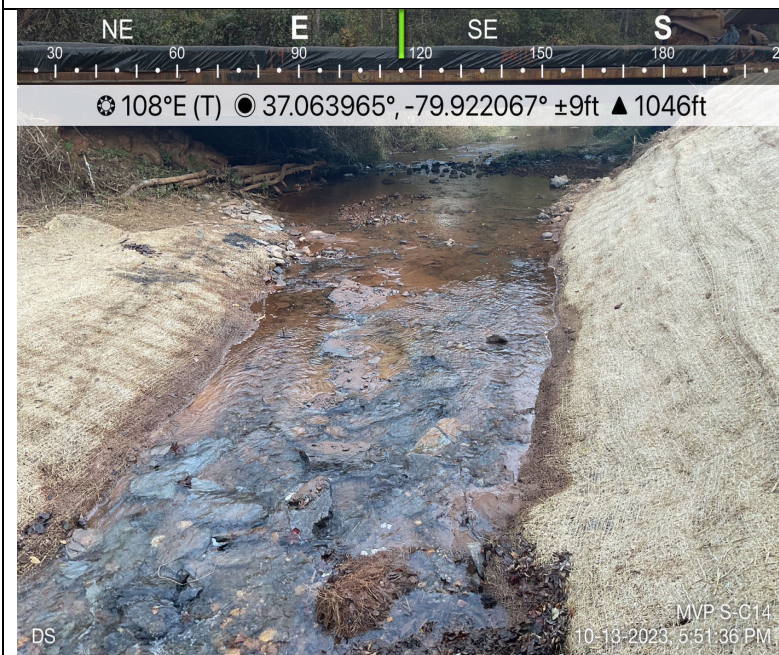
**Photo Description:** Downstream view of permitted impact area during post-construction assessment.

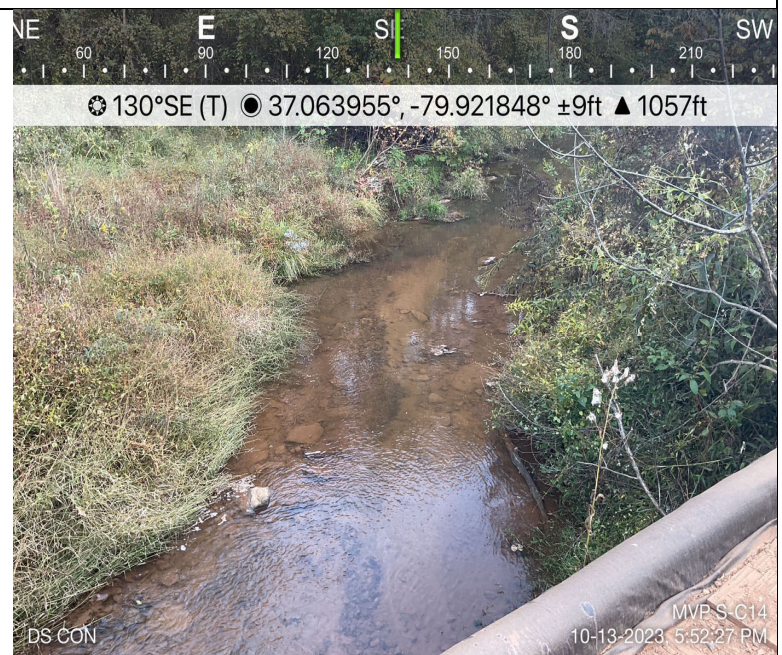
**Photo Description:** Conditions of the downstream area outside the ROW during post-construction assessment.

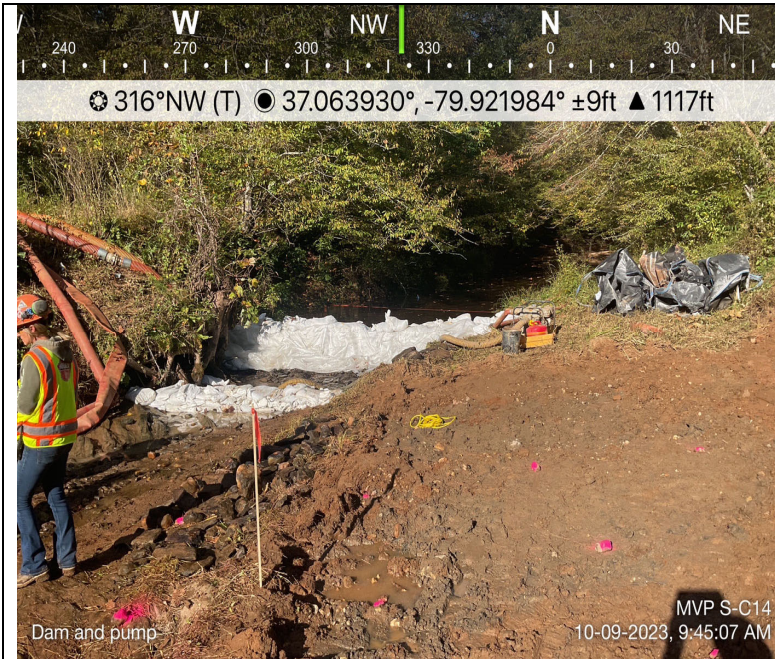
**Photo Description:** Dam and pump setup

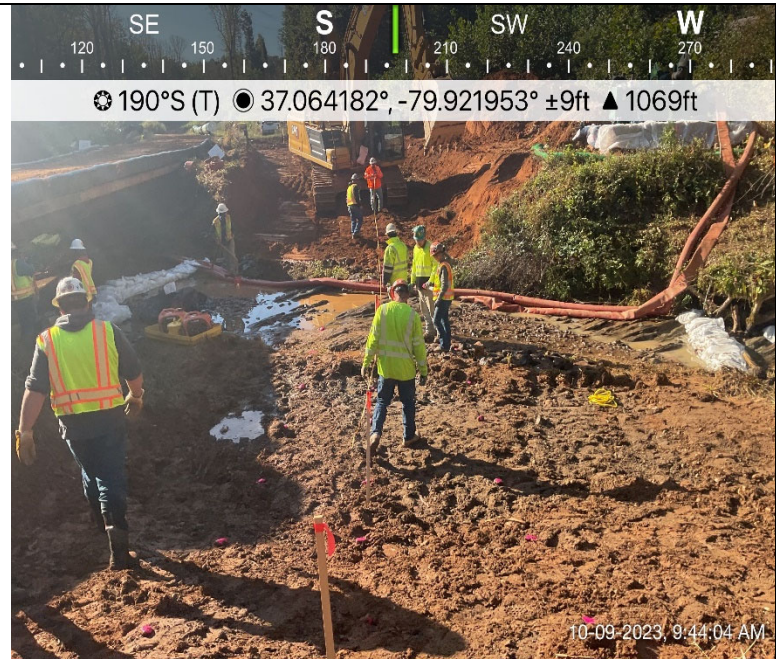
**Photo Description:** Crossing area preparation after topsoil/substrate removal.

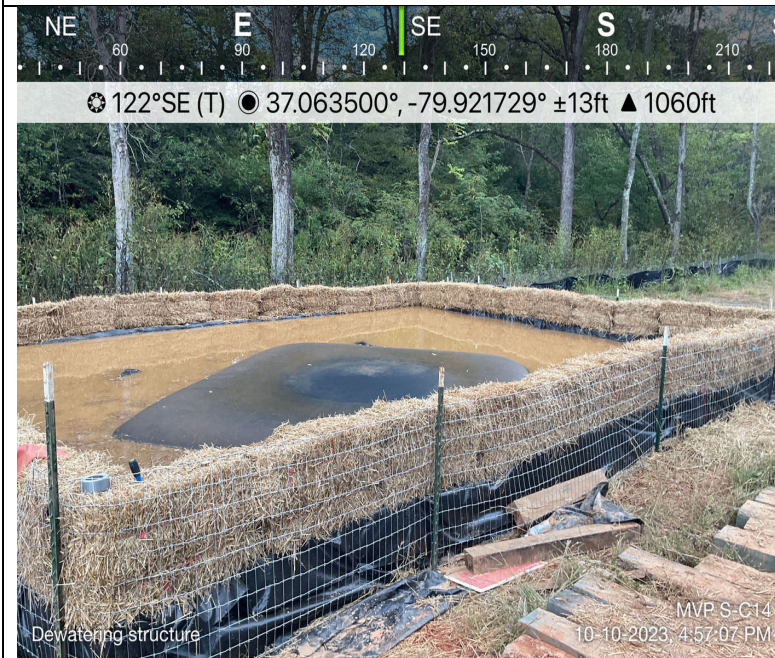
**Photo Description:** Dewatering structure

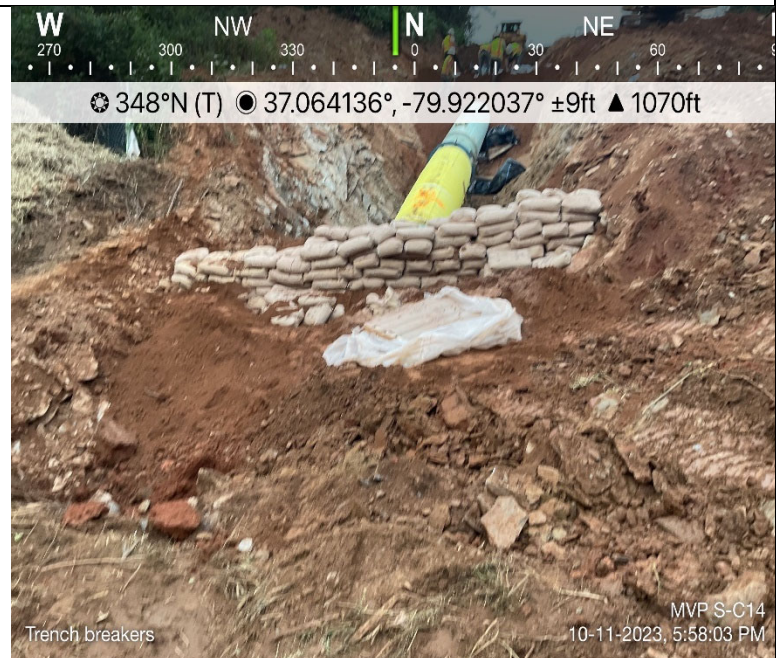
**Photo Description:** Trenchbreaker installed.
