STREAM BIOLOGICAL CONDITIONS ENVIRONMENTAL AUDITOR REPORT

Stream ID: S-C36	Crossing Start Date: 09/13/2023	Crossing Completion Date: 10/02/2023
Milepost: 229.4	Pre-Con Assessment Date: 09/11/2023	Post-Con Assessment Date: 10/02/2023
Station: 12122+00	Stream Classification: Intermittent (Perennial, Intermittent, Ephemeral)	Bankfull Width (ft.): 3
County: Montgomery	303(d) Impairment Listing: Not Impaired	Riffle:Pool Complexes Present? No

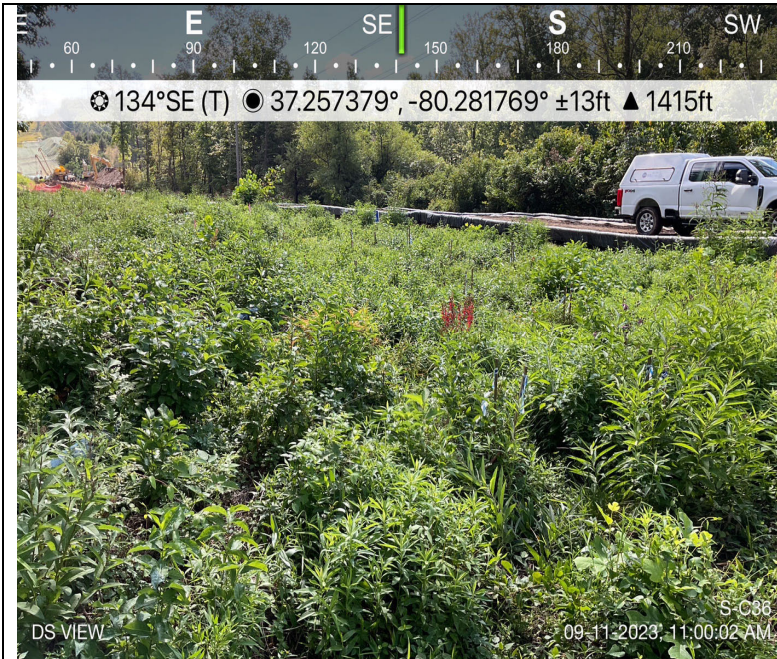
Photo Description: Downstream view of permitted impact area during pre-construction assessment.

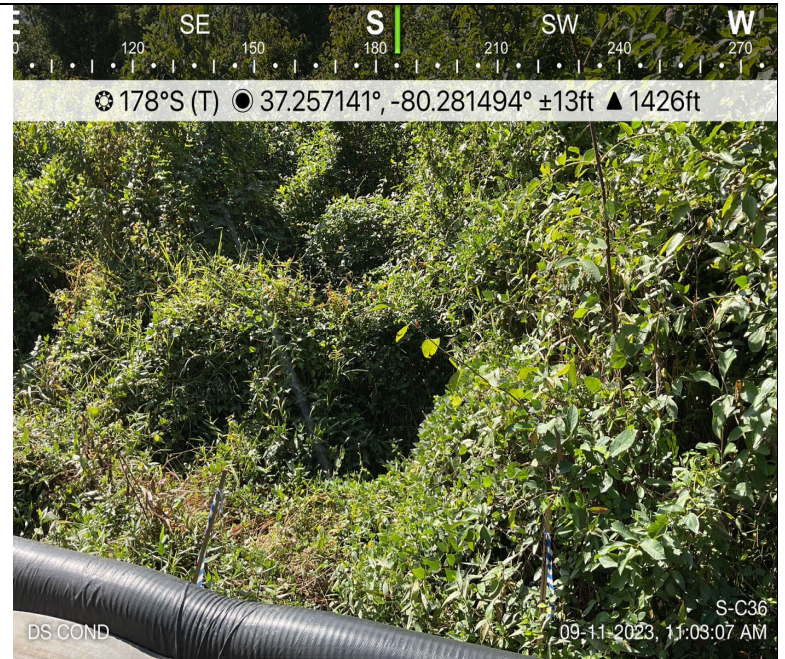
Photo Description: Conditions of the downstream area outside the ROW during pre-construction assessment.

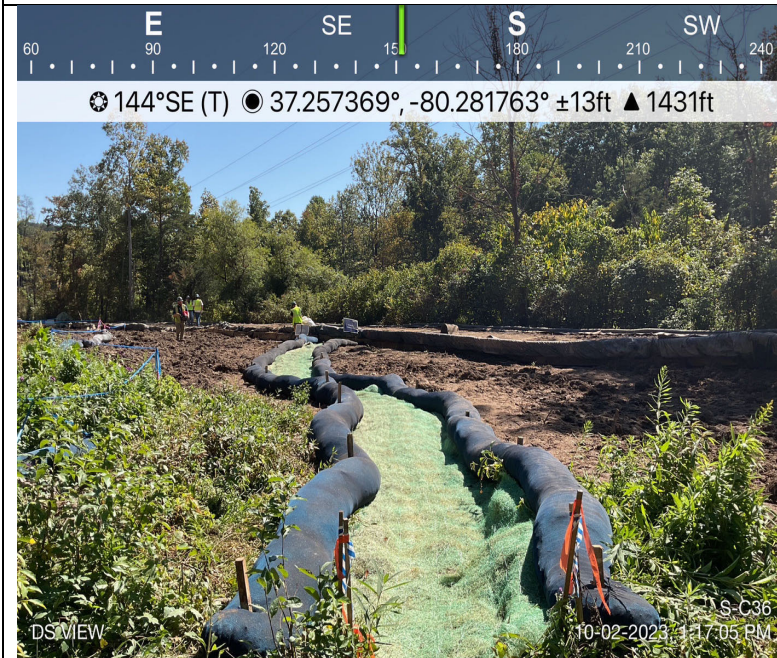
Photo Description: Downstream view of permitted impact area during post-construction assessment.

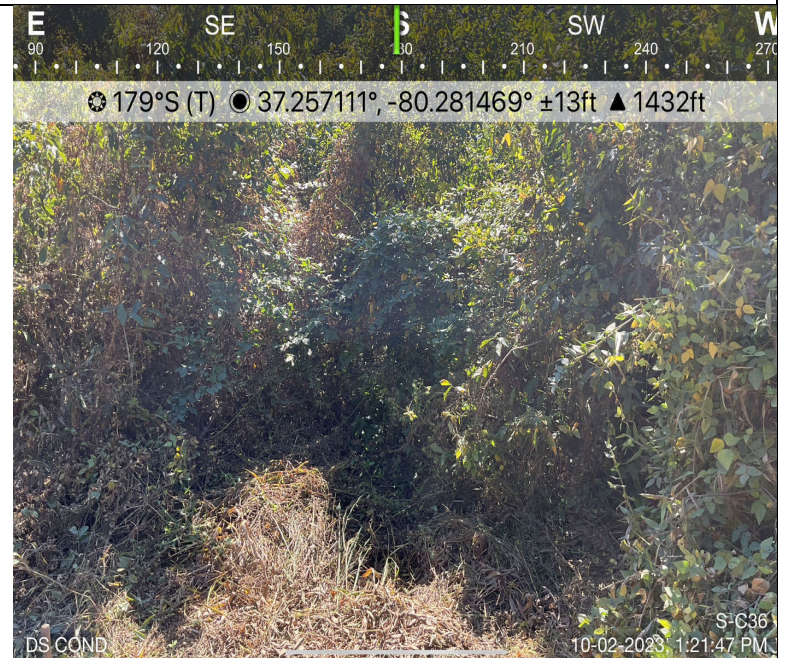
Photo Description: Conditions of the downstream area outside the ROW during post-construction assessment.

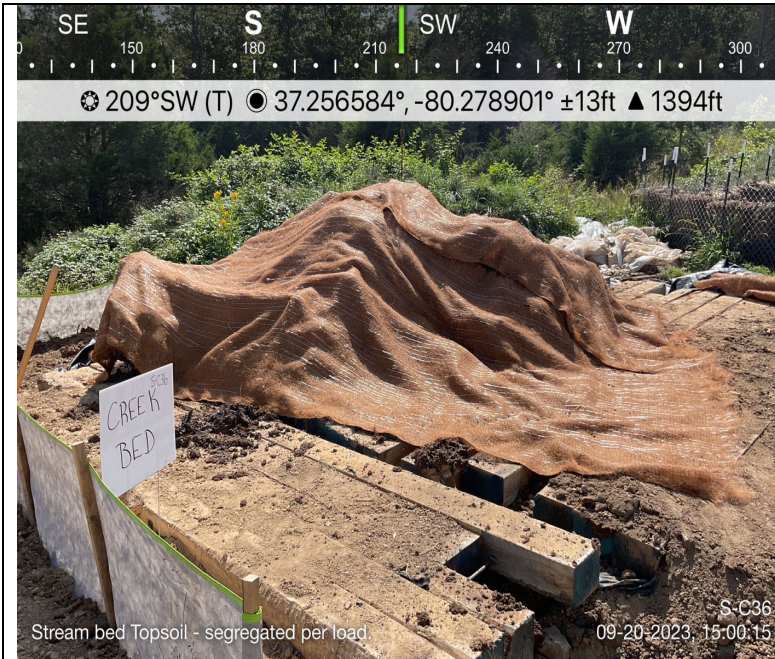
Photo Description: Stream bed material segregation and stabilization.

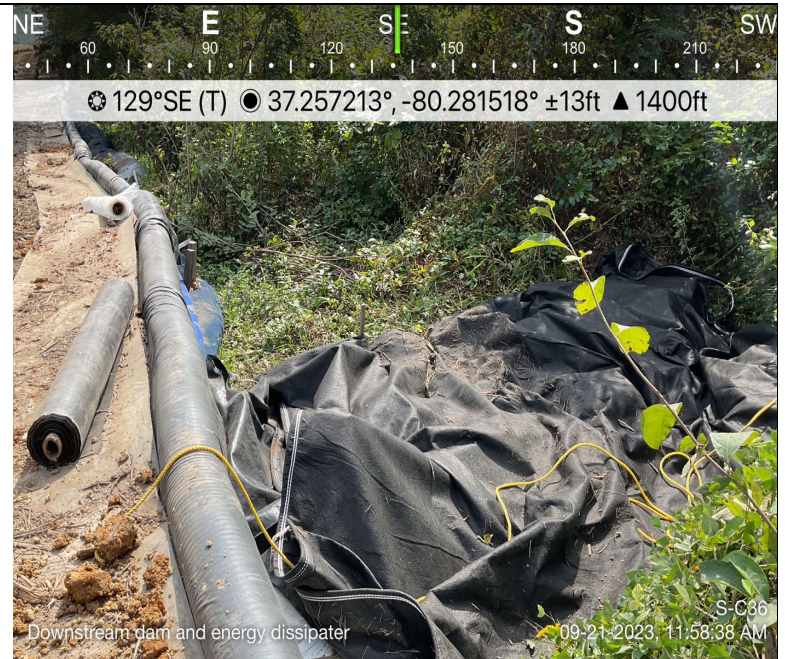
Photo Description: Downstream dam and energy dissipater.

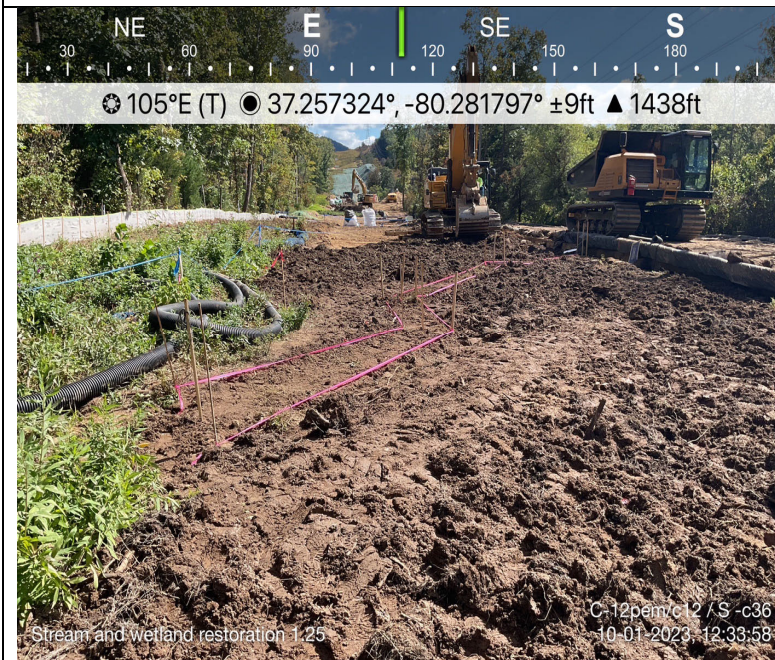
Photo Description: Survey staked stream for restoration.

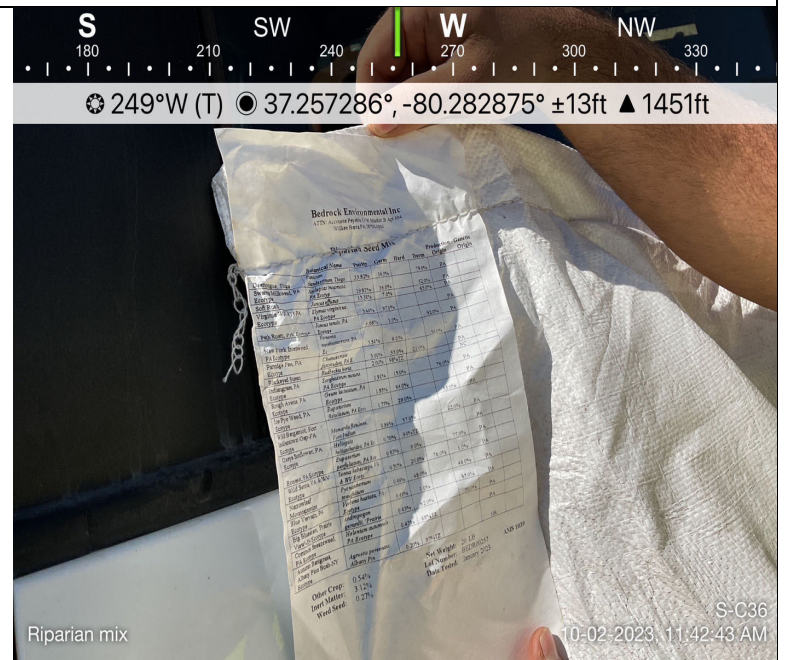
Photo Description: Stream seed tag for restoration and stabilization.
