# STREAM BIOLOGICAL CONDITIONS ENVIRONMENTAL AUDITOR REPORT

<b>Stream ID:</b> S-CD6	<b>Crossing Start Date:</b> 10/09/2023	<b>Crossing Completion Date:</b> 10/18/2023
<b>Milepost:</b> 262.6	<b>Pre-Con Assessment Date:</b> 10/09/2023	<b>Post-Con Assessment Date:</b> 10/19/2023
<b>Station:</b> 13874+96	<b>Stream Classification:</b> Perennial (Perennial, Intermittent, Ephemeral)	<b>Bankfull Width (ft.):</b> 70
<b>County:</b> Franklin	<b>303(d) Impairment Listing:</b> Impaired	<b>Riffle:Pool Complexes Present?</b> Yes

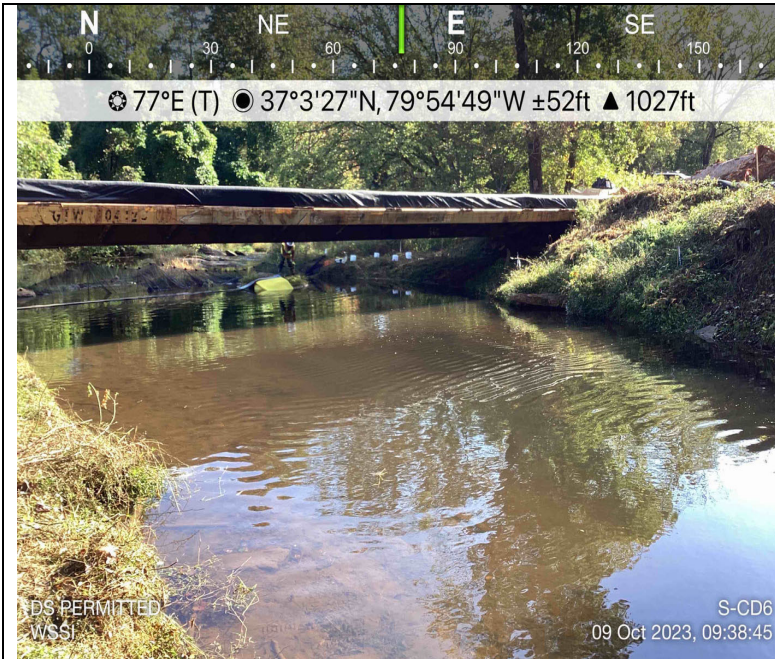
**Photo Description:** Downstream view of permitted impact area during pre-construction assessment.

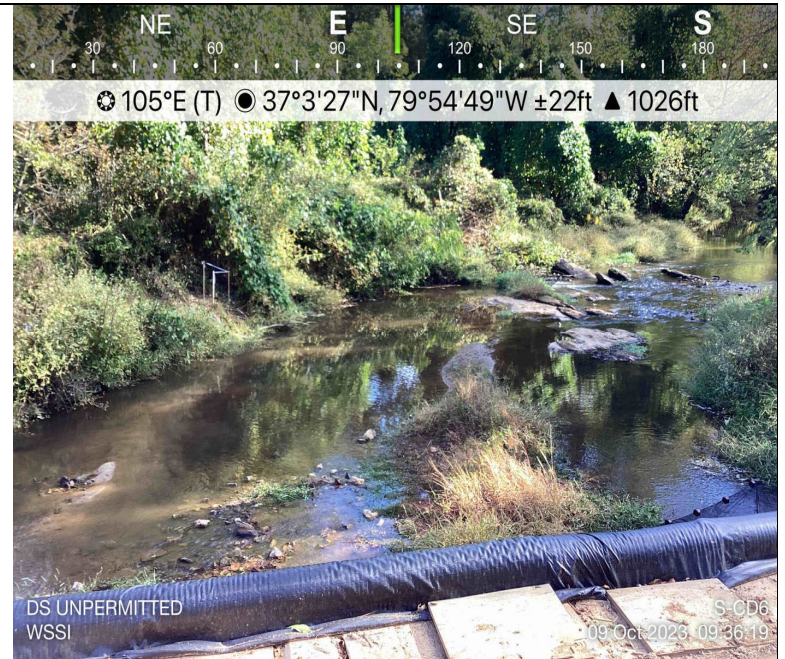
**Photo Description:** Conditions of the downstream area outside the ROW during pre-construction assessment.

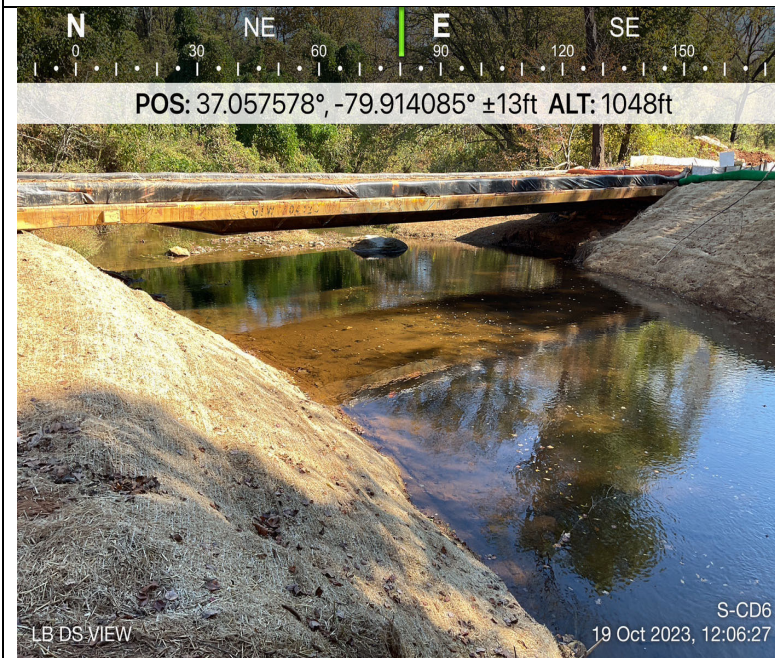
**Photo Description:** Downstream view of permitted impact area during post-construction assessment.

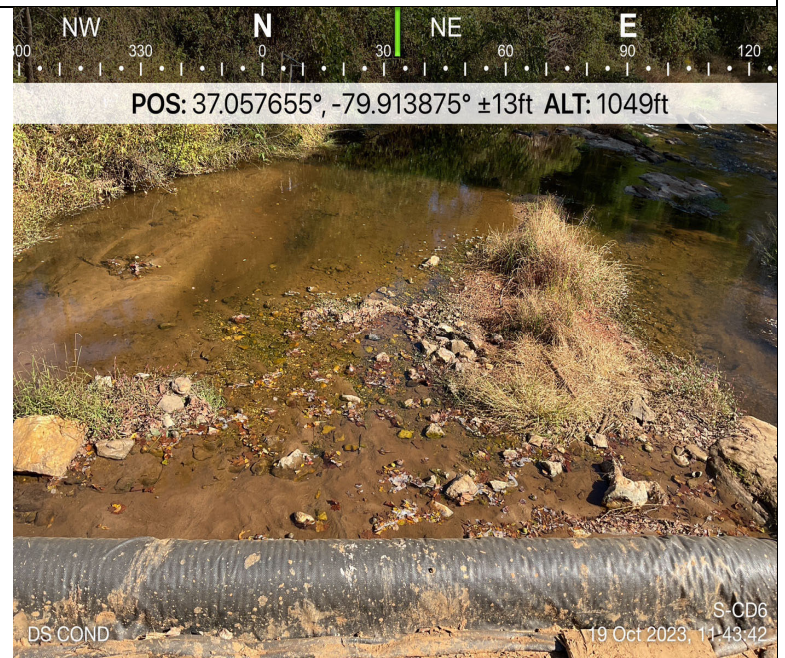
**Photo Description:** Conditions of the downstream area outside the ROW during post-construction assessment.

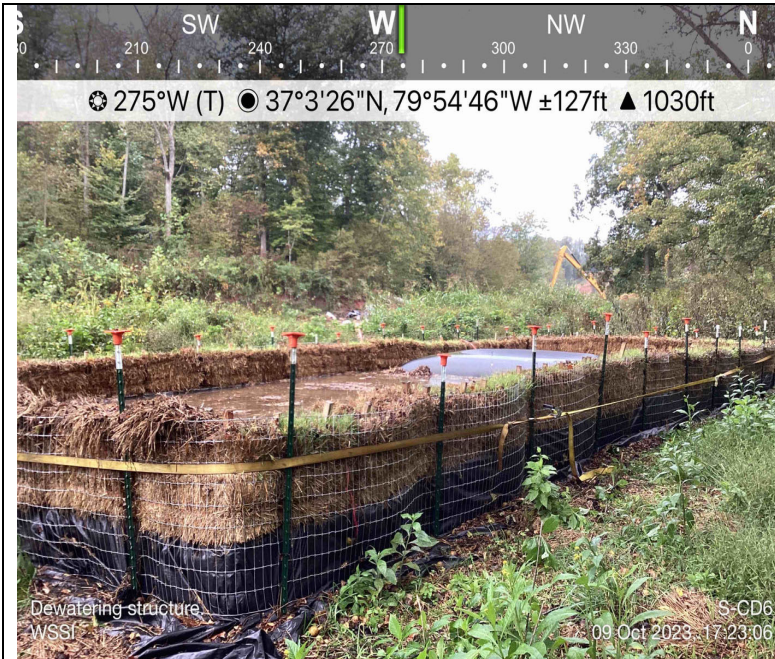
**Photo Description:** Overview of the dewatering operations.

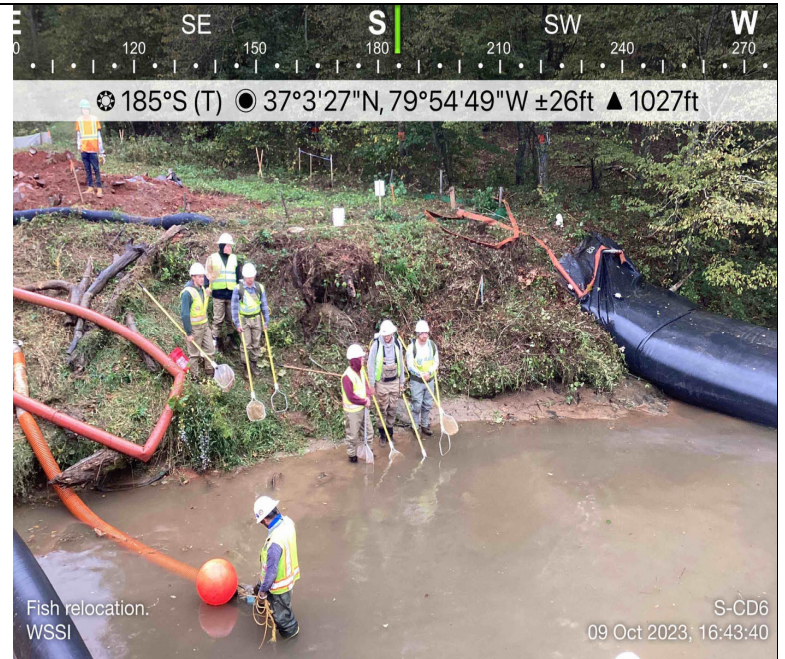
**Photo Description:** Fish relocation in progress.

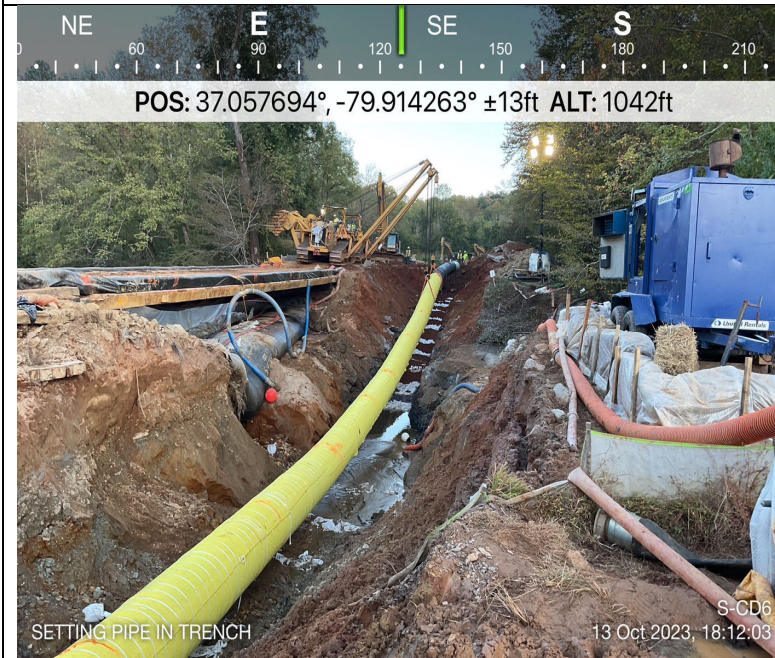
**Photo Description:** Lowering the pipe in the trench.

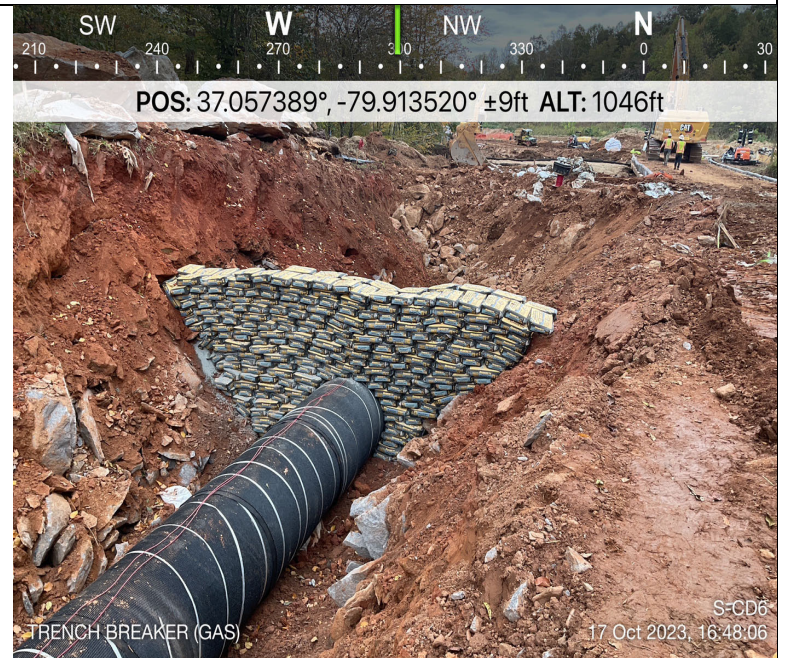
**Photo Description:** Trench breaker installed.
