# STREAM BIOLOGICAL CONDITIONS ENVIRONMENTAL AUDITOR REPORT

<b>Stream ID:</b> S-D1-EPH	<b>Crossing Start Date:</b> 10/26/2023	<b>Crossing Completion Date:</b> 10/30/2023
<b>Milepost:</b> 285	<b>Pre-Con Assessment Date:</b> 10/16/2023	<b>Post-Con Assessment Date:</b> 10/31/2023
<b>Station:</b> 15055+95	<b>Stream Classification:</b> Ephemeral (Perennial, Intermittent, Ephemeral)	<b>Bankfull Width (ft.):</b> 10
<b>County:</b> Pittsylvania	<b>303(d) Impairment Listing:</b> Not Impaired	<b>Riffle:Pool Complexes Present?</b> No

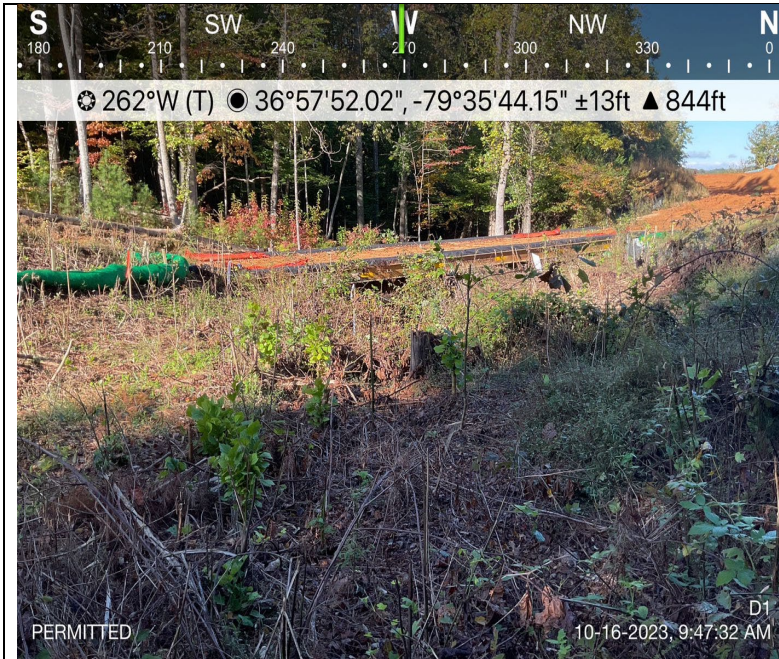
**Photo Description:** Downstream view of permitted impact area during pre-construction assessment.

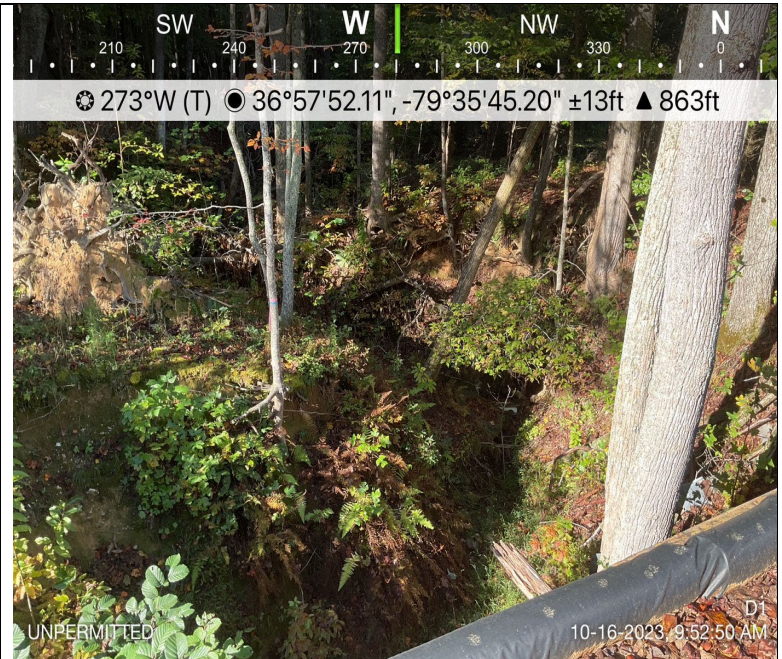
**Photo Description:** Conditions of the downstream area outside the ROW during pre-construction assessment.

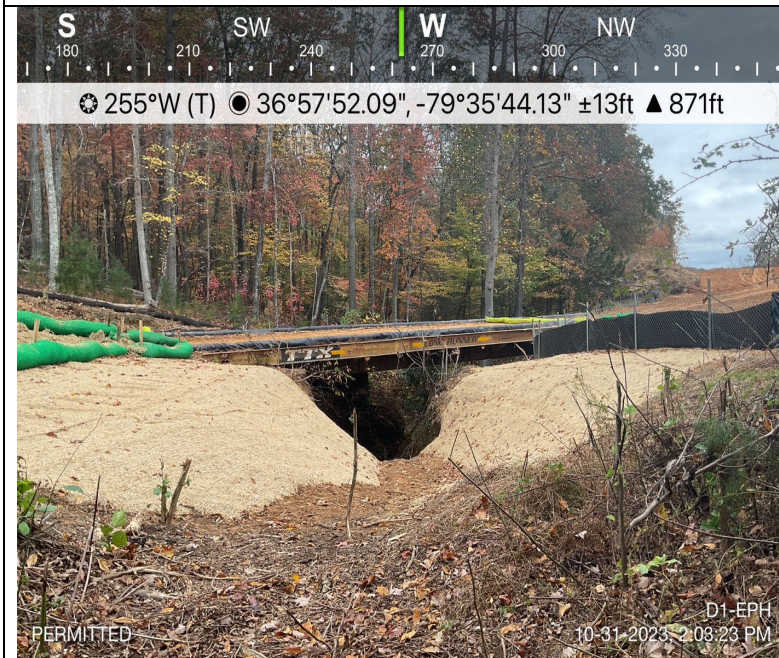
**Photo Description:** Downstream view of permitted impact area during post-construction assessment.

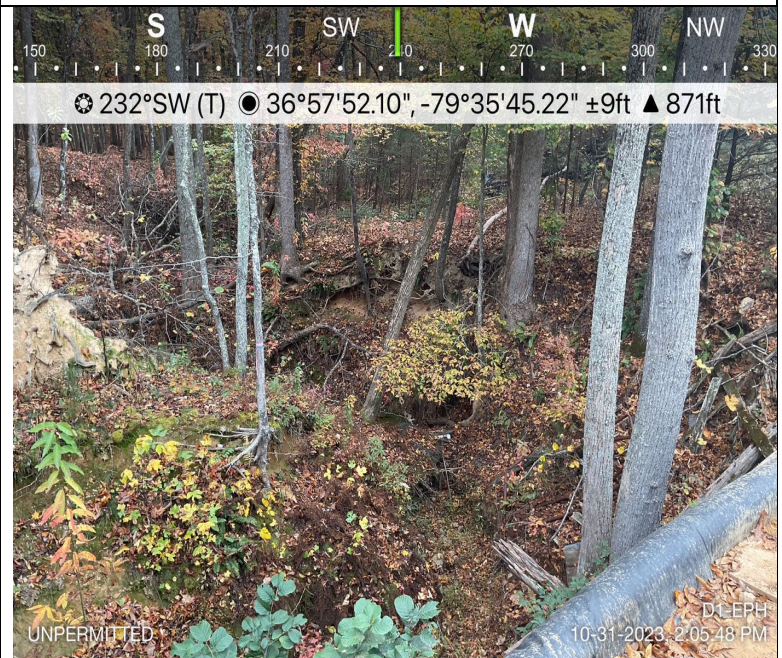
**Photo Description:** Conditions of the downstream area outside the ROW during post-construction assessment.

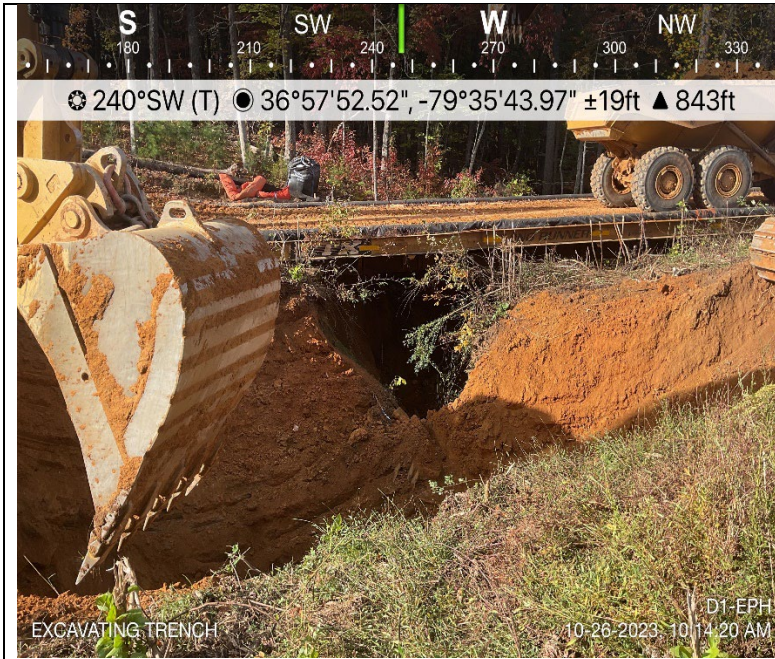
**Photo Description:** Excavation of the trench.

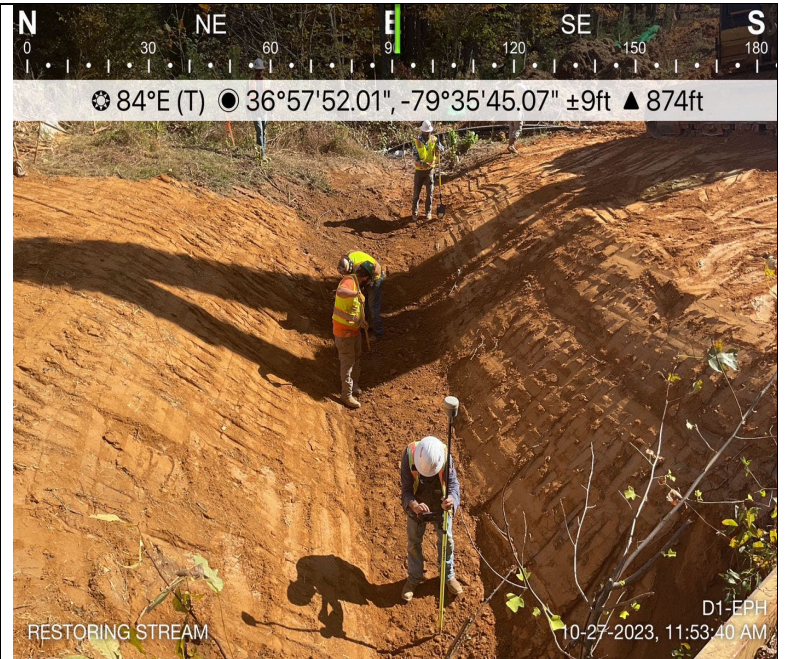
**Photo Description:** Surveying the stream for site restoration.

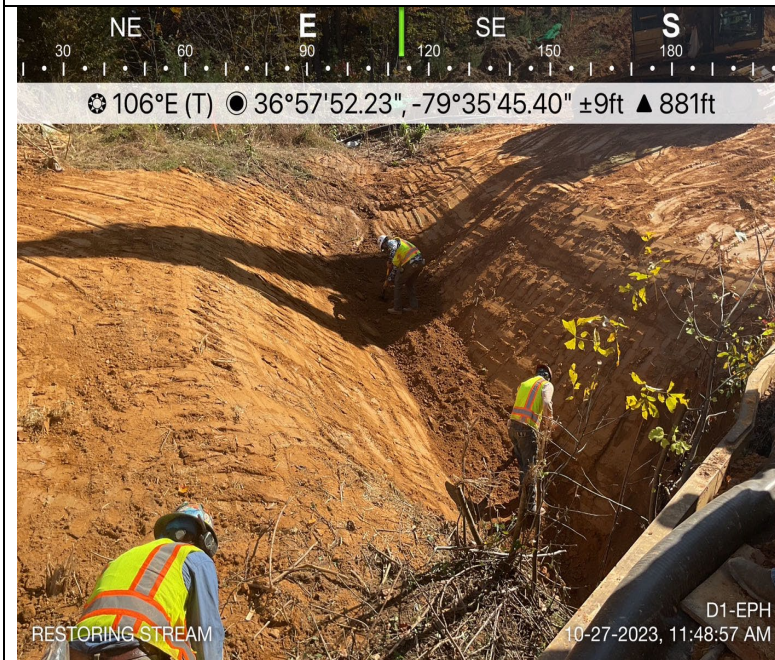
**Photo Description:** Restoration of the stream bed and banks.

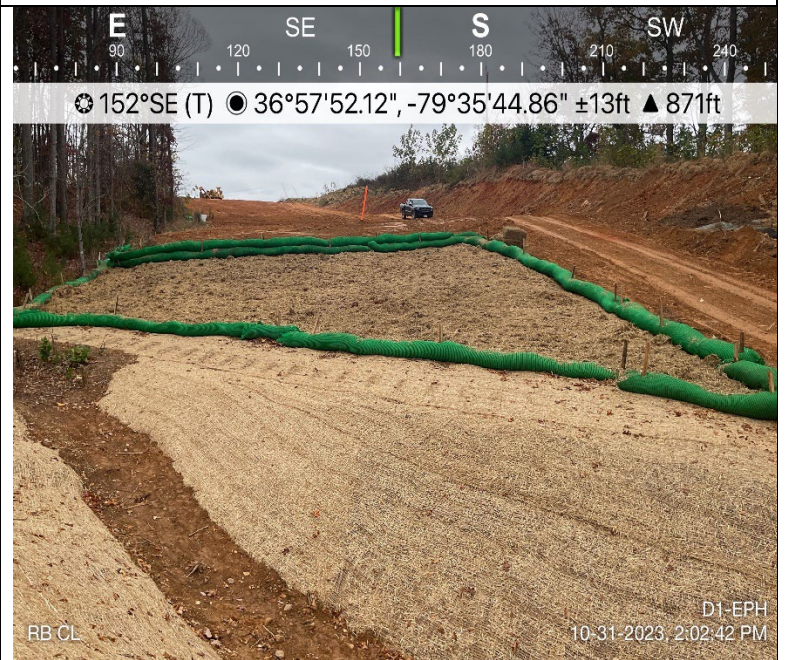
**Photo Description:** The site after the application of seed and erosion control matting.
