STREAM BIOLOGICAL CONDITIONS ENVIRONMENTAL AUDITOR REPORT

Stream ID: S-D23	Crossing Start Date: 09/26/2023	Crossing Completion Date: 09/29/2023
Milepost: 261	Pre-Con Assessment Date: 09/22/2023	Post-Con Assessment Date: 09/30/2023
Station: 13791+08	Stream Classification: Perennial (Perennial, Intermittent, Ephemeral)	Bankfull Width (ft.): 20
County: Franklin	303(d) Impairment Listing: Impaired	Riffle:Pool Complexes Present? Yes

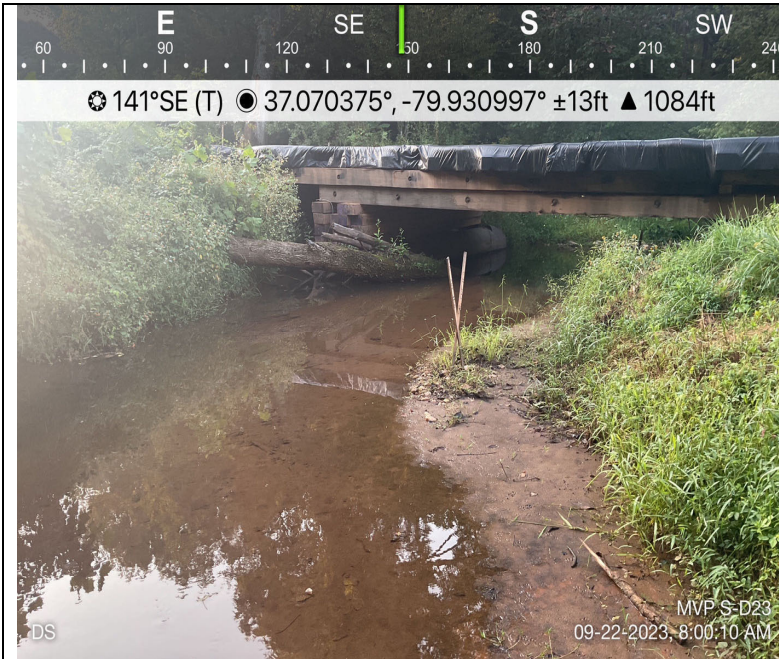
Photo Description: Downstream view of permitted impact area during pre-construction assessment.

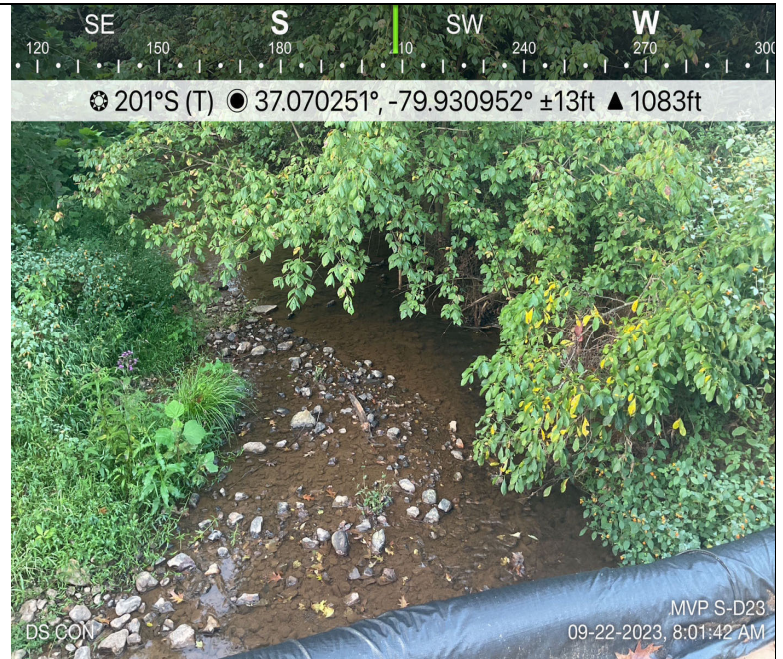
Photo Description: Conditions of the downstream area outside the ROW during pre-construction assessment.

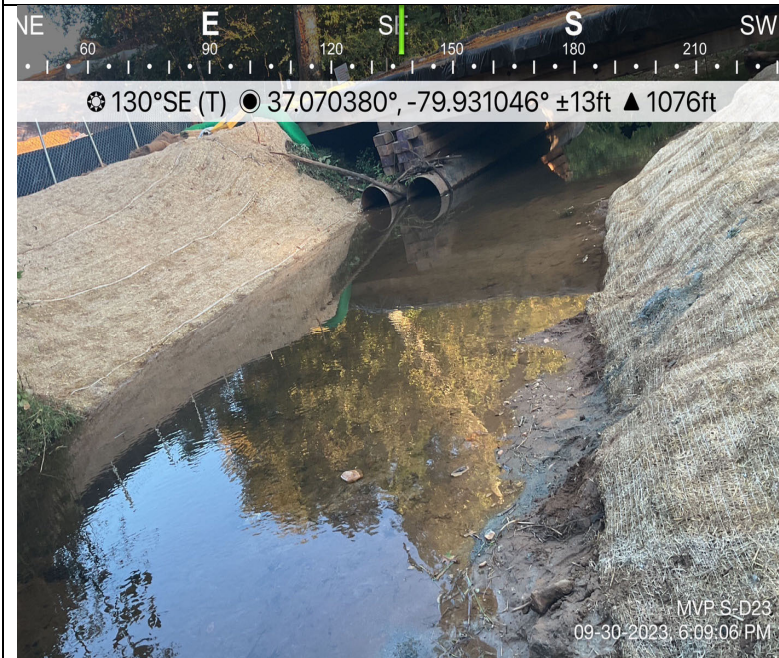
Photo Description: Downstream view of permitted impact area during post-construction assessment.

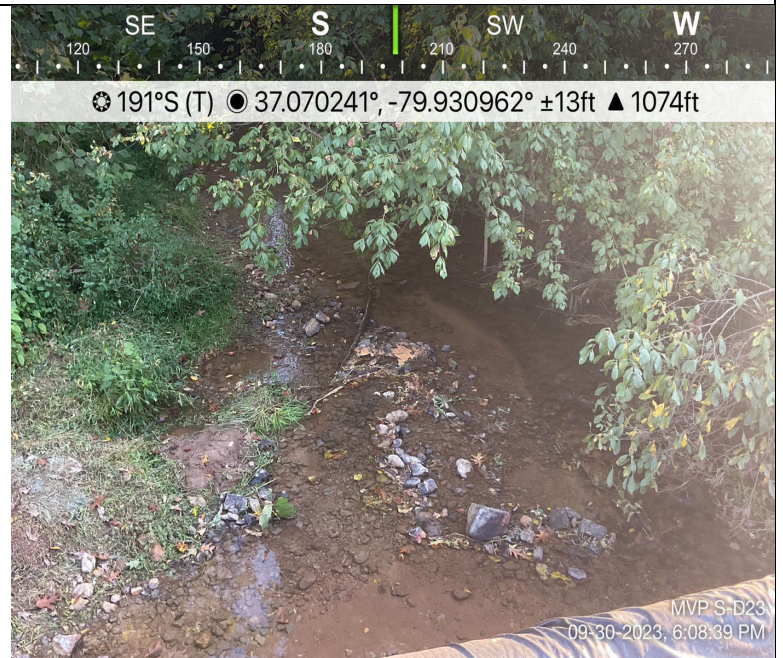
Photo Description: Conditions of the downstream area outside the ROW during post-construction assessment.

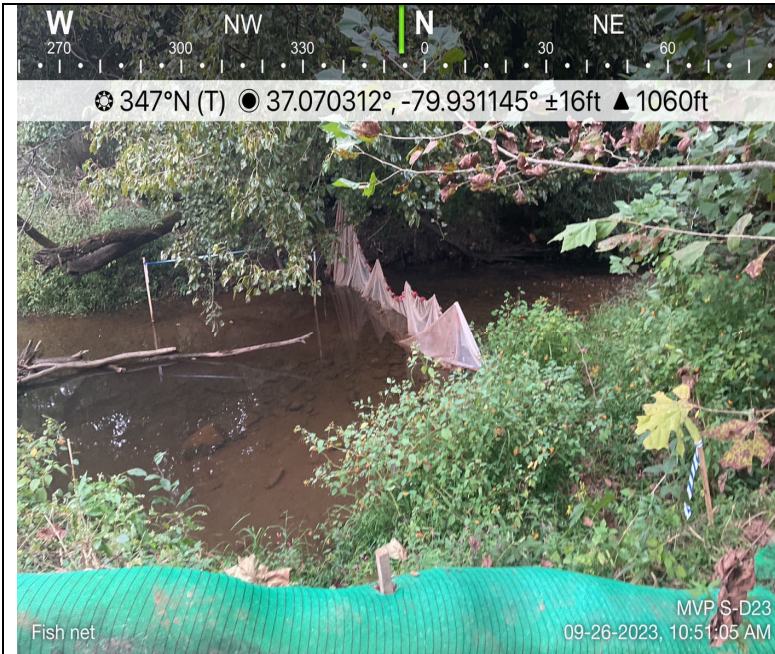
Photo Description: Fish net left in place throughout crossing to prevent fish from migrating back into impact area.

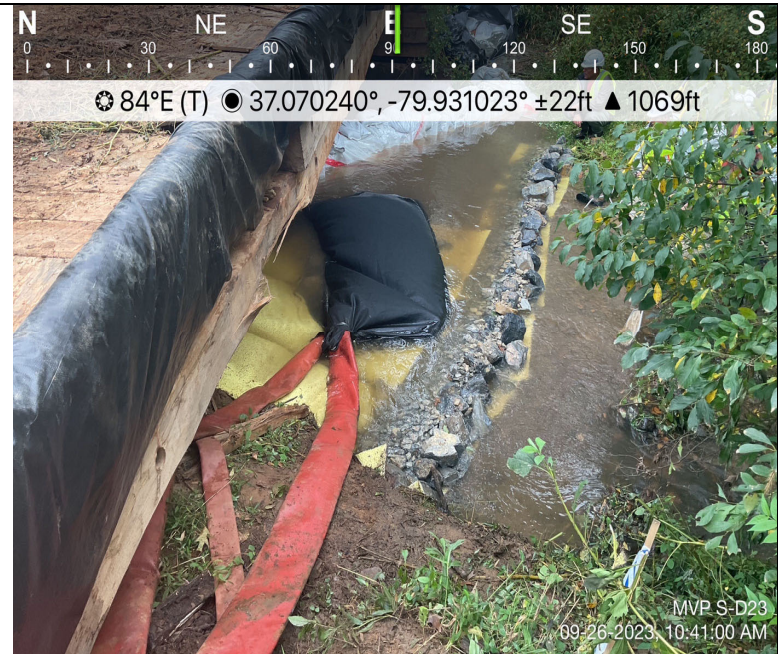
Photo Description: Pump around energy dissipator rock check.

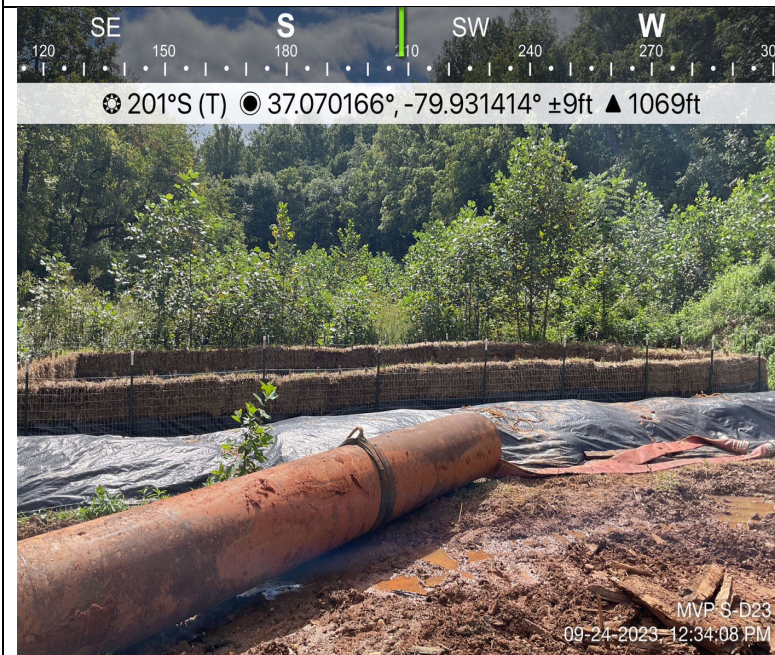
Photo Description: Dewatering structure set up in upland area and discharging onto vegetated area.

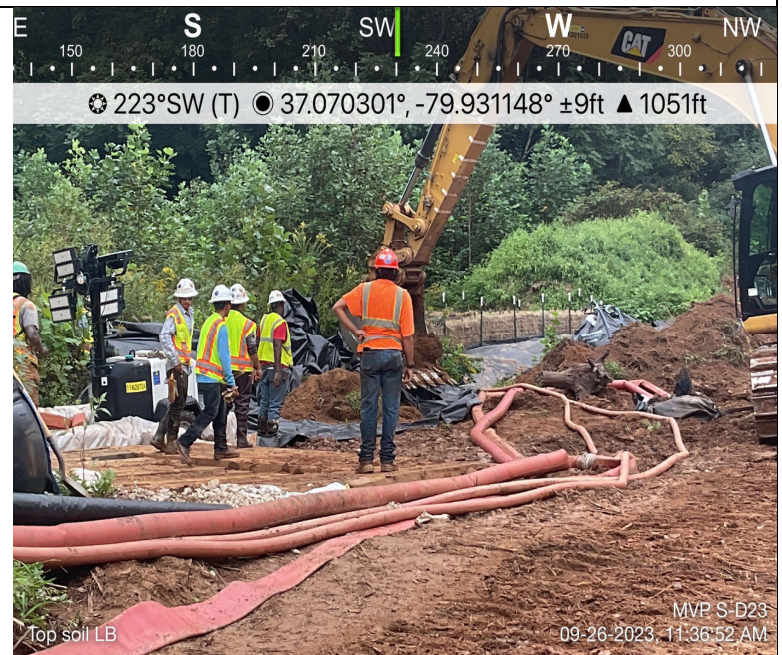
Photo Description: Left bank topsoil stockpiled separately from subsoil
