STREAM BIOLOGICAL CONDITIONS ENVIRONMENTAL AUDITOR REPORT

Stream ID: S-D4	Crossing Start Date: 10/18/2023	Crossing Completion Date: 10/21/2023
Milepost: 284.4	Pre-Con Assessment Date: 10/16/2023	Post-Con Assessment Date: 10/21/2023
Station: 15027+37	Stream Classification: Intermittent (Perennial, Intermittent, Ephemeral)	Bankfull Width (ft.): 6
County: Pittsylvania	303(d) Impairment Listing: Not Impaired	Riffle:Pool Complexes Present? No

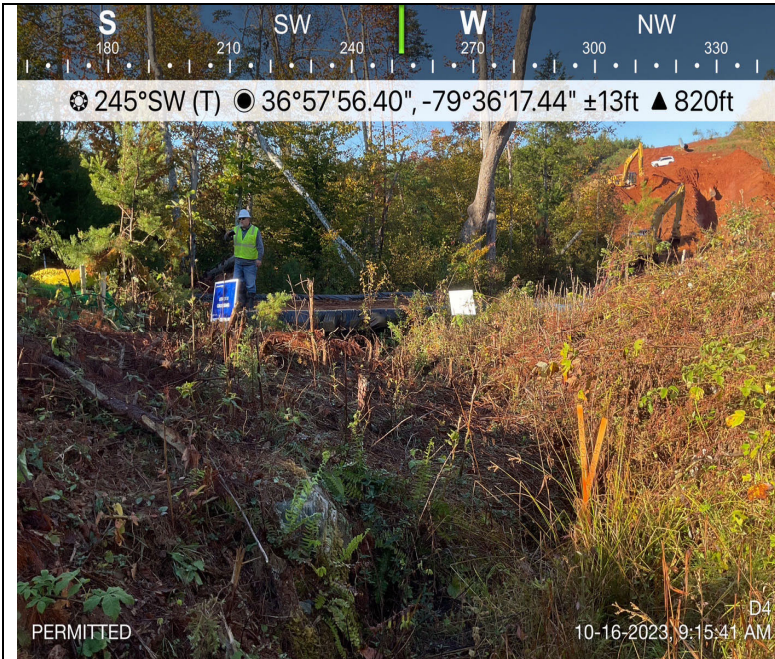
Photo Description: Downstream view of permitted impact area during pre-construction assessment.

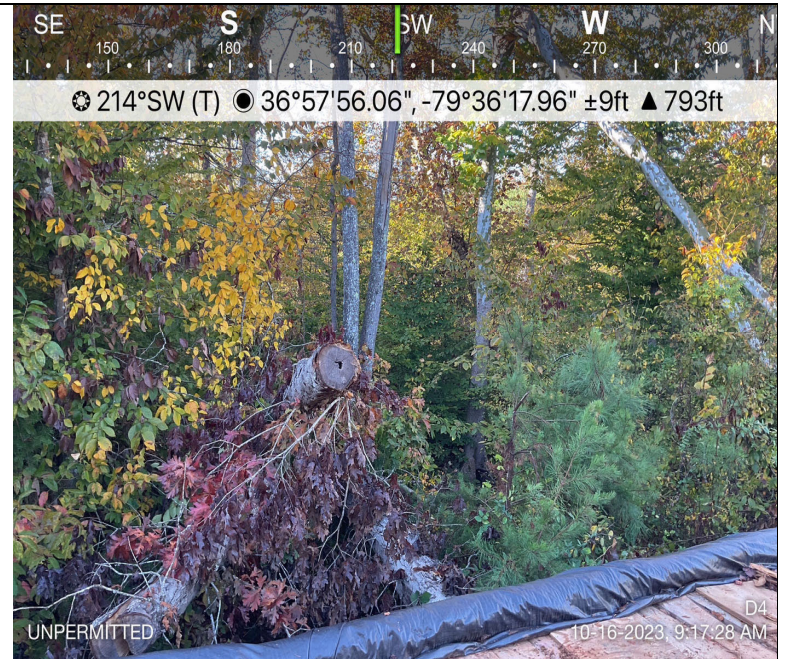
Photo Description: Conditions of the downstream area outside the ROW during pre-construction assessment.

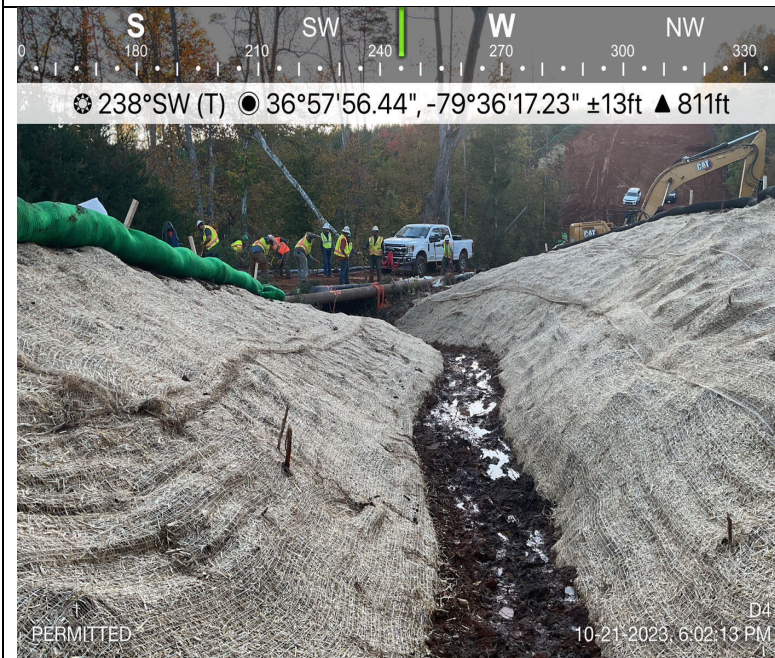
Photo Description: Downstream view of permitted impact area during post-construction assessment.

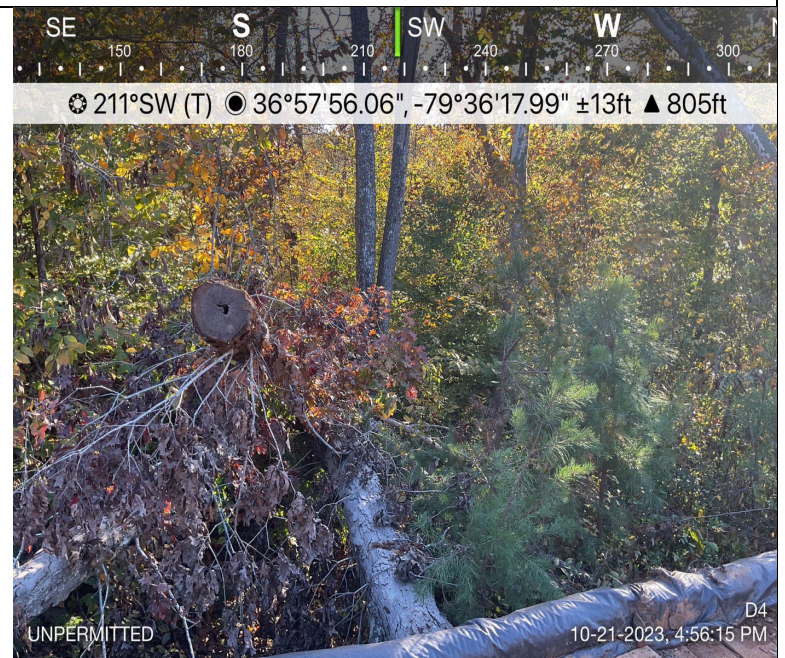
Photo Description: Conditions of the downstream area outside the ROW during post-construction assessment.

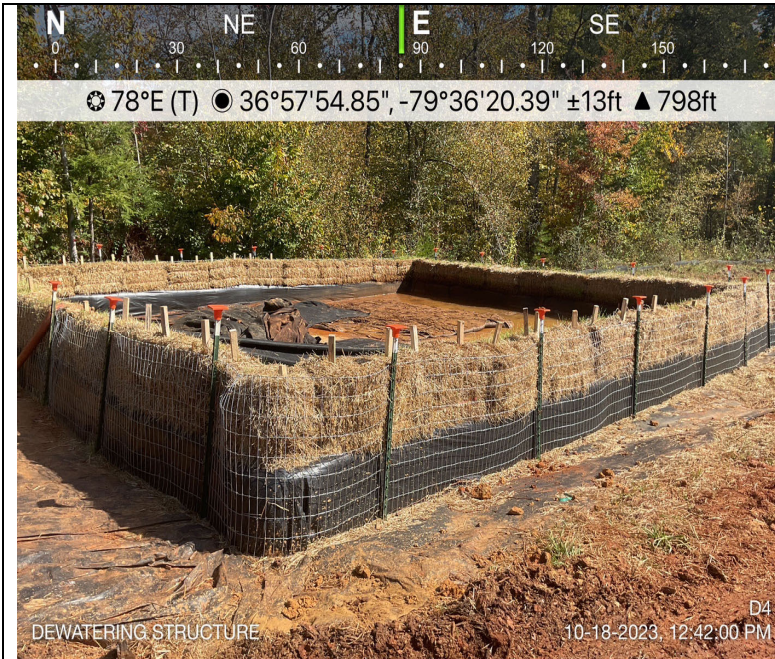
Photo Description: Overview of the Dewatering structure.

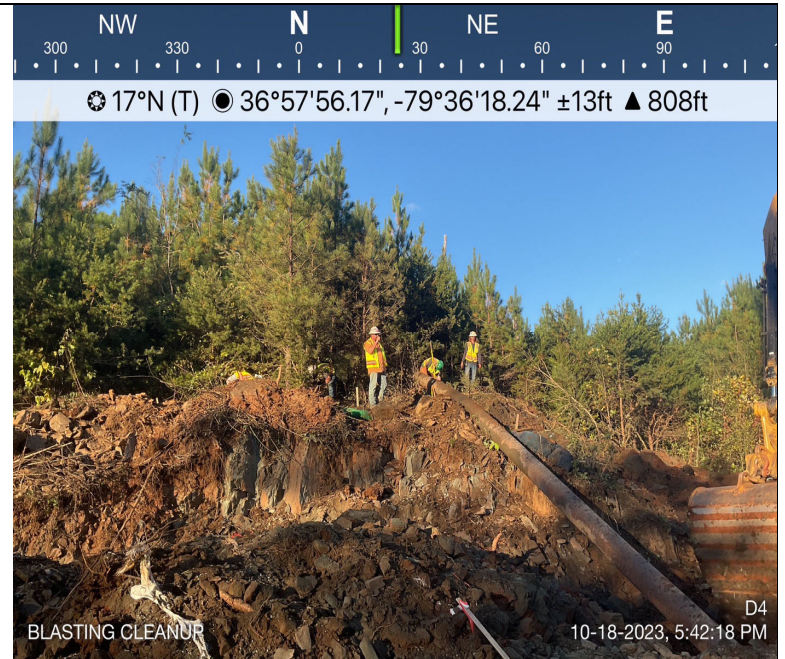
Blasting activities began. Blasting activities area complete. The blasting activities resulted in the inadvertent deposition of blasting debris approximately 10-feet outside of the upland ROW boundaries. The situation was relayed to MVP officials and the crew is waiting on guidance before removing the debris that is outside of the ROW. No material was deposited within the unpermitted resource area. Excavation of the trench began.

10-19-2023: Excavation continued. A hydraulic hammer was utilized to break rock in the trench. Per project personnel, the contractor's environmental crews are waiting for authorization before leaving the ROW to remove the blasting debris that remains outside of the ROW. -G. Aceves

As of the completion of the resource crossing and post-construction auditor assessment, blasting material/debris outside upland ROW boundary had not been removed.

Photo Description: Assessment by contractor of the blasting debris that went off ROW in upland area. As of completion of auditor report, material had not been retrieved from off-site.

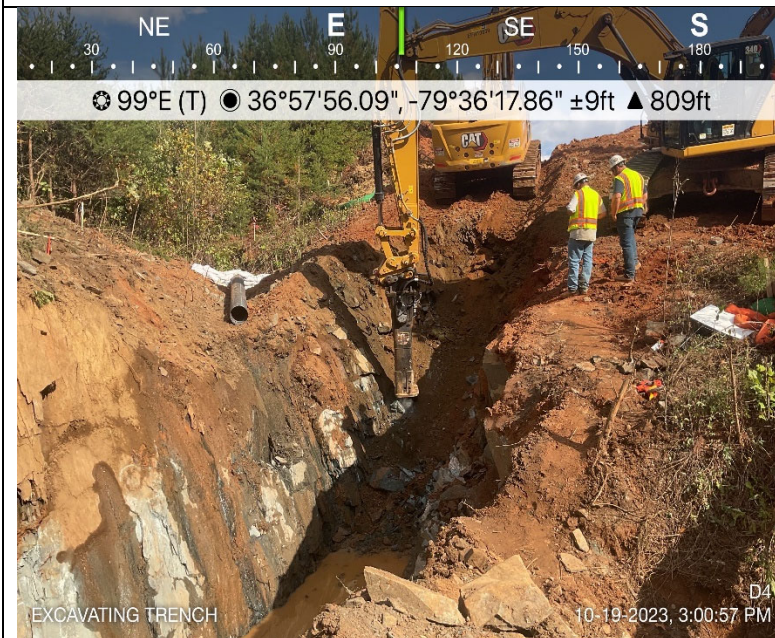
Photo Description: Excavation of the trench.

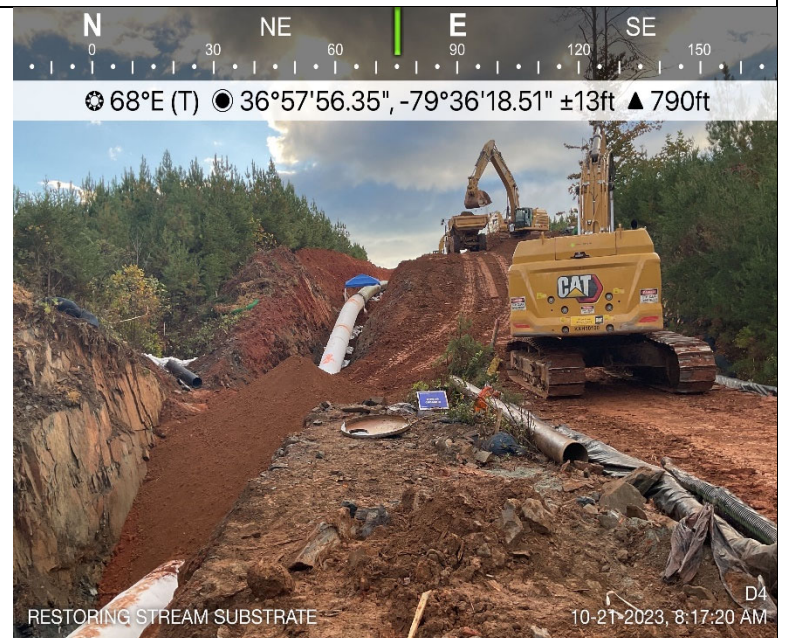
Photo Description: Restoration of the stream substrate.
