STREAM BIOLOGICAL CONDITIONS ENVIRONMENTAL AUDITOR REPORT

Stream ID: S-D7	Crossing Start Date: 09/29/2023	Crossing Completion Date: 10/03/2023
Milepost: 283.7	Pre-Con Assessment Date: 09/27/2023	Post-Con Assessment Date: 10/03/2023
Station: 14991+12	Stream Classification: Intermittent (Perennial, Intermittent, Ephemeral)	Bankfull Width (ft.): 8
County: Franklin	303(d) Impairment Listing: Not Impaired	Riffle:Pool Complexes Present? No

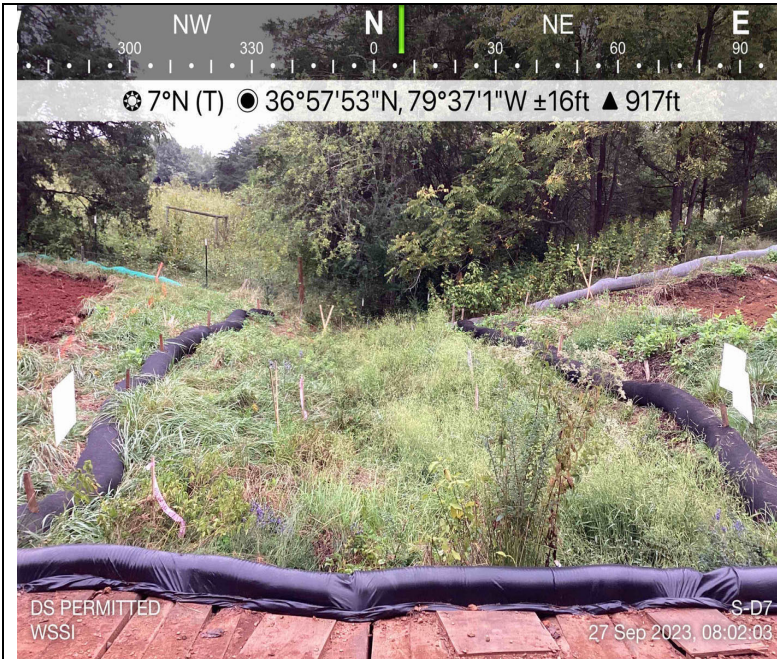
Photo Description: Downstream view of permitted impact area during pre-construction assessment.

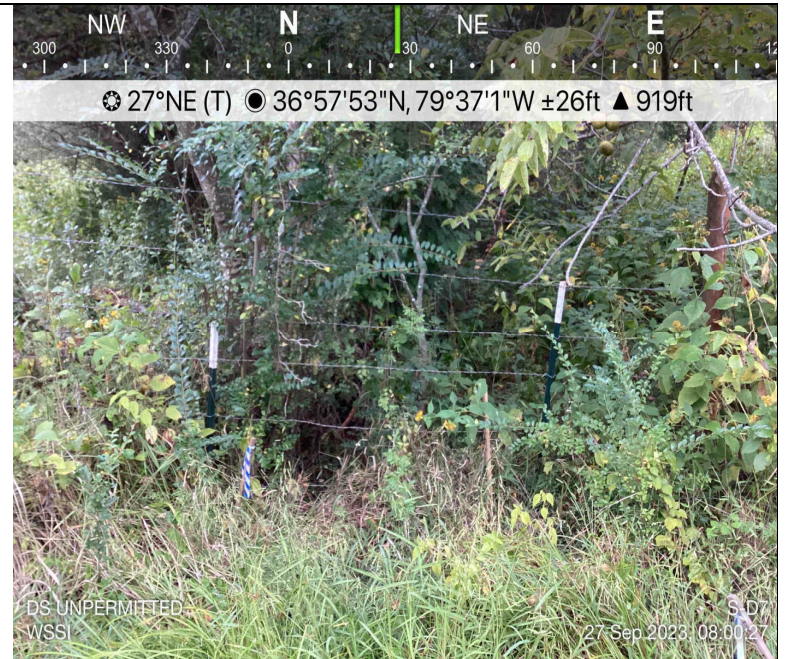
Photo Description: Conditions of the downstream area outside the ROW during pre-construction assessment.

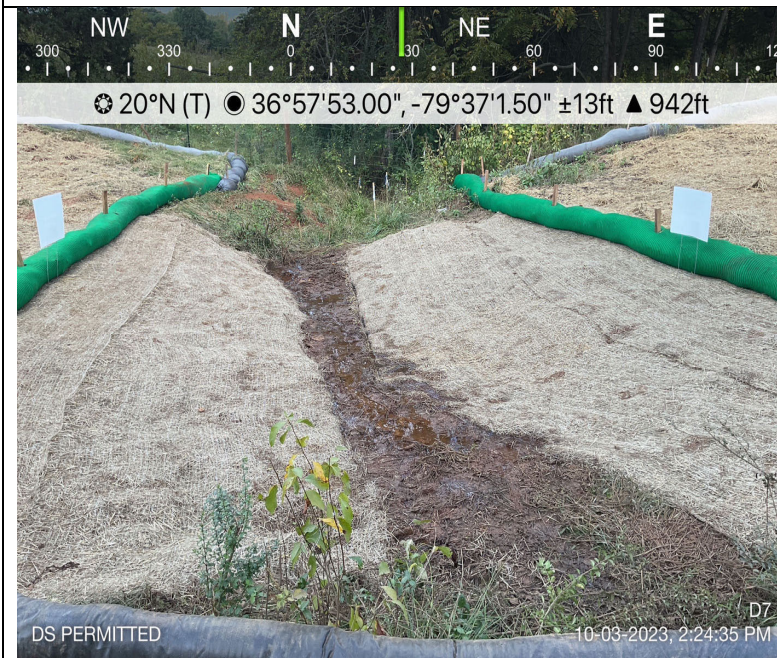
Photo Description: Downstream view of permitted impact area during post-construction assessment.

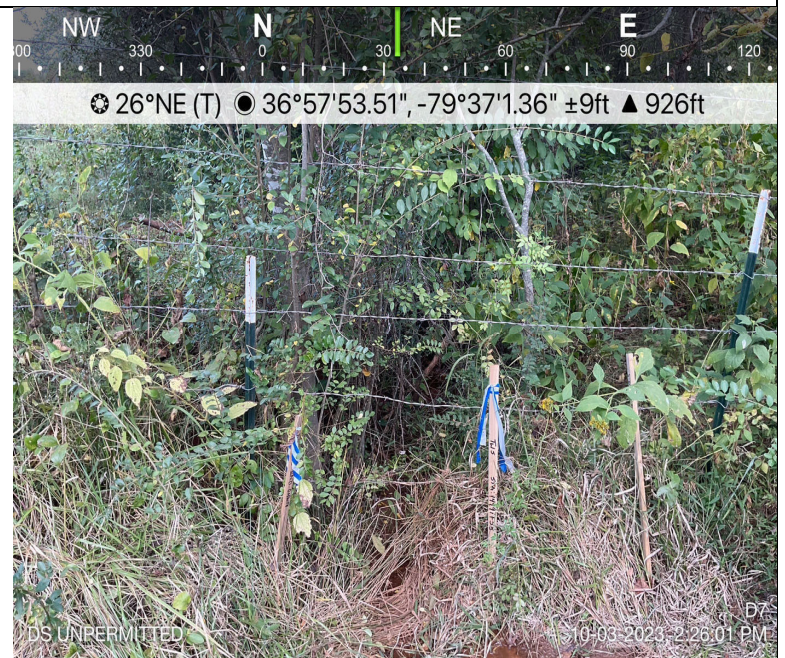
Photo Description: Conditions of the downstream area outside the ROW during post-construction assessment.

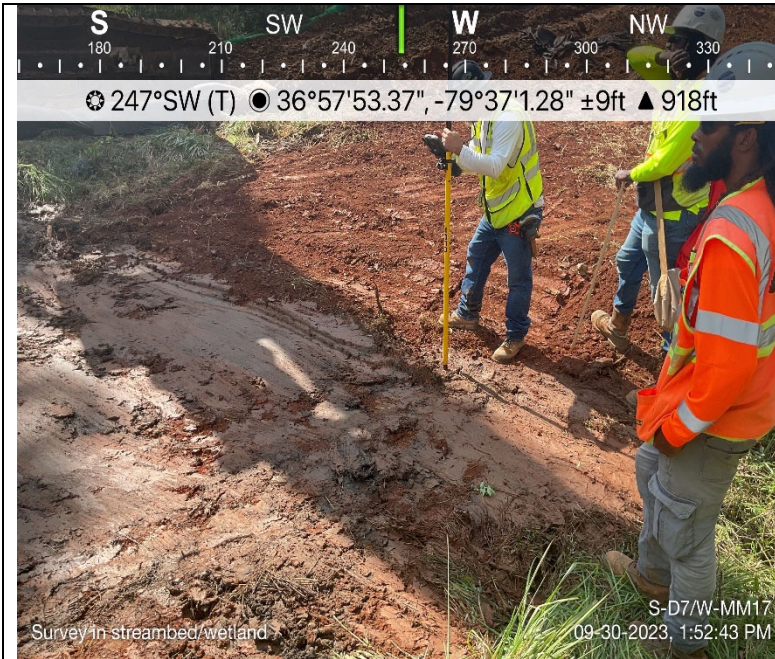
Photo Description: Survey crews stake out of pre-existing conditions for restoration purposes.

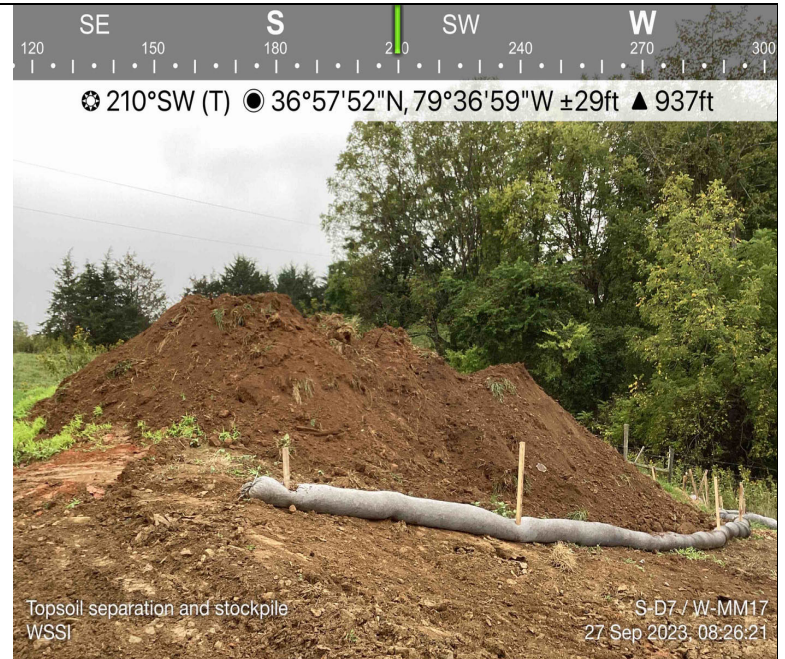
Photo Description: Buffer zone topsoil stockpiled separately from subsoil.

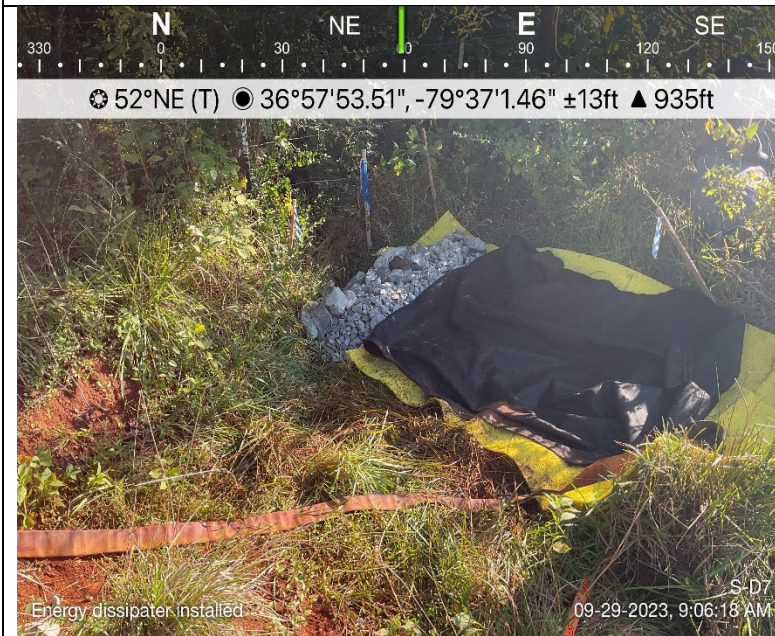
Photo Description: Dam and pump downstream outlet and energy dissipation.

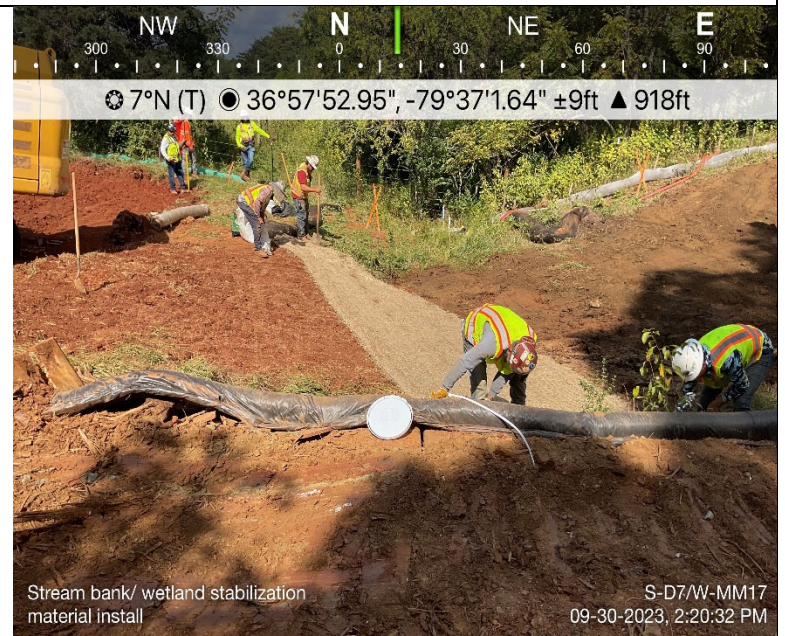
Photo Description: Restoration crews applying seed and stabilization matting to impacted resource areas.
