STREAM BIOLOGICAL CONDITIONS ENVIRONMENTAL AUDITOR REPORT

Stream ID: S-E17	Crossing Start Date: 09/19/2023	Crossing Completion Date: 09/25/2023
Milepost: 276	Pre-Con Assessment Date: 09/13/2023	Post-Con Assessment Date: 09/25/2023
Station: 14582+99	Stream Classification: Perennial (Perennial, Intermittent, Ephemeral)	Bankfull Width (ft.): 8
County: Franklin	303(d) Impairment Listing: Not Impaired	Riffle:Pool Complexes Present? No

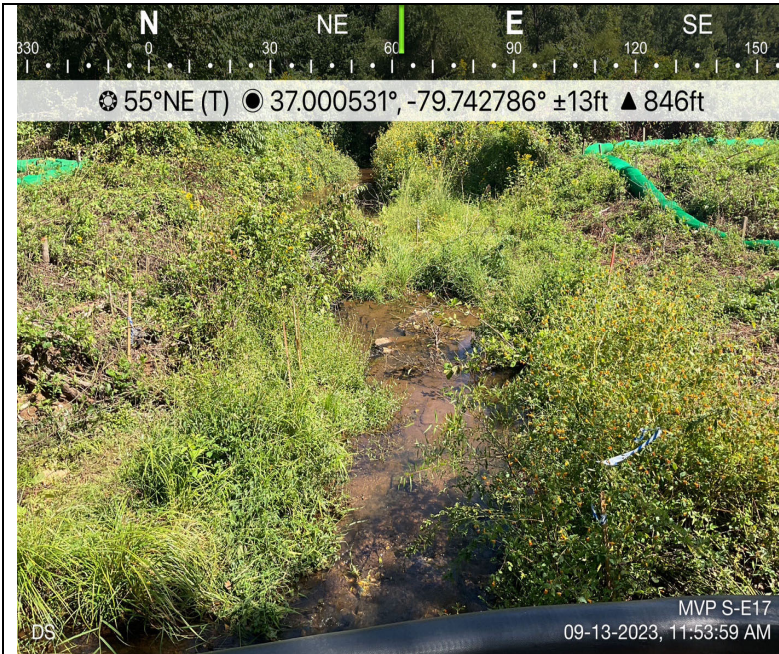
Photo Description: Downstream view of permitted impact area during pre-construction assessment.

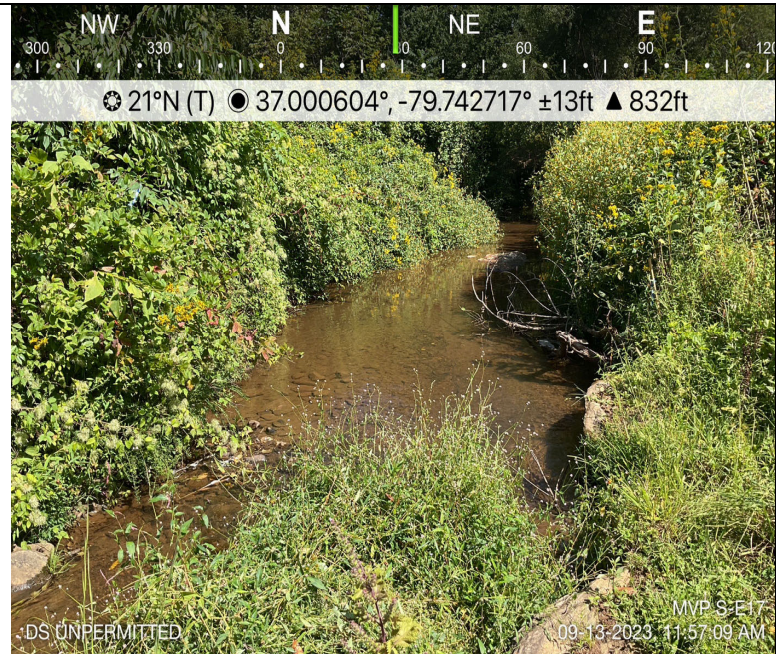
Photo Description: Conditions of the downstream area outside the ROW during pre-construction assessment.

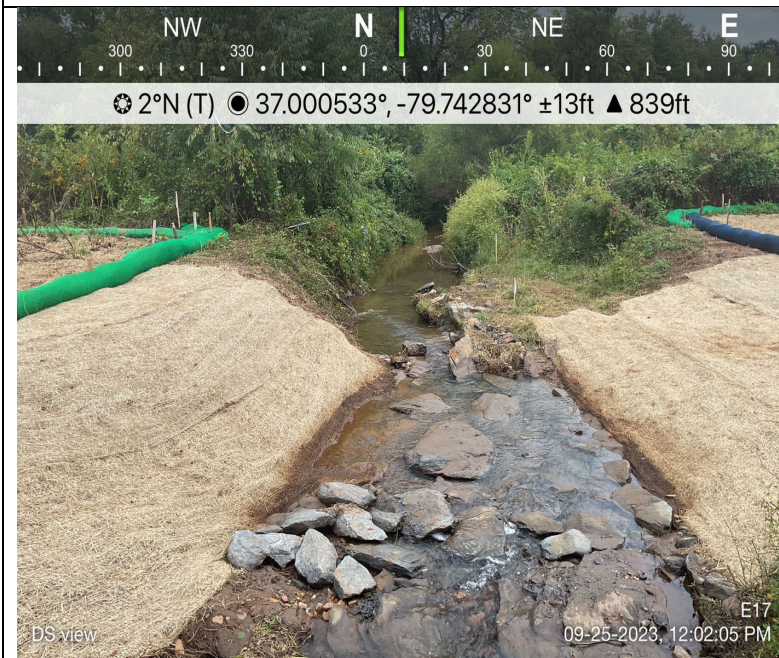
Photo Description: Downstream view of permitted impact area during post-construction assessment.

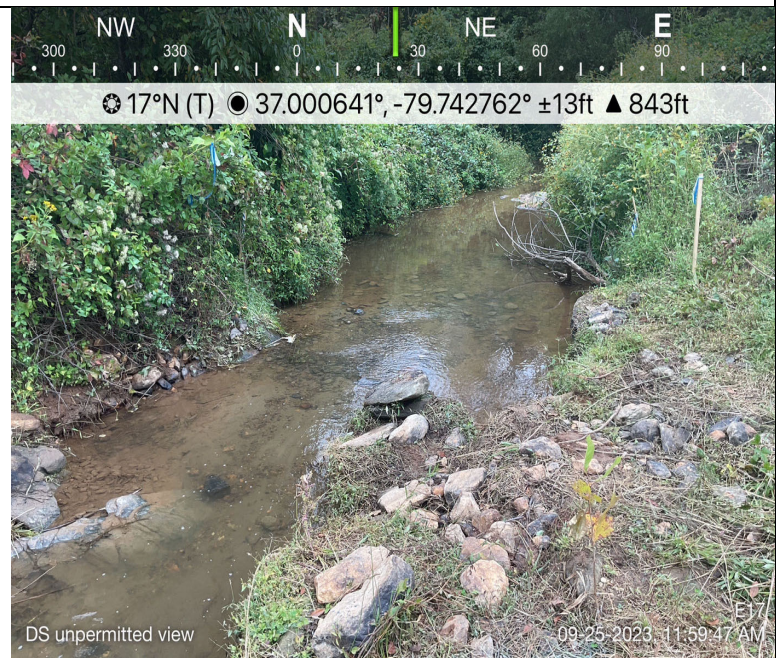
Photo Description: Conditions of the downstream area outside the ROW during post-construction assessment.

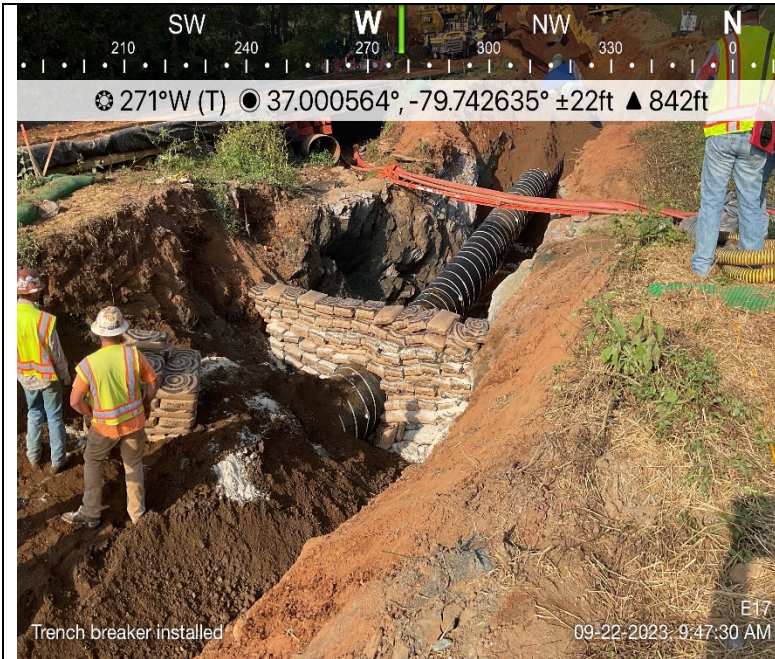
Photo Description: Trench breaker installation.

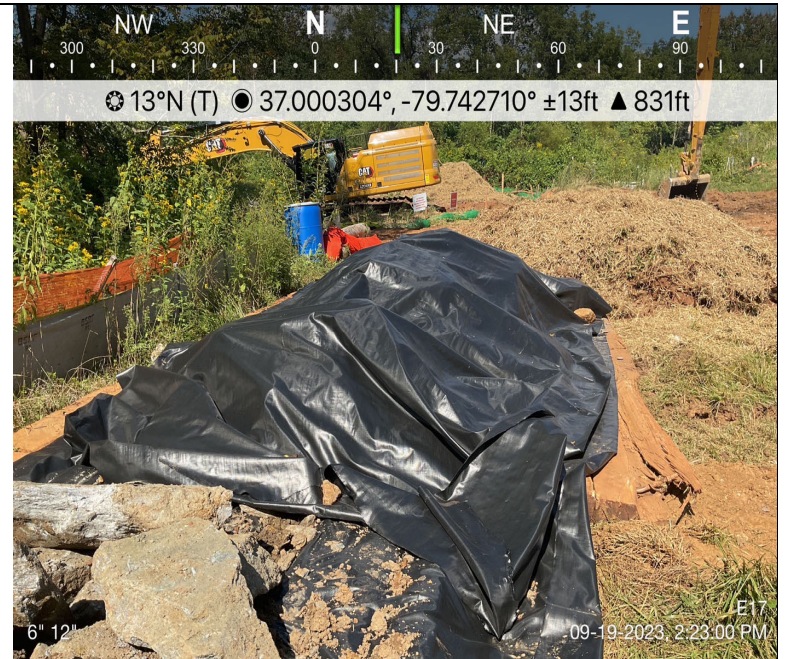
Photo Description: Streambed material stockpiled separately from subsoil.

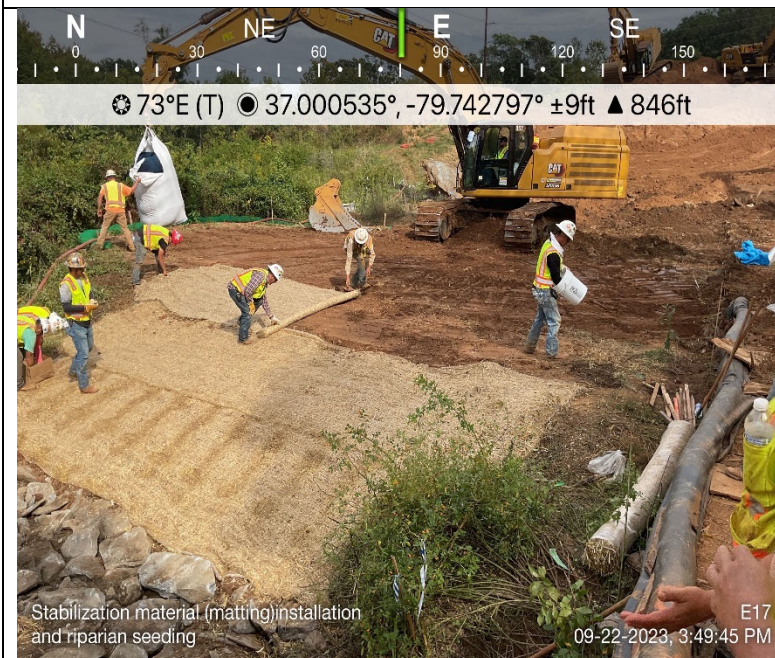
Photo Description: Bank restoration with riparian seed mix and erosion control matting.

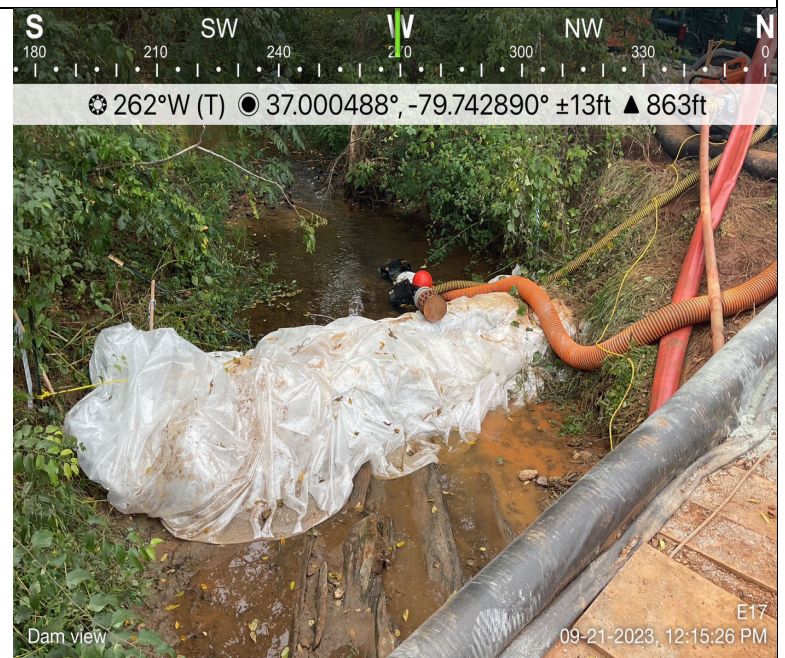
Photo Description: View of upstream dam for pump around operation.
