STREAM BIOLOGICAL CONDITIONS ENVIRONMENTAL AUDITOR REPORT

Stream ID: S-E18	Crossing Start Date: 09/26/2023	Crossing Completion Date: 09/27/2023
Milepost: 275.7	Pre-Con Assessment Date: 09/22/2023	Post-Con Assessment Date: 09/27/2023
Station: 14569+14	Stream Classification: Perennial (Perennial, Intermittent, Ephemeral)	Bankfull Width (ft.): 7
County: Franklin	303(d) Impairment Listing: Not Impaired	Riffle:Pool Complexes Present? No

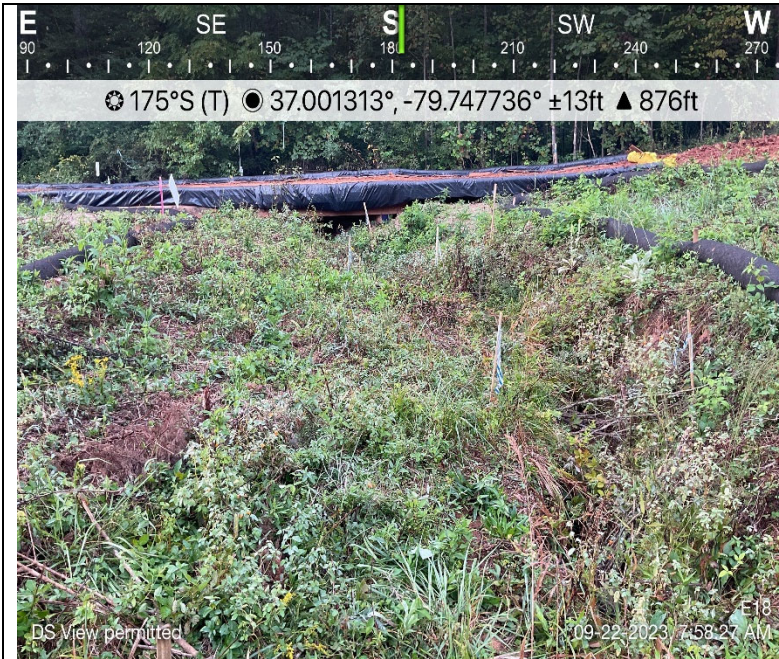
Photo Description: Downstream view of permitted impact area during pre-construction assessment.

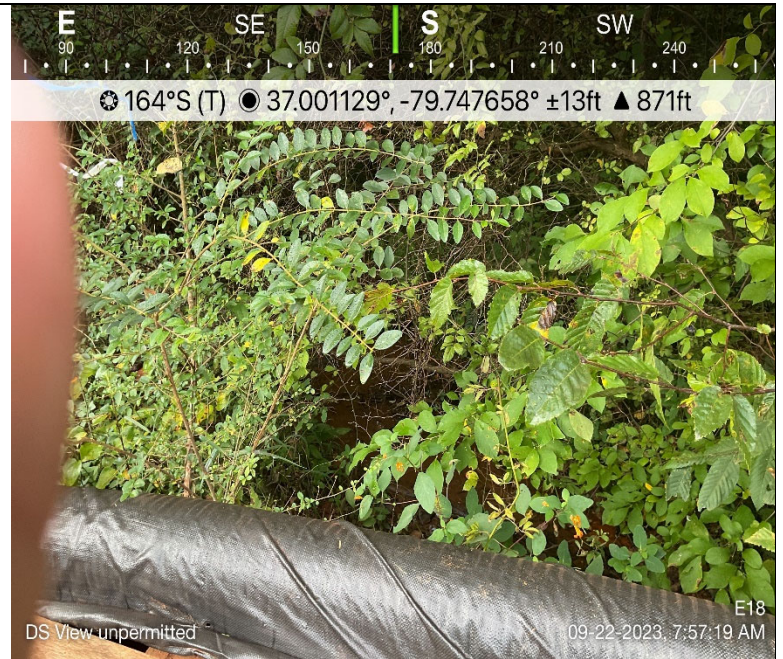
Photo Description: Conditions of the downstream area outside the ROW during pre-construction assessment.

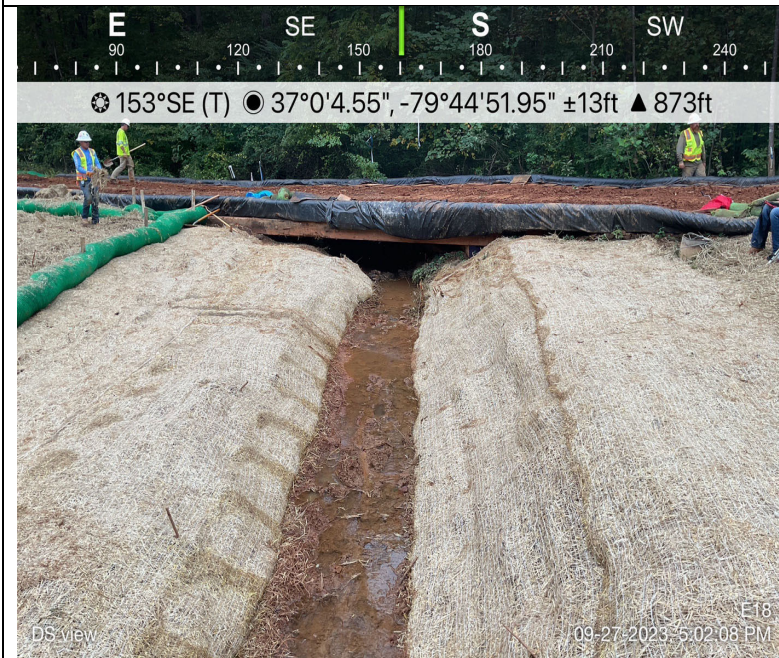
Photo Description: Downstream view of permitted impact area during post-construction assessment.

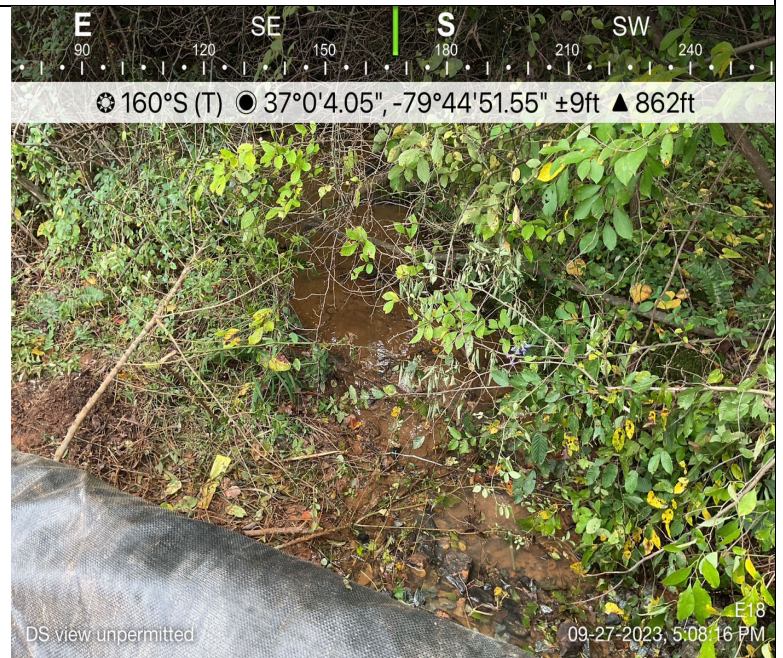
Photo Description: Conditions of the downstream area outside the ROW during post-construction assessment.

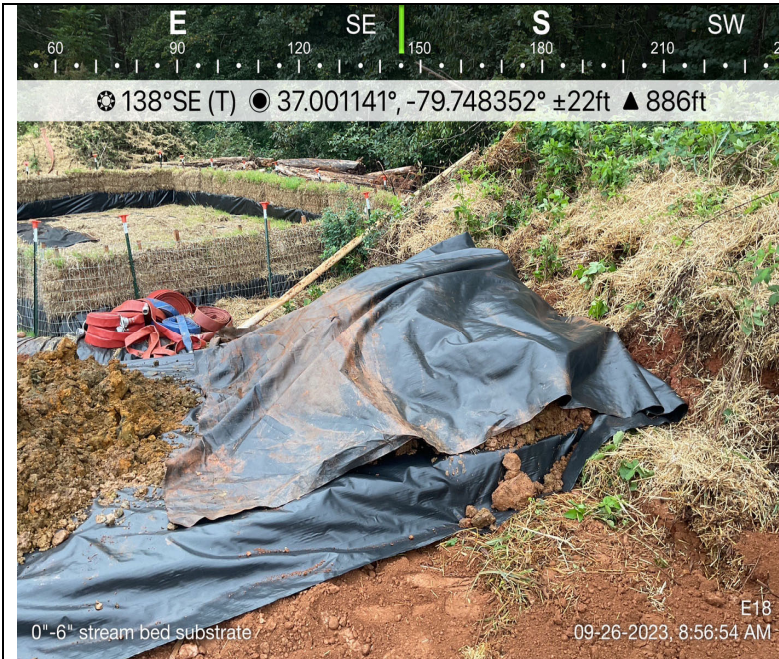
Photo Description: Stream substrate 0-6" stream segregated and stockpiled separately from subsoil

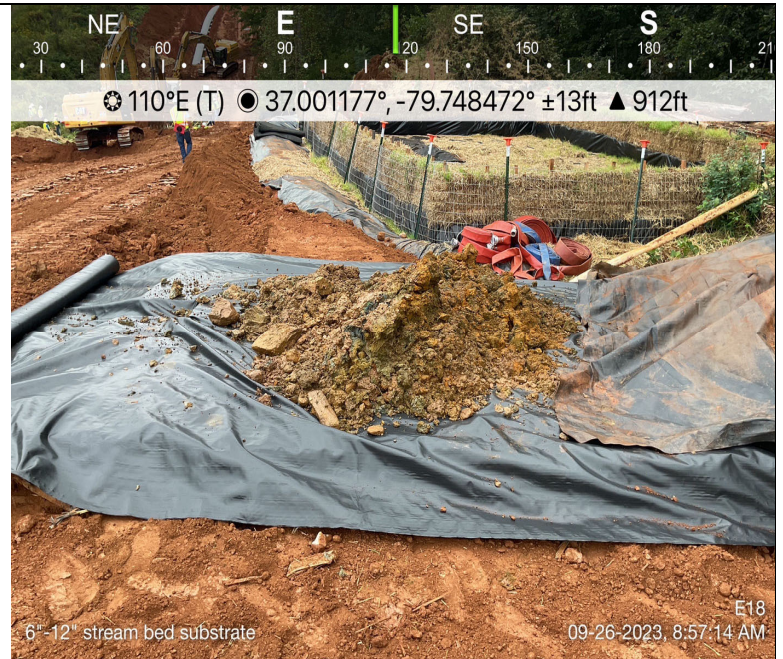
Photo Description: Stream topsoil layer (6-12") segregated and stockpiled separately from subsoil.

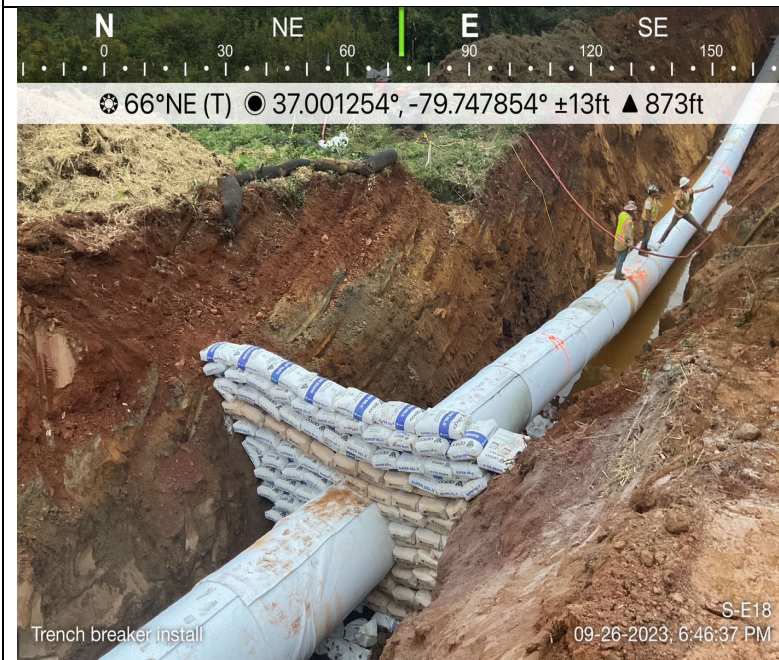
Photo Description: Trenchbreaker installation.

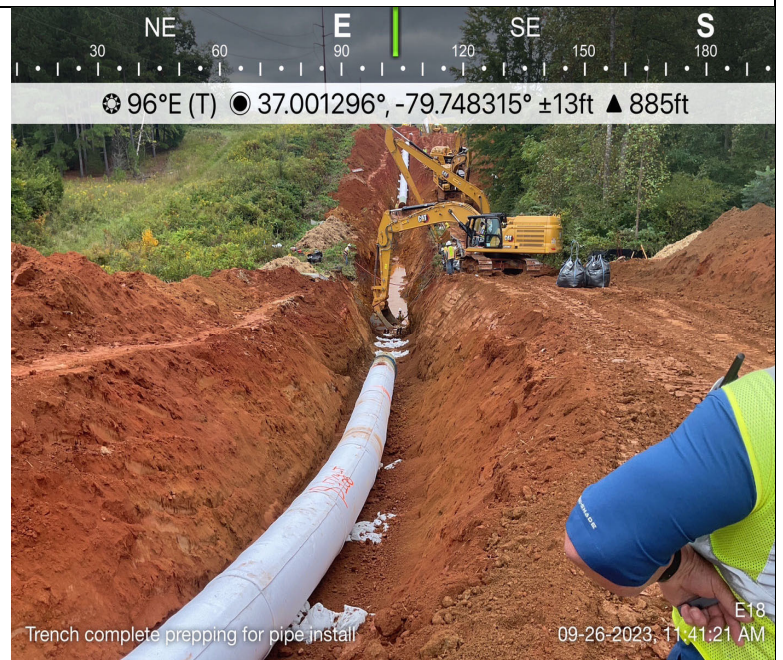
Photo Description: Trench open and pipe laid across the resource.
