# STREAM BIOLOGICAL CONDITIONS ENVIRONMENTAL AUDITOR REPORT

<b>Stream ID:</b> S-E28-E	<b>Crossing Start Date:</b> 09/12/2023	<b>Crossing Completion Date:</b> 09/16/2023
<b>Milepost:</b> 259.3	<b>Pre-Con Assessment Date:</b> 08/29/2023	<b>Post-Con Assessment Date:</b> 09/18/2023
<b>Station:</b> 13704+90	<b>Stream Classification:</b> Perennial (Perennial, Intermittent, Ephemeral)	<b>Bankfull Width (ft.):</b> 12
<b>County:</b> Franklin	<b>303(d) Impairment Listing:</b> Impaired	<b>Riffle:Pool Complexes Present?</b> Yes

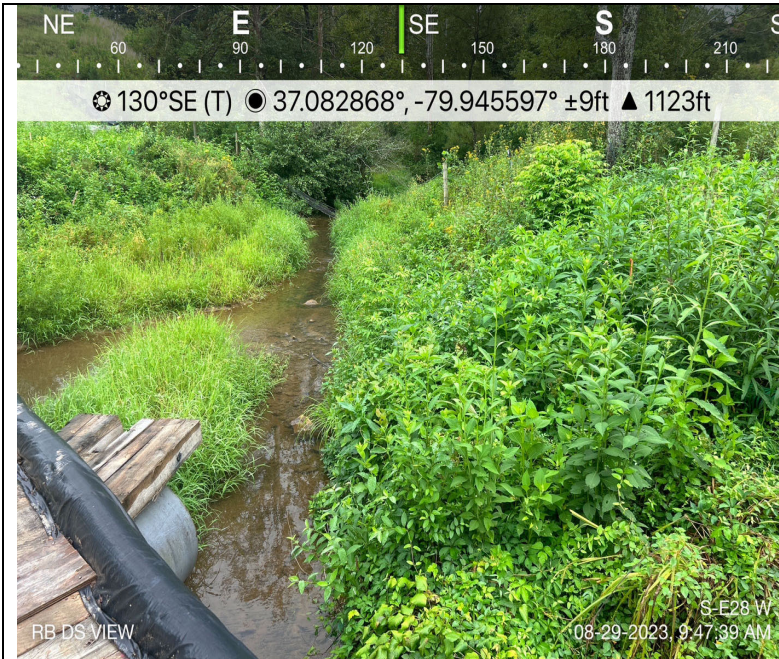
**Photo Description:** Downstream view of permitted impact area during pre-construction assessment.

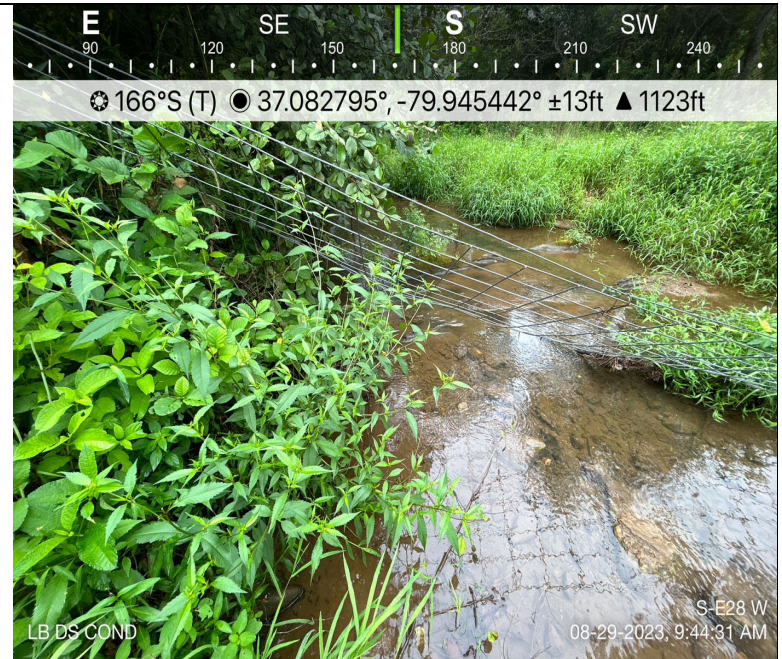
**Photo Description:** Conditions of the downstream area outside the ROW during pre-construction assessment.

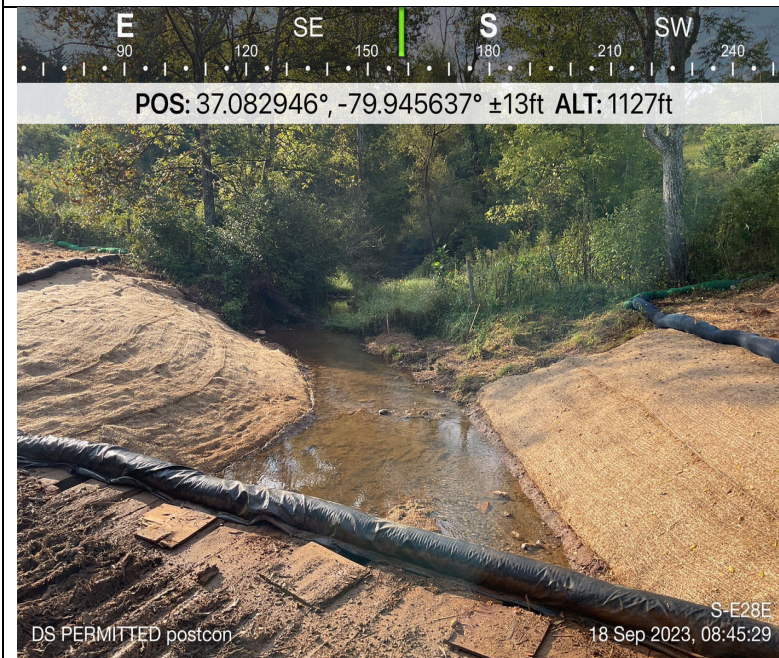
**Photo Description:** Downstream view of permitted impact area during post-construction assessment.

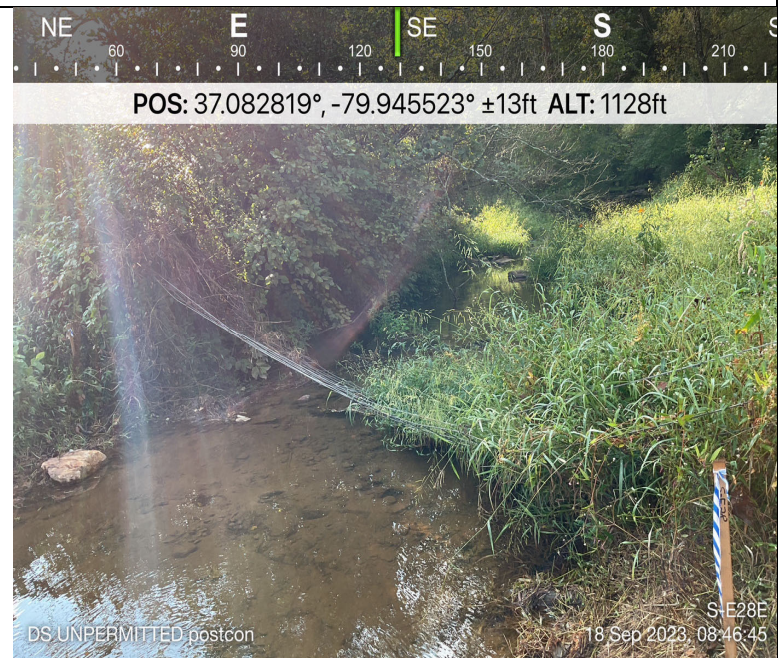
**Photo Description:** Conditions of the downstream area outside the ROW during post-construction assessment.

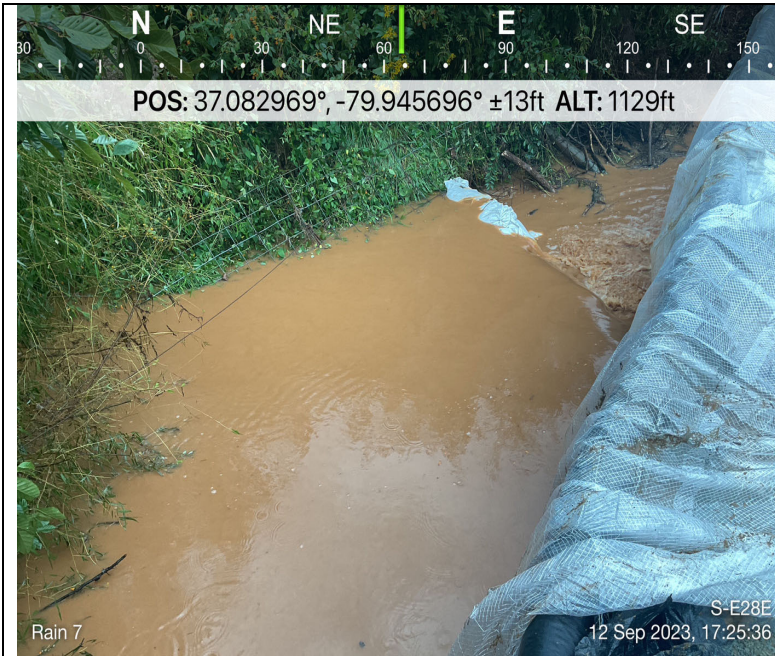
Item #14: Flash rain event in the afternoon caused water to overtake the dams at the stream, filling the trench. Prior to the flow topping the dams the crew added additional bags to raise the height of the dams and started running a second pump to contain the additional flow, but the flow was too heavy. Site received ~1in rainfall in 20-30 minutes. Crew added two additional pumps (total of 4) in order to try and control the flow of water in order to install the new dams. Filter bags were being used on the pumps. 2 workers to stay overnight to ensure pumps are functioning. See additional photos below.

**Photo Description:** Overtopped/flooded upstream dam at S-E28-E crossing.

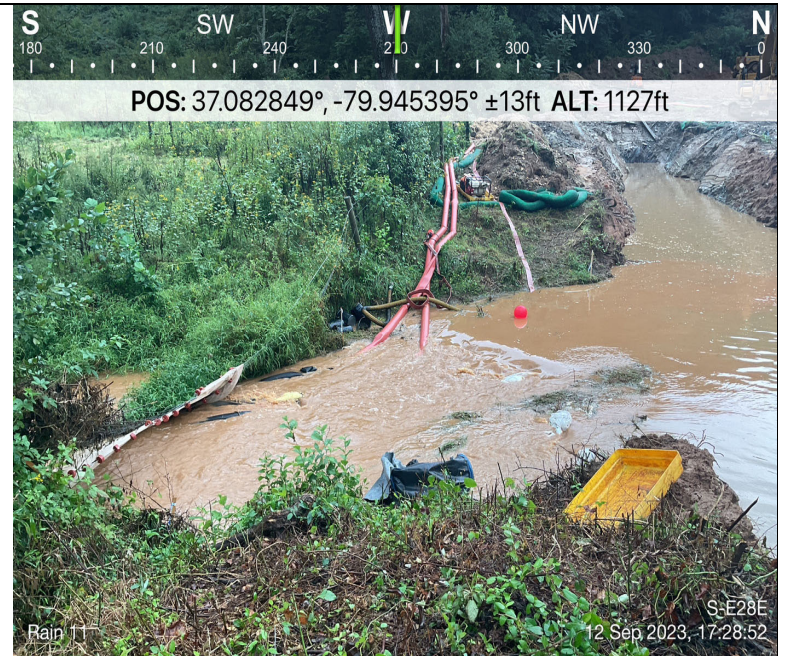
**Photo Description:** Open trench flooded and downstream dam overtopped by rain/flood waters.

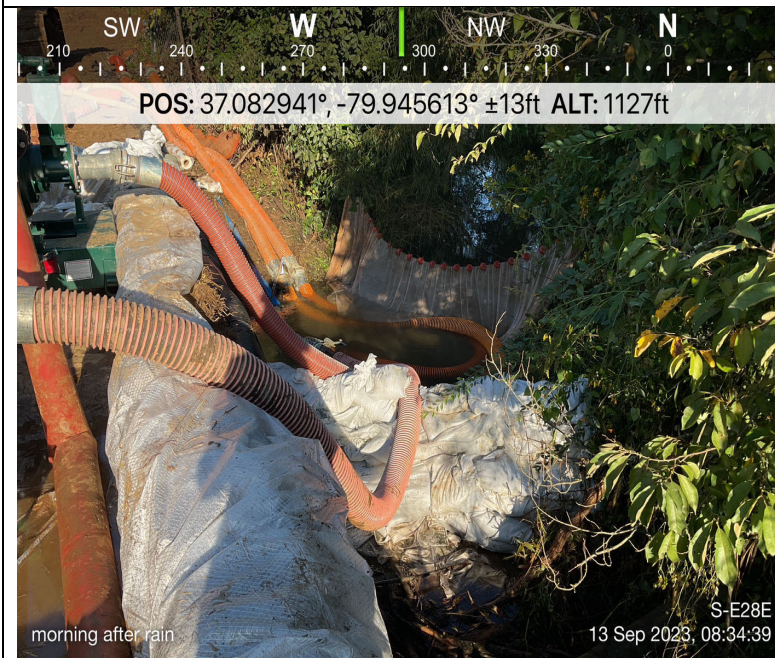
**Photo Description:** Next day additional pumps and dam reinforcements installed.

9-13-2023: Water level has gone down and dams are re-established. Dewatering the trench into dewatering area to the east. Crew did not end up using the metal dams because they were only authorized to do so after the water was under control and dams in place. DEQ Marshall Willis was on site to inspect the aftermath of the rain event. Dug out the rest of the trench. Lowered pipe into trench onto bags. Connection point being welded. PipeSaks installed at crossing. 6ft clearance from top of pipe without the pipesaks and 5ft clearance with the sacks at the crossing. Fill dirt being installed. Trench breakers may start tonight/tomorrow morning. Trench breakers to be installed approx 50' outside top of bank due to safety concerns. -S. Canfield

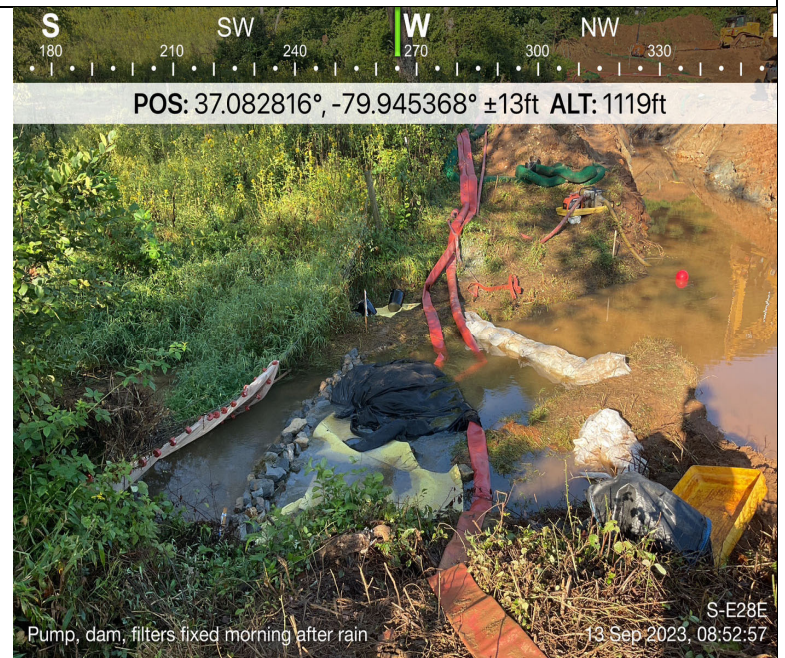
**Photo Description:** Downstream dam re-established and flooded trench now isolated from S-E28-E stream flow. Downstream turbidity significantly reduced from work area turbidity.

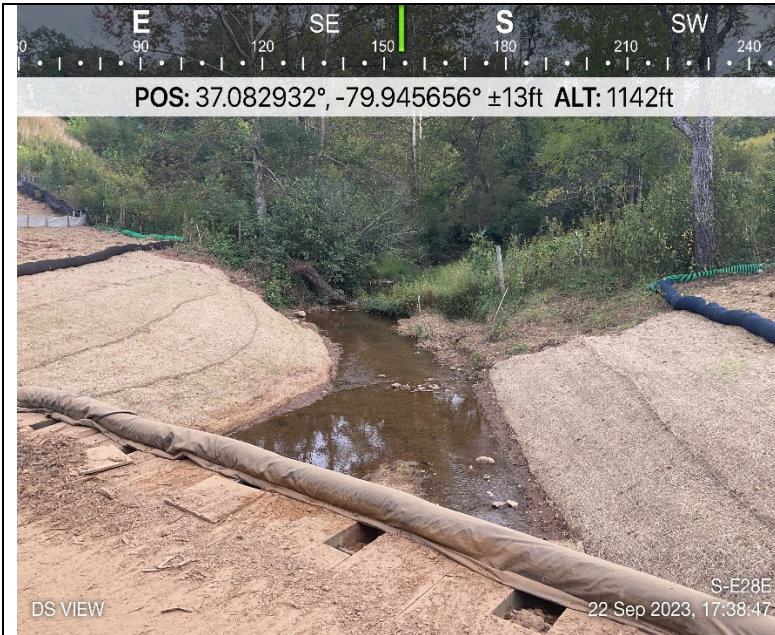
Item #14: No accumulated construction material or visible sediment deposition was observed outside the permitted LOD, and the incident did not appear to adversely impact biological conditions. Fish, crayfish, frogs, and a crane were observed within the stream channel post-restoration. –S. Canfield

**Photo Description:** Downstream view of restoration 5 days post-restoration. No accumulated material, significant turbidity, or signs of accelerated erosion of stream banks was observed.

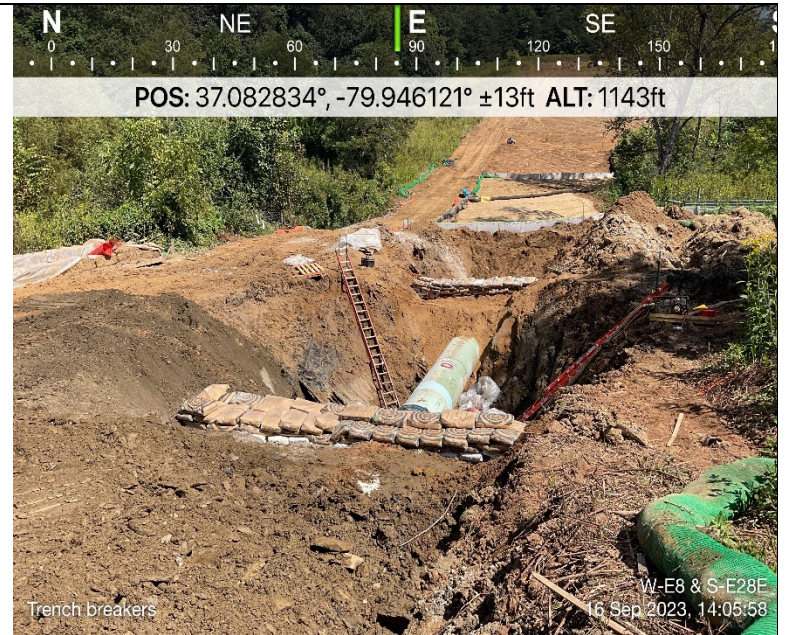
9-15-2023: Trench breaker off of LB installed 27ft instead of within 25ft top of bank. The breaker was placed farther away to avoid placing it on a weld. Anticipate the second trench breaker off the RB will be installed 9-16-2023. 50ft buffer zones stabilized.

**Photo Description:** Trench breaker installations.

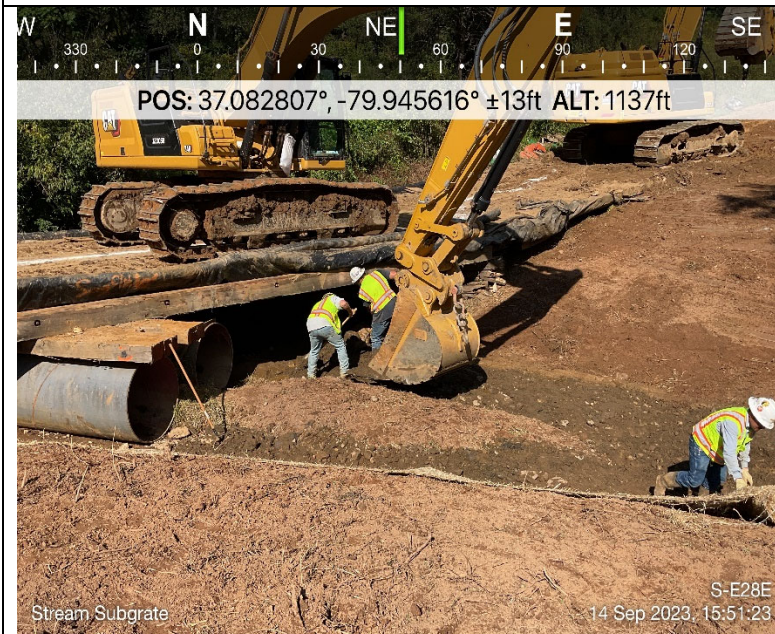
**Photo Description:** Restoration of stream substrate to channel.

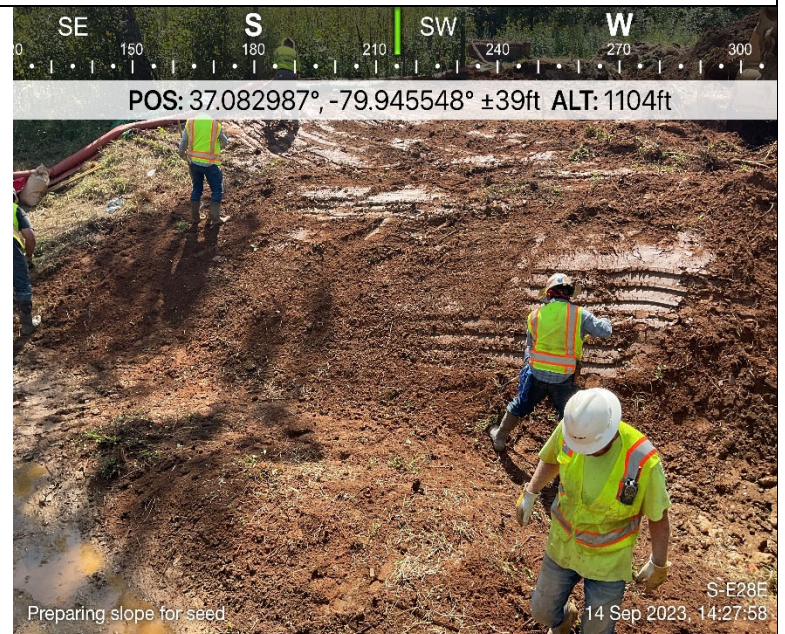
**Photo Description:** Bank fine grading and raking of bank surface prior to application of seed mixes.
