STREAM BIOLOGICAL CONDITIONS ENVIRONMENTAL AUDITOR REPORT

Stream ID: S-E28-M	Crossing Start Date: 08/31/2023	Crossing Completion Date: 09/02/2023
Milepost: 259.1	Pre-Con Assessment Date: 08/29/2023	Post-Con Assessment Date: 09/02/2023
Station: 13693+07	Stream Classification: Perennial (Perennial, Intermittent, Ephemeral)	Bankfull Width (ft.): 12
County: Franklin	303(d) Impairment Listing: Impaired	Riffle:Pool Complexes Present? Yes

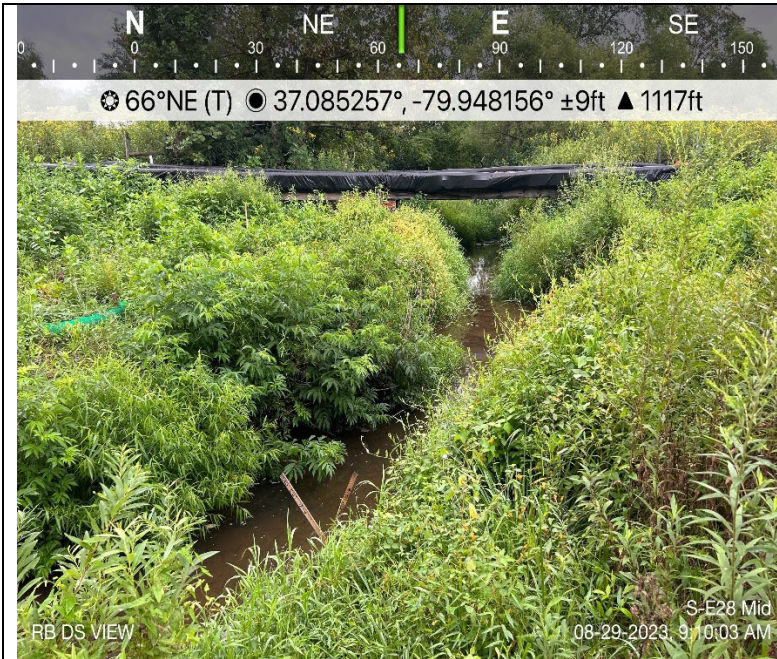
Photo Description: Downstream view of permitted impact area during pre-construction assessment.

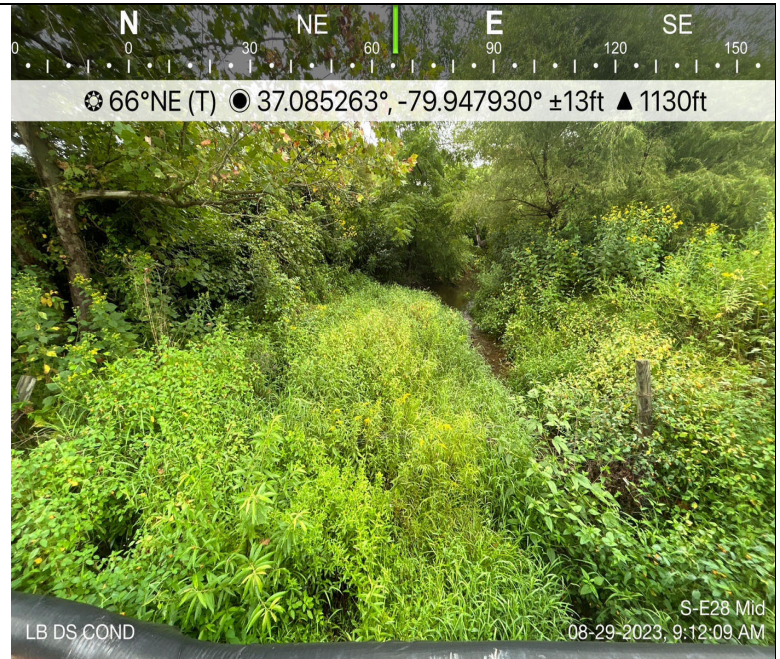
Photo Description: Conditions of the downstream area outside the ROW during pre-construction assessment.

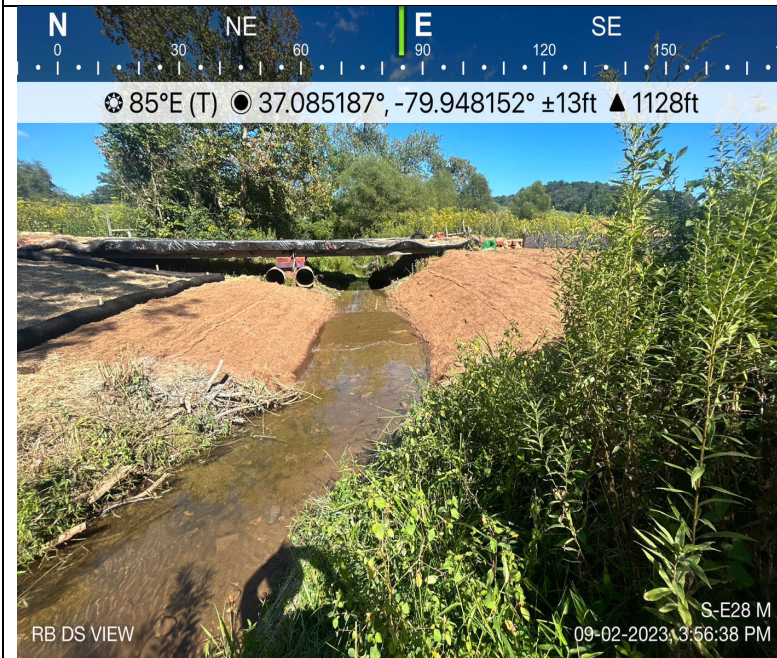
Photo Description: Downstream view of permitted impact area during post-construction assessment.

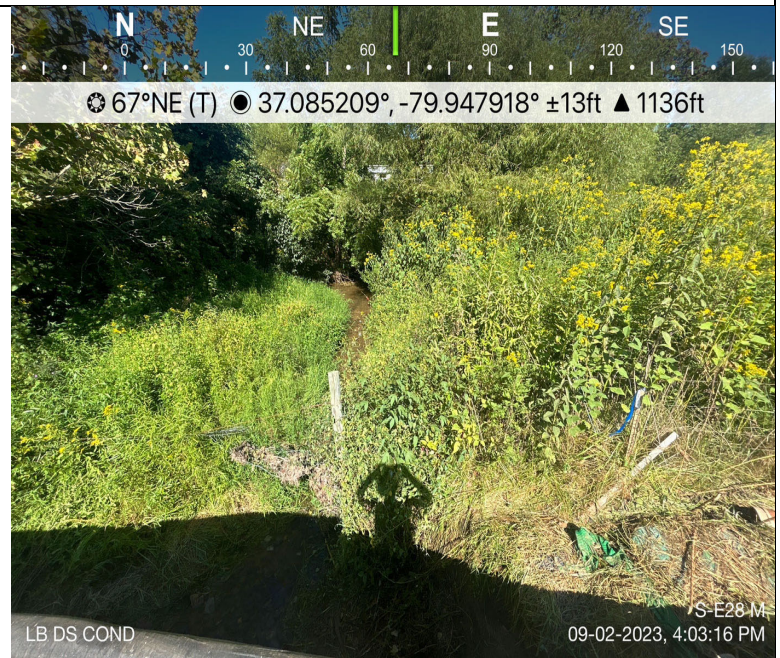
Photo Description: Conditions of the downstream area outside the ROW during post-construction assessment.

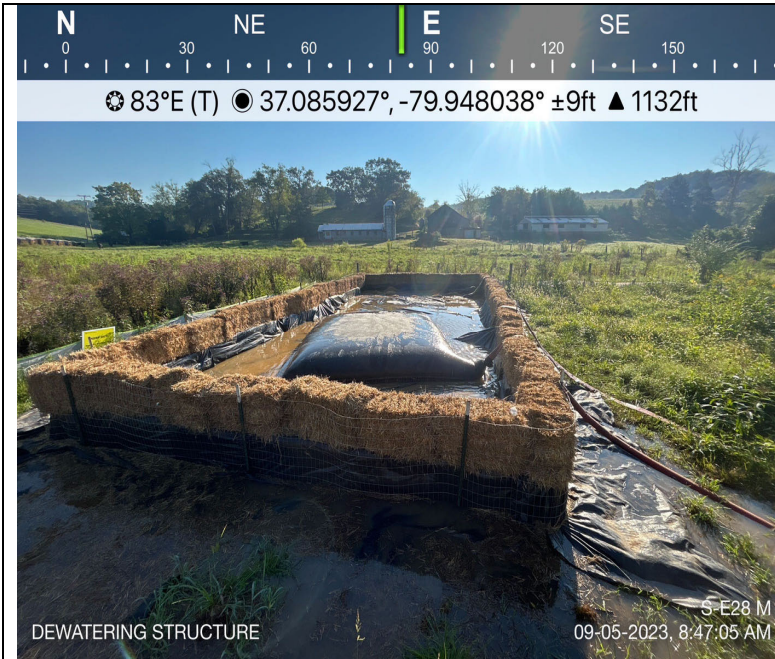
Photo Description: Dewatering structure installed and operating.

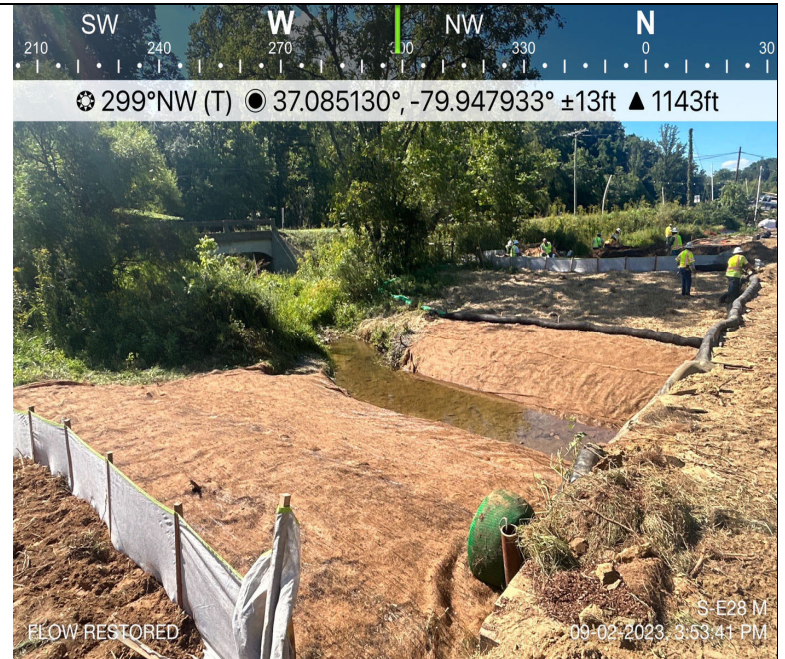
9-2-2023: Survey and environmental crews on site. Trench backfilling continued. Stream channel formed, toe of bank has been restored to pre construction points. Banks have been graded to 3:1 slope. The natural benches of the banks were restored whenever possible. Channel material replaced. Seed and matting installed on banks. Flow restored. -J. Vandertill

Photo Description: Restored and stabilized stream banks.

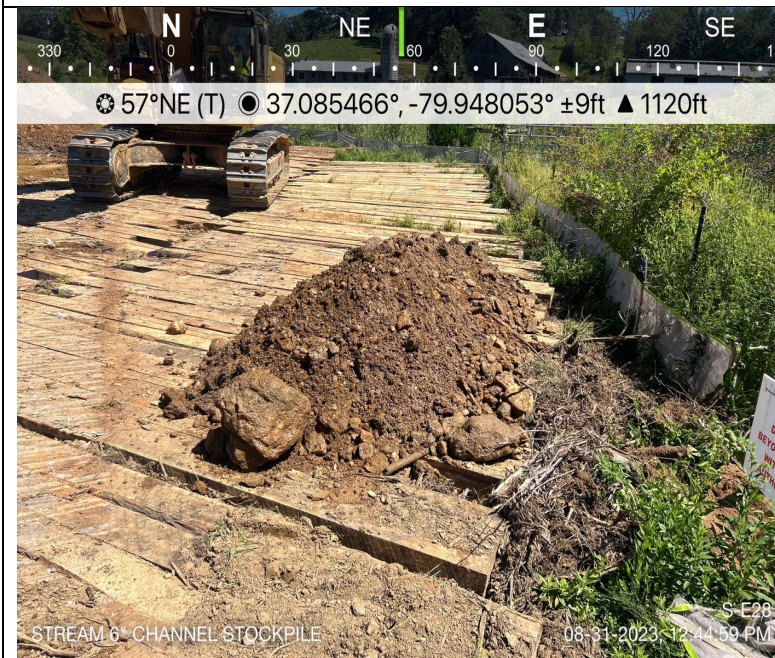
Photo Description: Channel substrate segregated and stockpiled on timber mat.

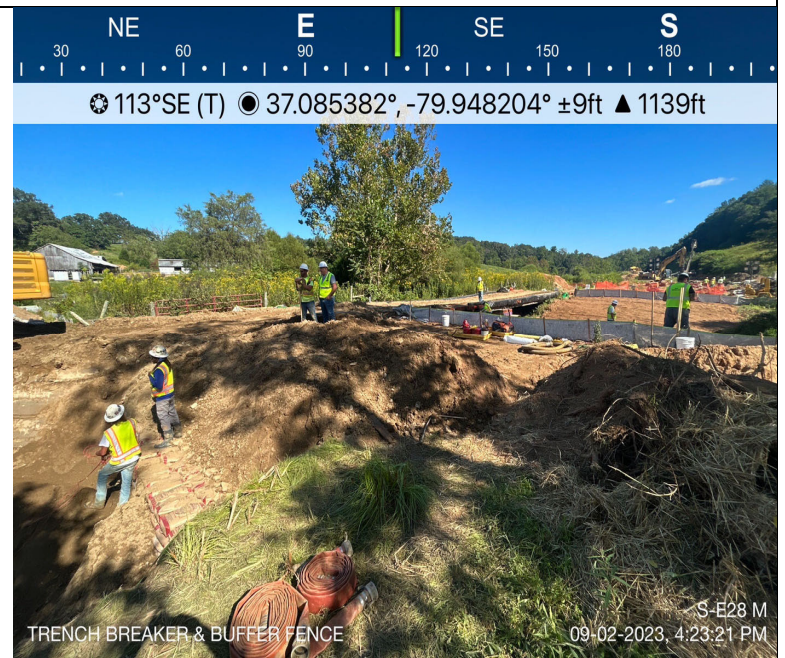
Item #9: The trench breaker was installed approximately 30' outside of the top of bank, per specification MVP-20. A change order was approved by MVP Environmental, and the project noted that a variance request for trench breaker spacing will be submitted to DEQ, if required. Trench backfilling began and stream channel roughed in. -J. Vandertill

9-9-2023: Trench breaker installed on the RB. The trench breaker was installed approximately 40' from top-of-bank per specification MVP-20. -J. Vandertill

Photo Description: Trench breaker installation.
