# STREAM BIOLOGICAL CONDITIONS ENVIRONMENTAL AUDITOR REPORT

<b>Stream ID:</b> S-EF12	<b>Crossing Start Date:</b> 10/02/2023	<b>Crossing Completion Date:</b> 10/05/2023
<b>Milepost:</b> 260.3	<b>Pre-Con Assessment Date:</b> 09/24/2023	<b>Post-Con Assessment Date:</b> 10/05/2023
<b>Station:</b> 13755+26	<b>Stream Classification:</b> Perennial (Perennial, Intermittent, Ephemeral)	<b>Bankfull Width (ft.):</b> 20
<b>County:</b> Franklin	<b>303(d) Impairment Listing:</b> Impaired	<b>Riffle:Pool Complexes Present?</b> No

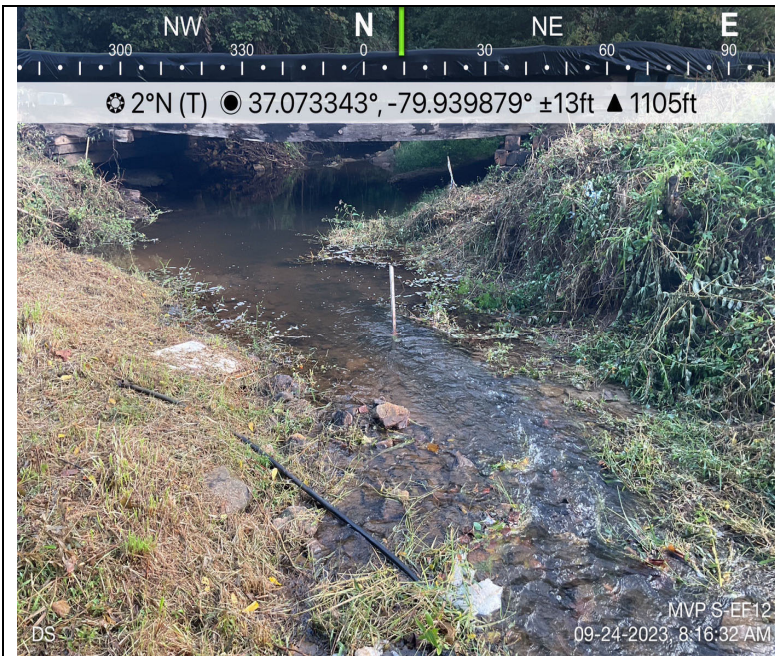
**Photo Description:** Downstream view of permitted impact area during pre-construction assessment.

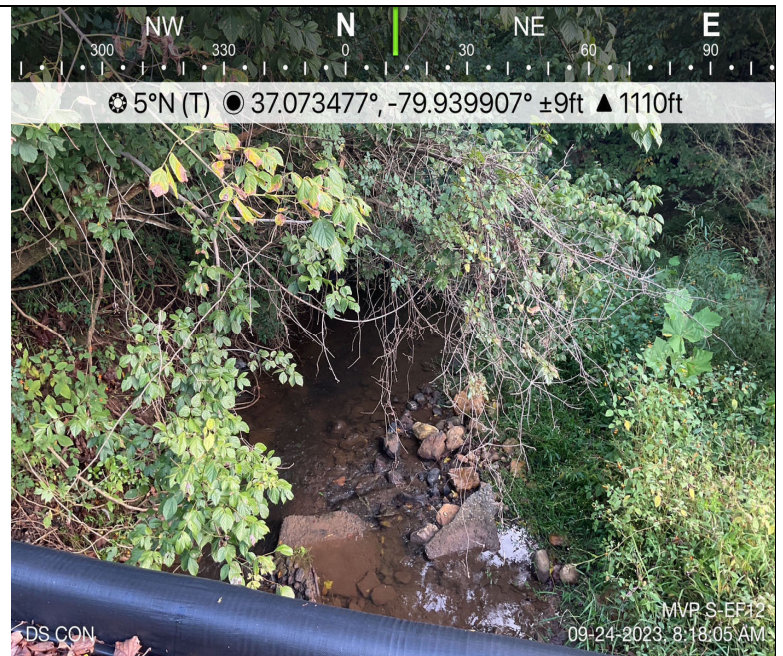
**Photo Description:** Conditions of the downstream area outside the ROW during pre-construction assessment.

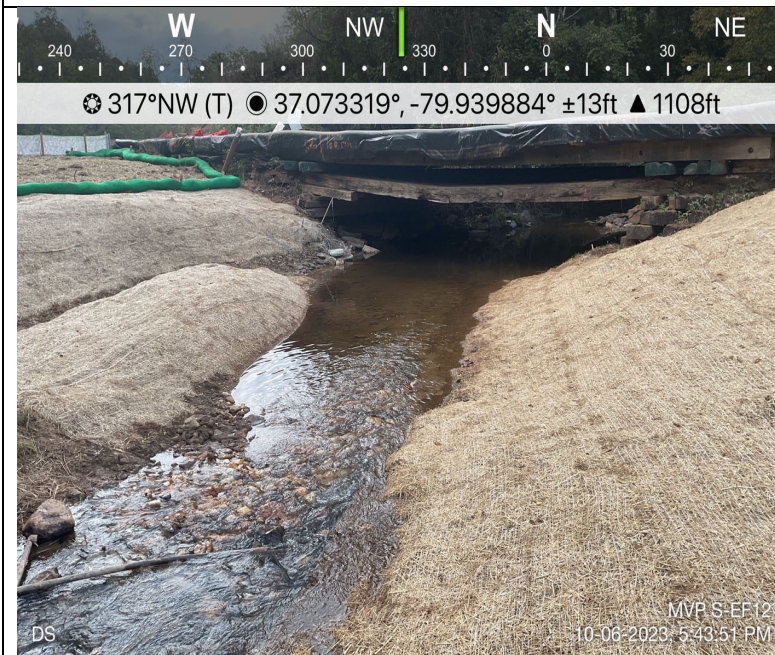
**Photo Description:** Downstream view of permitted impact area during post-construction assessment.

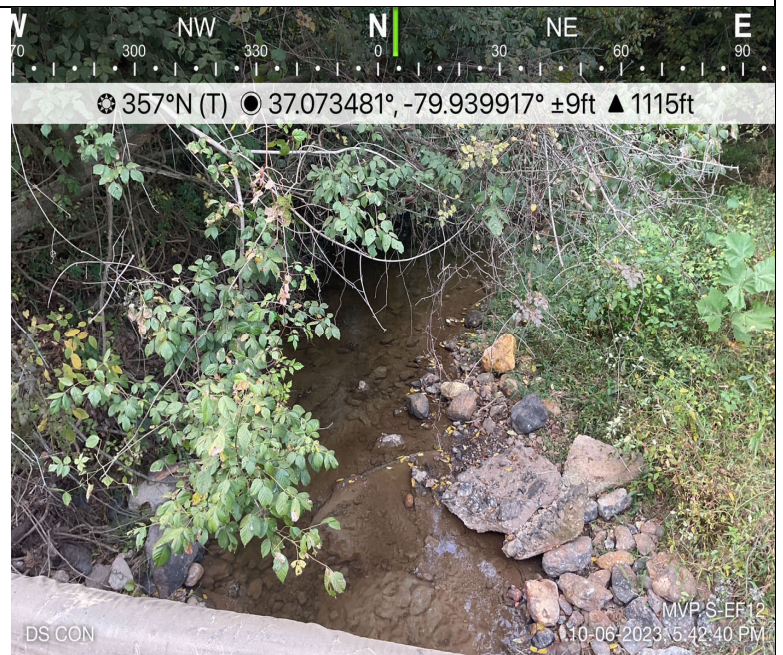
**Photo Description:** Conditions of the downstream area outside the ROW during post-construction assessment.

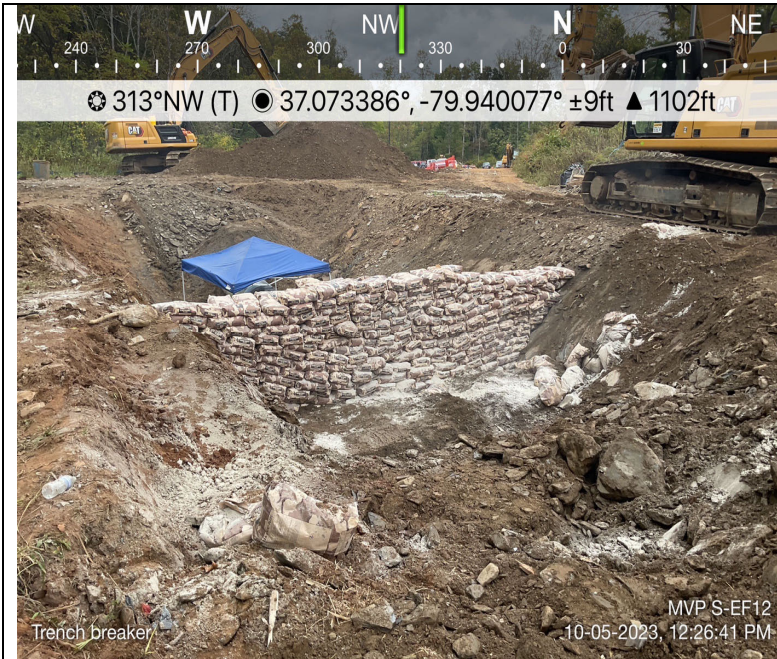
**Photo Description:** Trench breaker installation.

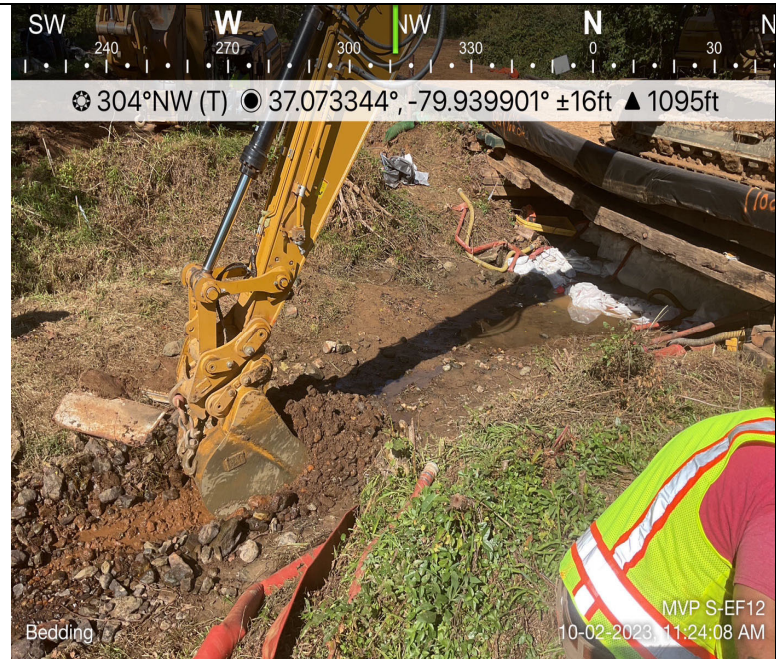
**Photo Description:** Streambed removal.

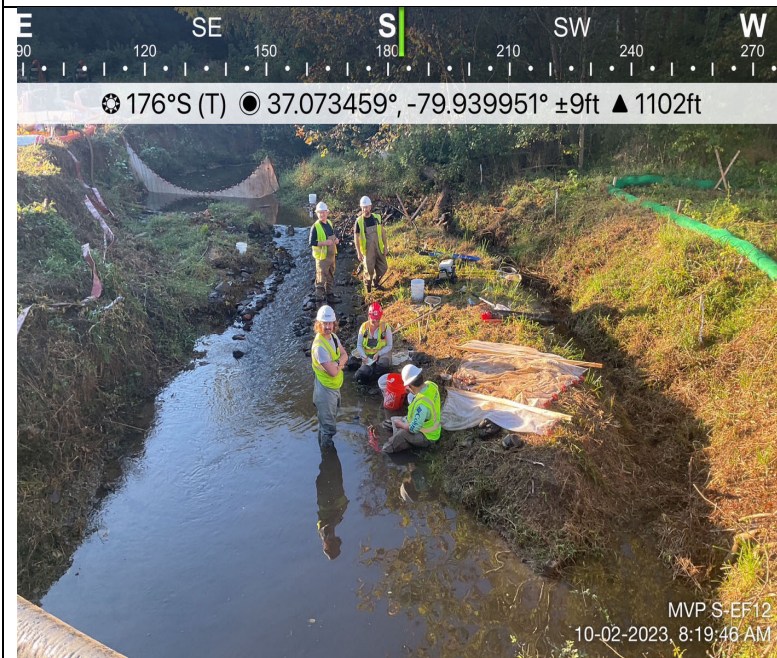
**Photo Description:** Fish relocation by Edge.

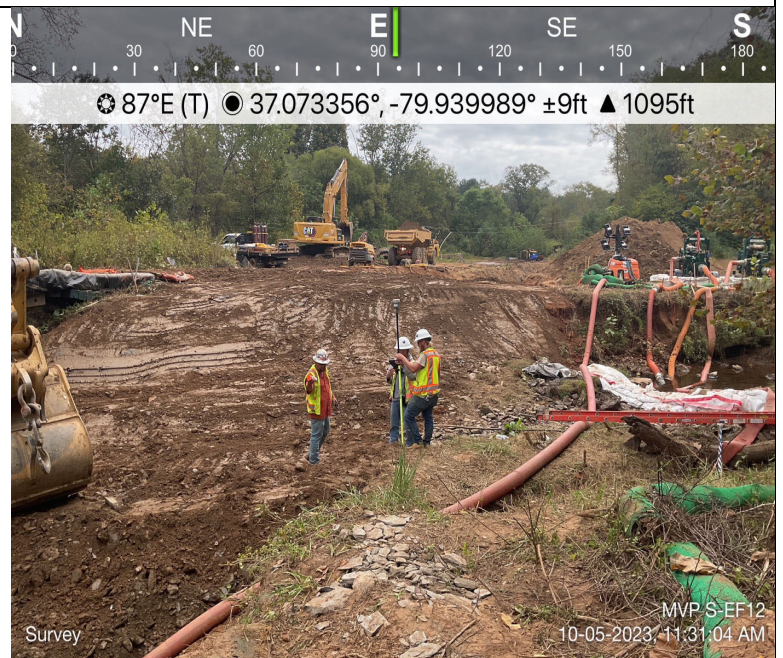
**Photo Description:** Survey for restoration of resource impact area.
