# STREAM BIOLOGICAL CONDITIONS ENVIRONMENTAL AUDITOR REPORT

<b>Stream ID:</b> S-EF34b	<b>Crossing Start Date:</b> 08/31/2023	<b>Crossing Completion Date:</b> 09/22/2023
<b>Milepost:</b> 241.1	<b>Pre-Con Assessment Date:</b> 08/26/2023	<b>Post-Con Assessment Date:</b> 09/25/2023
<b>Station:</b> 12743+84	<b>Stream Classification:</b> Perennial (Perennial, Intermittent, Ephemeral)	<b>Bankfull Width (ft.):</b> 10
<b>County:</b> Roanoke	<b>303(d) Impairment Listing:</b> Not Impaired	<b>Riffle:Pool Complexes Present?</b> No

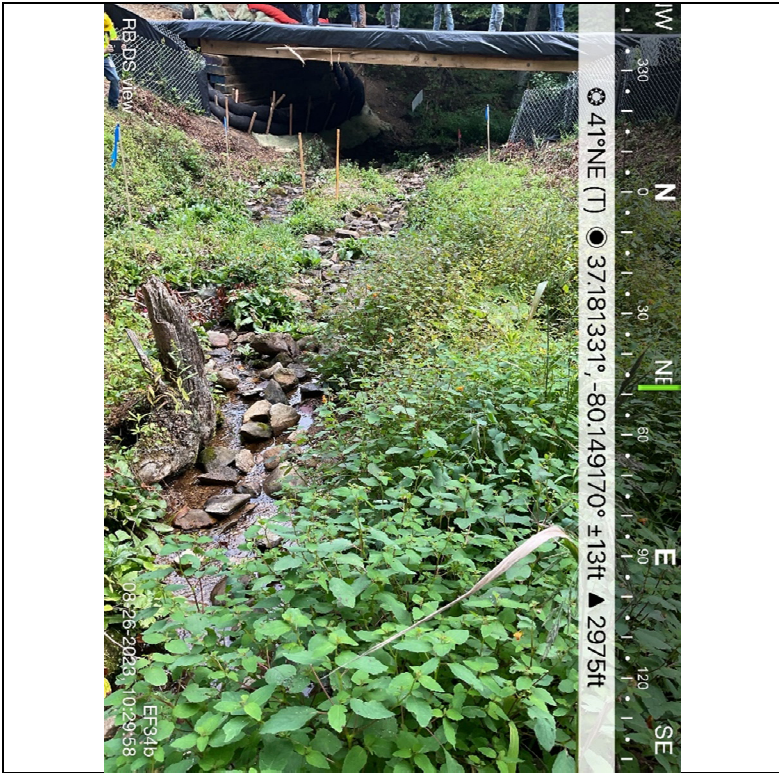
**Photo Description:** Downstream view of permitted impact area during pre-construction assessment. Landscape mode malfunction on Solocator App.

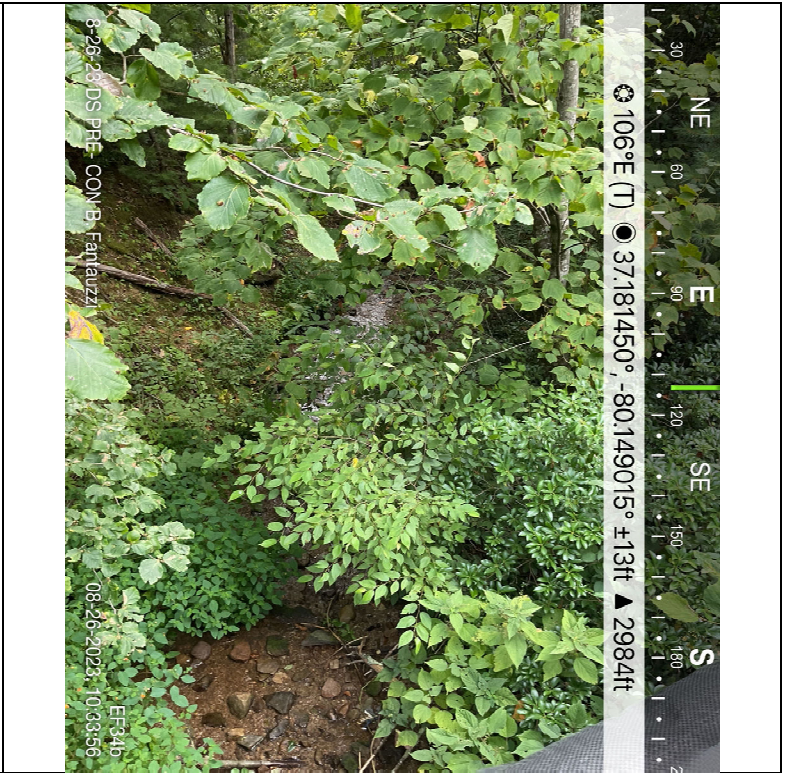
**Photo Description:** Conditions of the downstream area outside the ROW during pre-construction assessment. Landscape mode malfunction on Solocator App

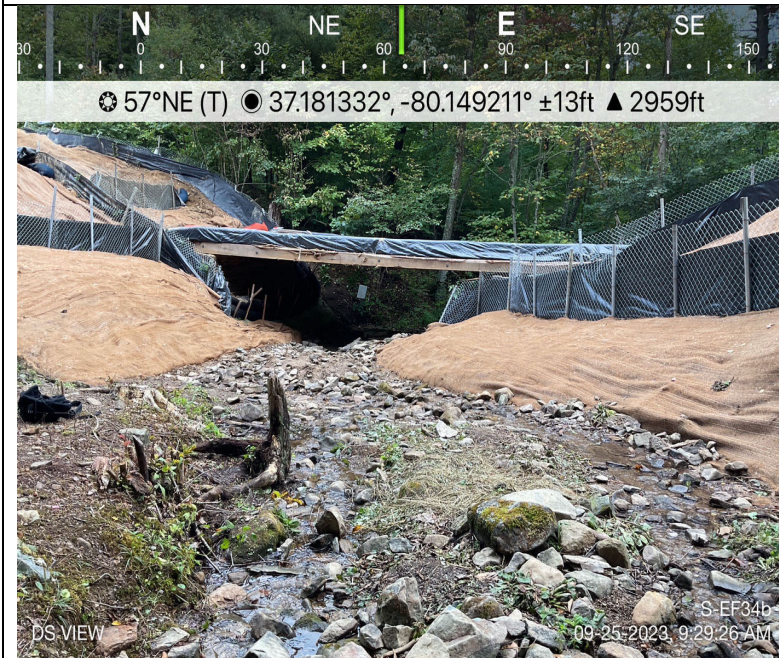
**Photo Description:** Downstream view of permitted impact area during post-construction assessment.

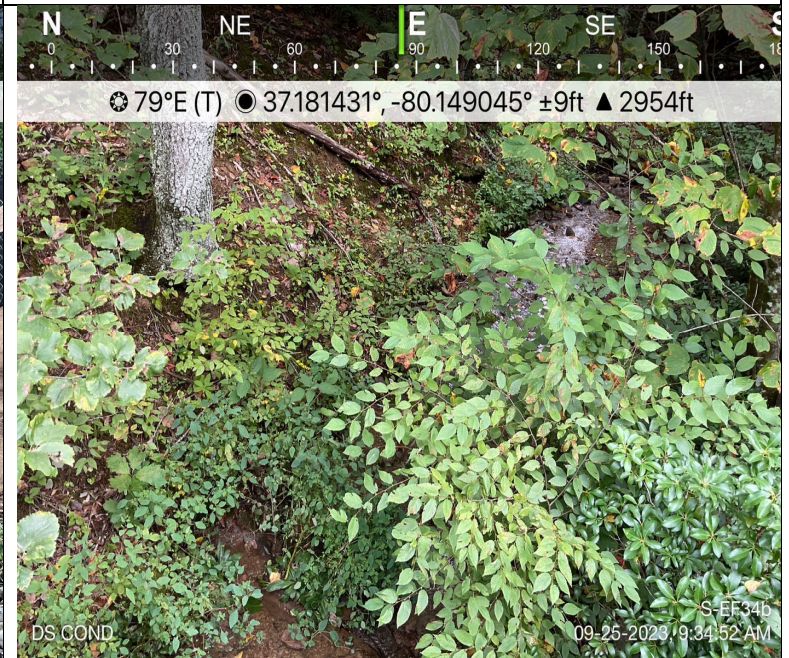
**Photo Description:** Conditions of the downstream area outside the ROW during post-construction assessment.
