STREAM BIOLOGICAL CONDITIONS ENVIRONMENTAL AUDITOR REPORT

Stream ID: S-EF48	Crossing Start Date: 09/26/2023	Crossing Completion Date: 09/30/2023
Milepost: 266.2	Pre-Con Assessment Date: 09/14/2023	Post-Con Assessment Date: 10/03/2023
Station: 14066+75	Stream Classification: Intermittent (Perennial, Intermittent, Ephemeral)	Bankfull Width (ft.): 2
County: Franklin	303(d) Impairment Listing: Not Impaired	Riffle:Pool Complexes Present? No

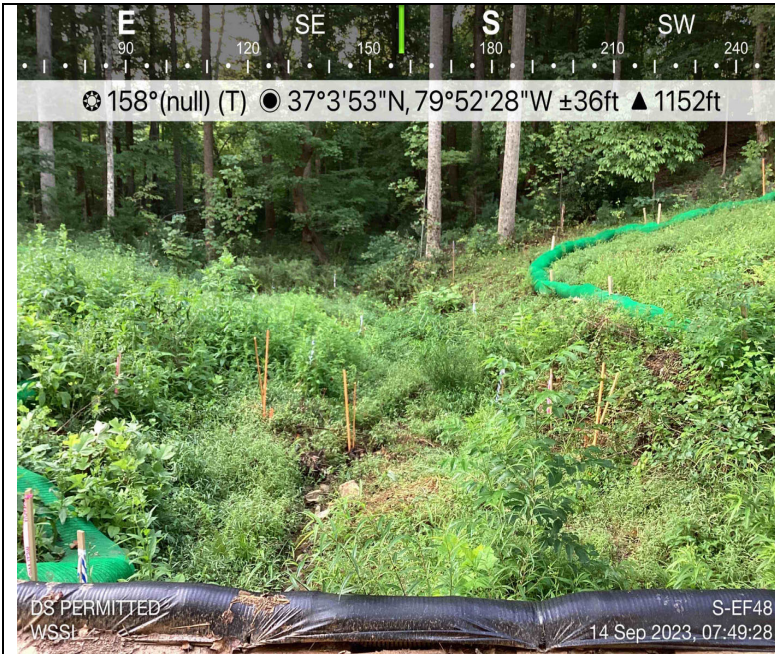
Photo Description: Downstream view of permitted impact area during pre-construction assessment.

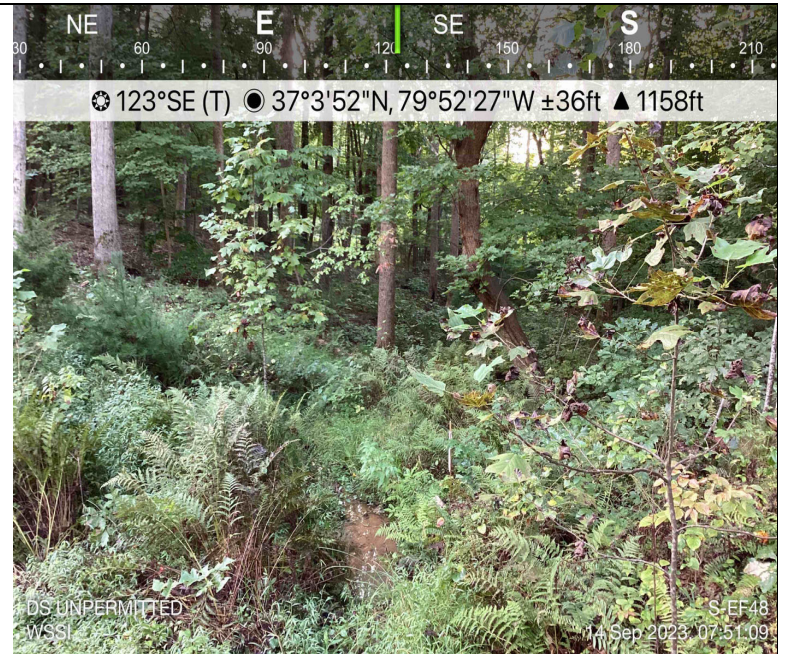
Photo Description: Conditions of the downstream area outside the ROW during pre-construction assessment.

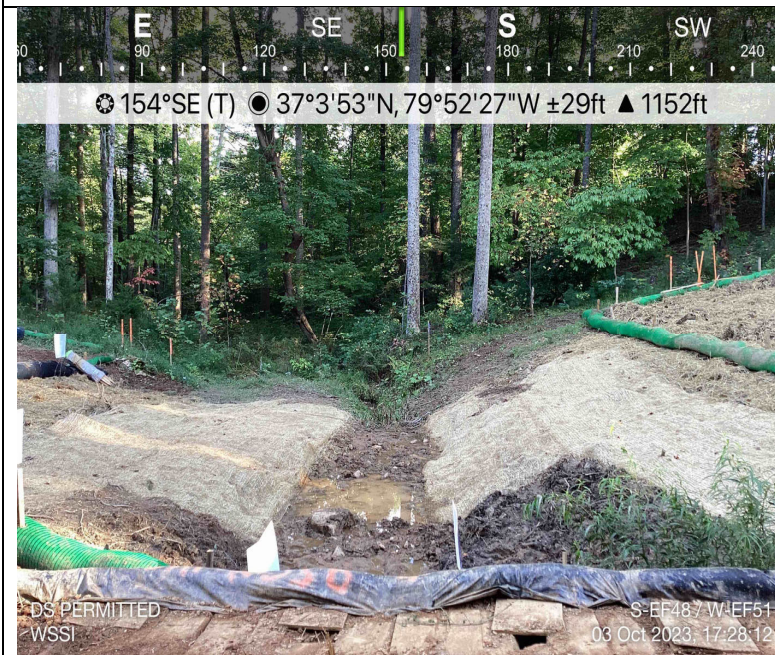
Photo Description: Downstream view of permitted impact area during post-construction assessment.

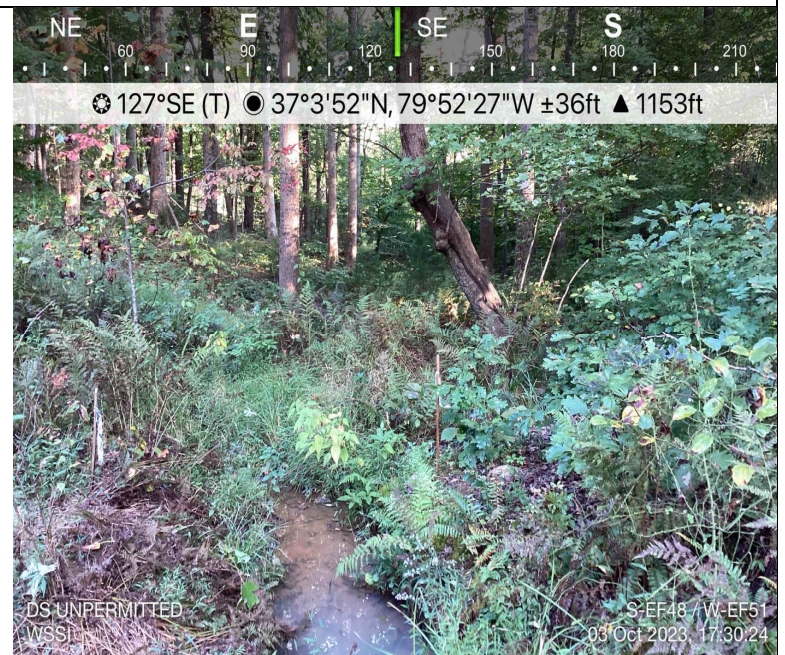
Photo Description: Conditions of the downstream area outside the ROW during post-construction assessment.

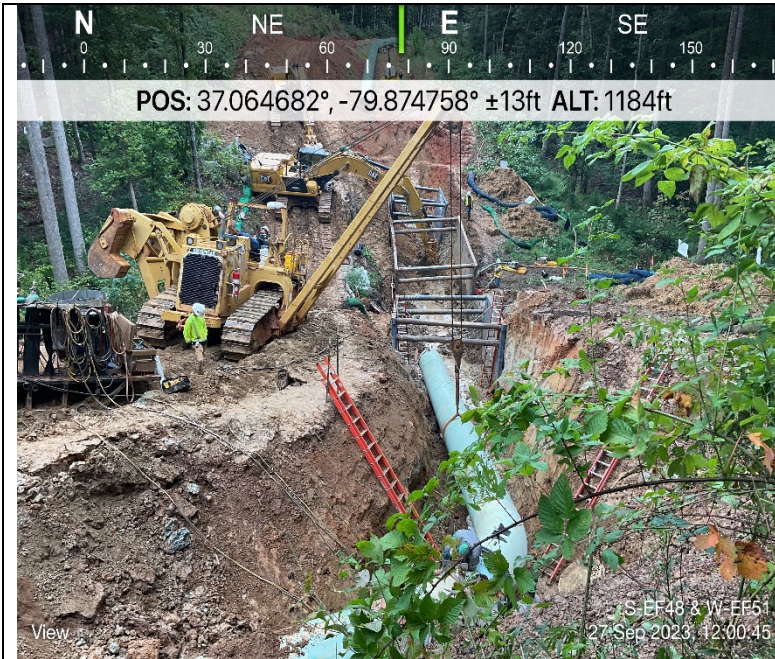
Photo Description: Pipe lowered into trench and trench boxes installed for safety.

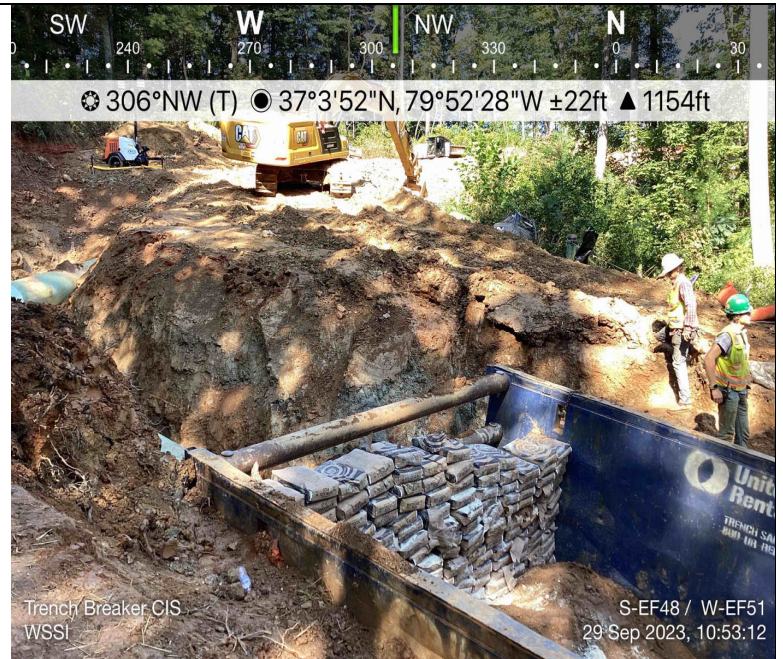
Photo Description: Trenchbreaker installed.

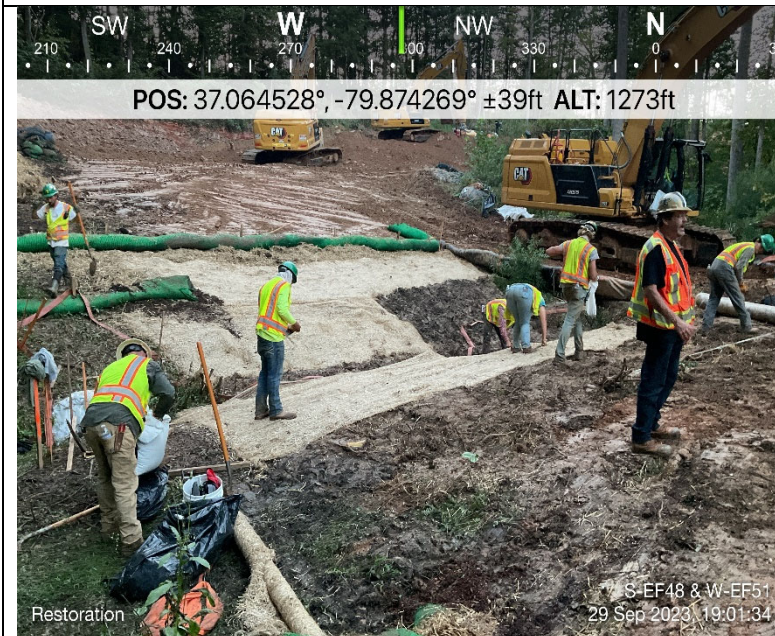
Photo Description: Restoration crews applying seed & stabilization matting to resource banks.

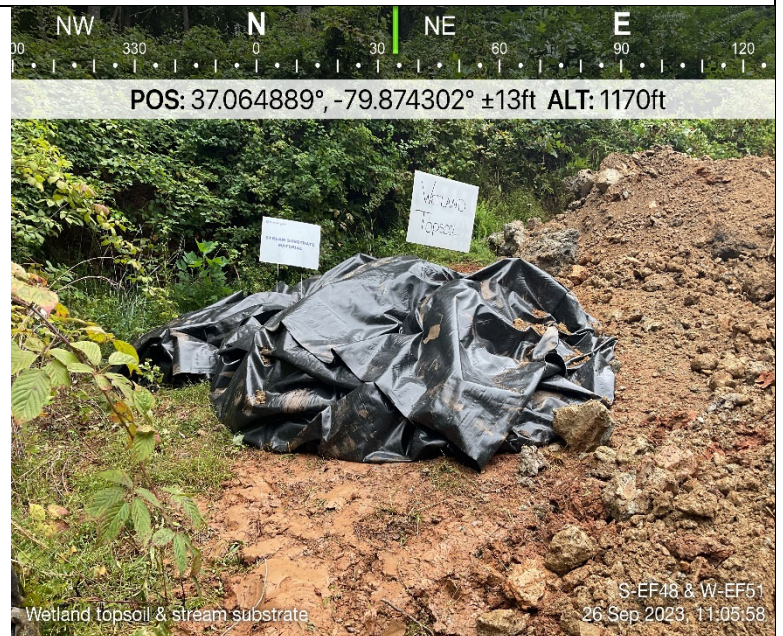
Photo Description: Stream substrate and wetland topsoil stockpiled separately from subsoil.
