# STREAM BIOLOGICAL CONDITIONS ENVIRONMENTAL AUDITOR REPORT

<b>Stream ID:</b> S-EF4	<b>Crossing Start Date:</b> 09/18/2023	<b>Crossing Completion Date:</b> 09/25/2023
<b>Milepost:</b> 259.8	<b>Pre-Con Assessment Date:</b> 09/15/2023	<b>Post-Con Assessment Date:</b> 09/25/2023
<b>Station:</b> 13728+02	<b>Stream Classification:</b> Perennial (Perennial, Intermittent, Ephemeral)	<b>Bankfull Width (ft.):</b> 11
<b>County:</b> Franklin	<b>303(d) Impairment Listing:</b> Not Impaired	<b>Riffle:Pool Complexes Present?</b> No

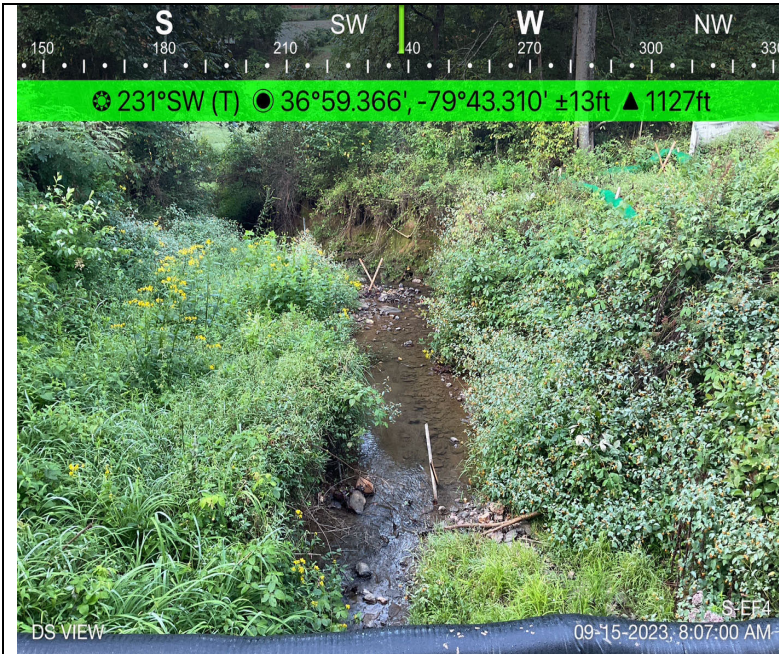
**Photo Description:** Downstream view of permitted impact area during pre-construction assessment.

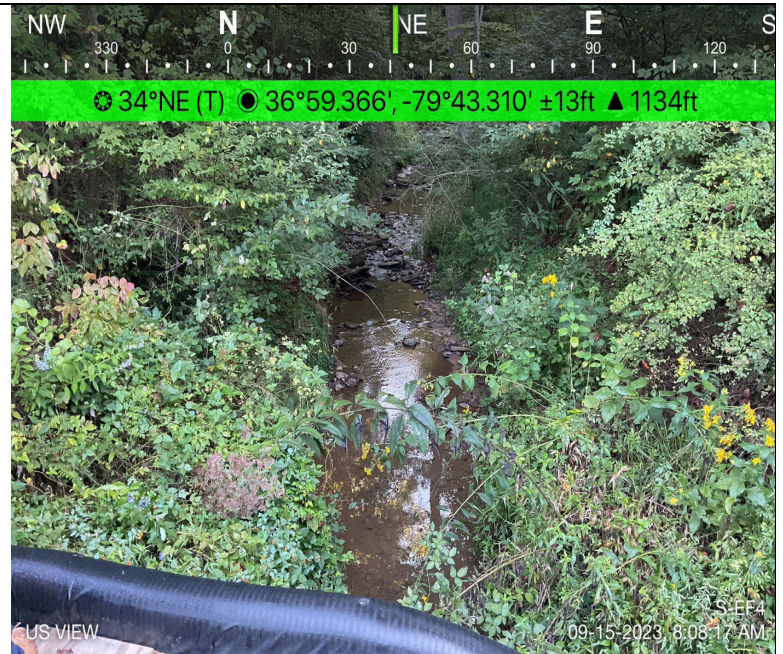
**Photo Description:** Conditions of the downstream area outside the ROW during pre-construction assessment.

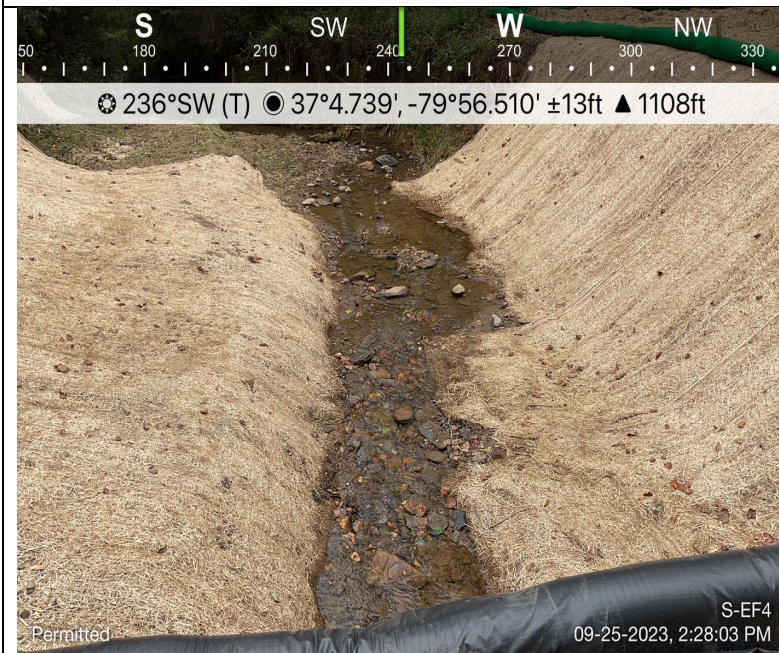
**Photo Description:** Downstream view of permitted impact area during post-construction assessment.

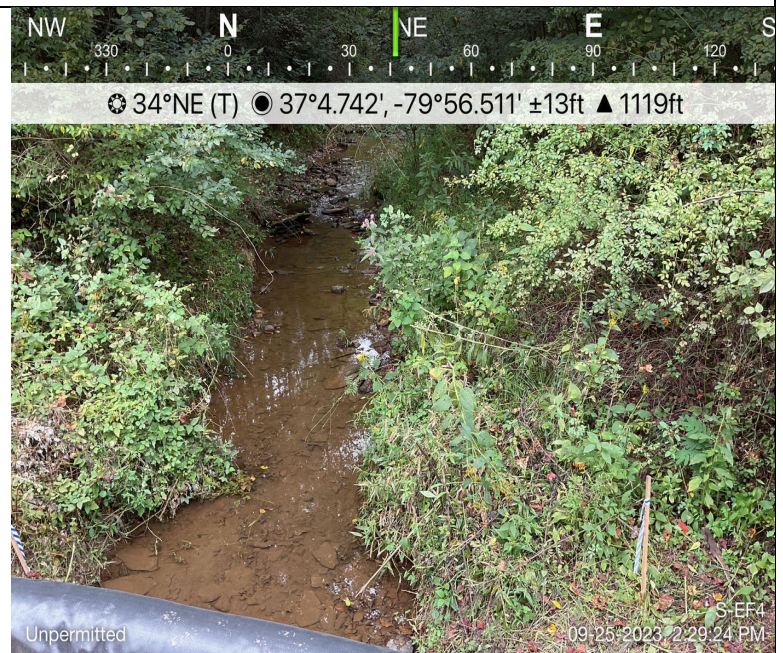
**Photo Description:** Conditions of the downstream area outside the ROW during post-construction assessment.
