STREAM BIOLOGICAL CONDITIONS ENVIRONMENTAL AUDITOR REPORT

Stream ID: S-EF55	Crossing Start Date: 08/31/2023	Crossing Completion Date: 09/22/2023
Milepost: 241.1	Pre-Con Assessment Date: 08/26/2023	Post-Con Assessment Date: 09/25/2023
Station: 12743+89	Stream Classification: Intermittent (Perennial, Intermittent, Ephemeral)	Bankfull Width (ft.): 8
County: Roanoke	303(d) Impairment Listing: Not Impaired	Riffle:Pool Complexes Present? No

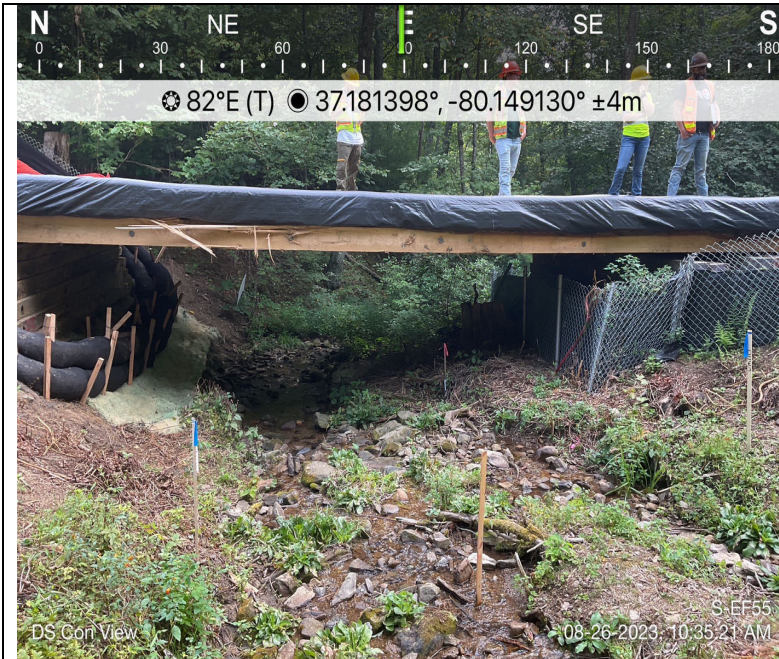
Photo Description: Downstream view of permitted impact area during pre-construction assessment.

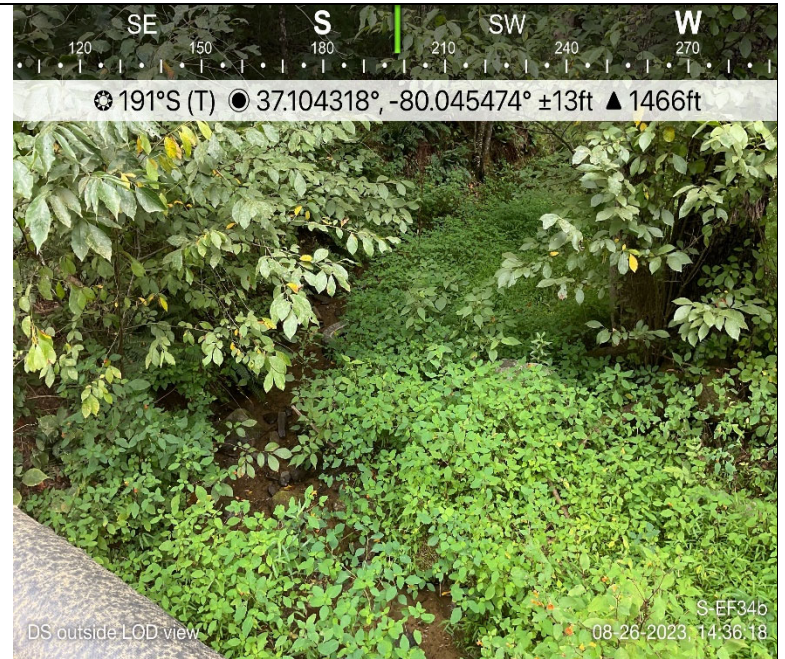
Photo Description: Conditions of the downstream area outside the ROW during pre-construction assessment. S-EF55 converges with S-EF34b within ROW, then S-EF34b flows off ROW.

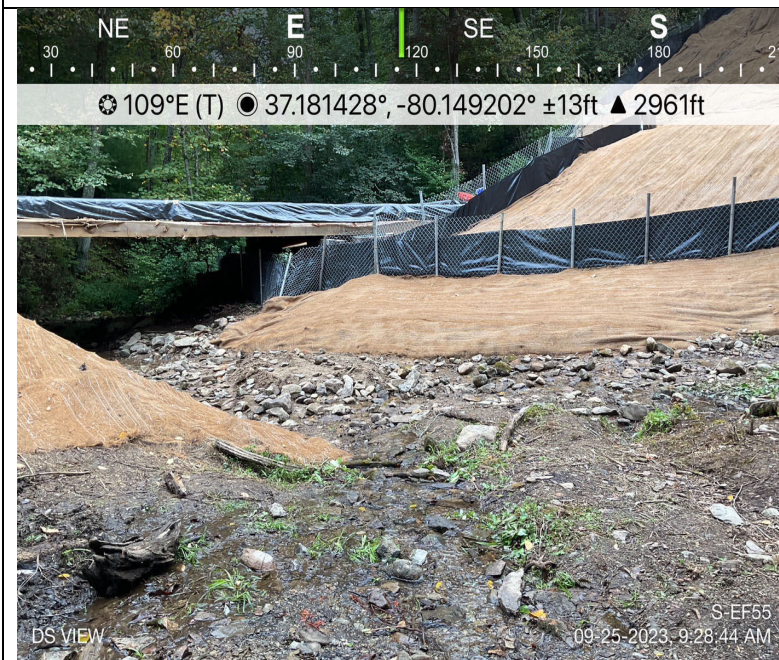
Photo Description: Downstream view of permitted impact area during post-construction assessment.

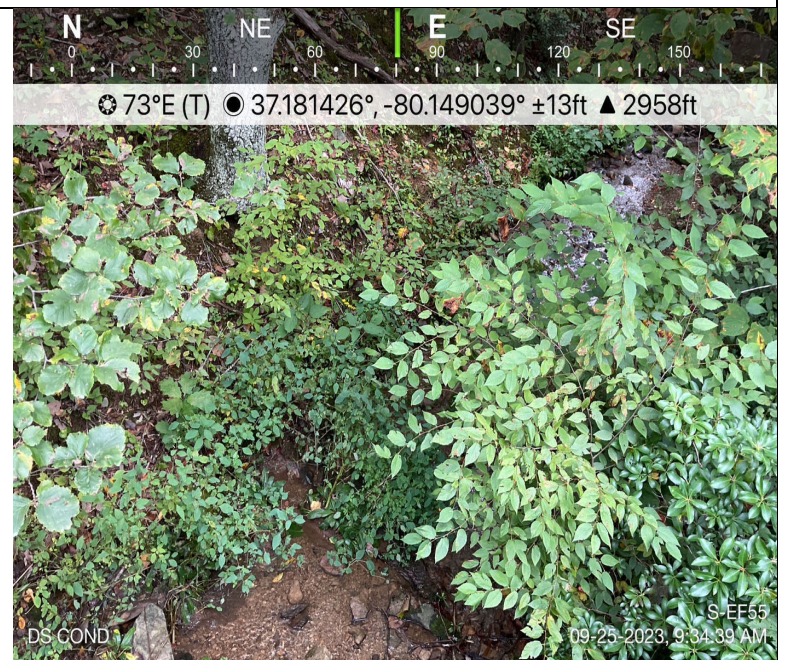
Photo Description: Conditions of the downstream area outside the ROW during post-construction assessment.

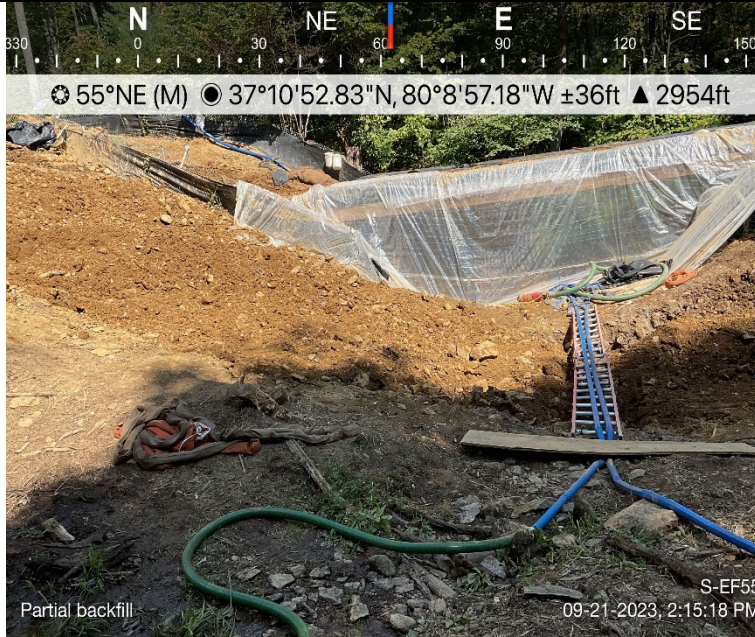
Photo Description: Partial backfill of resource with subsoil prior to restoration. Dam and pumps remain installed and functioning.

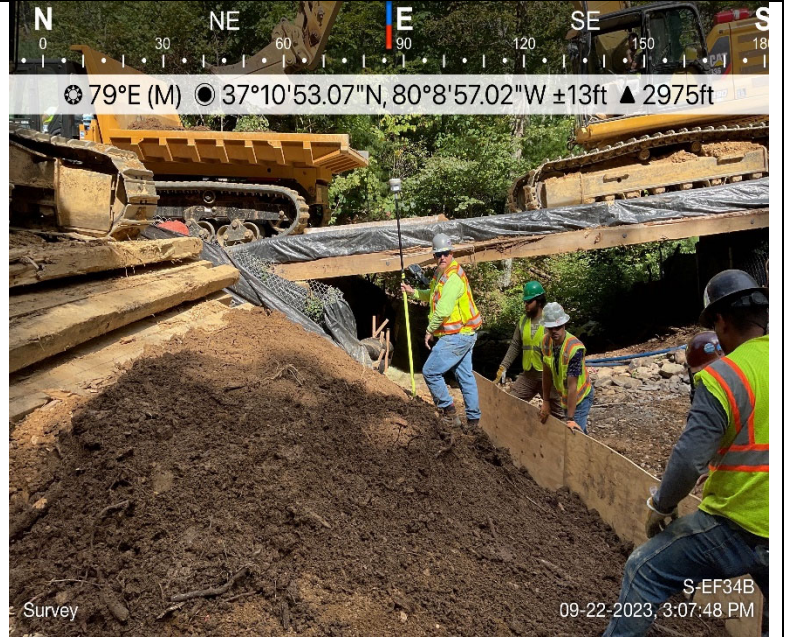
Photo Description: Survey crews staking out as-builts for restoration crews.

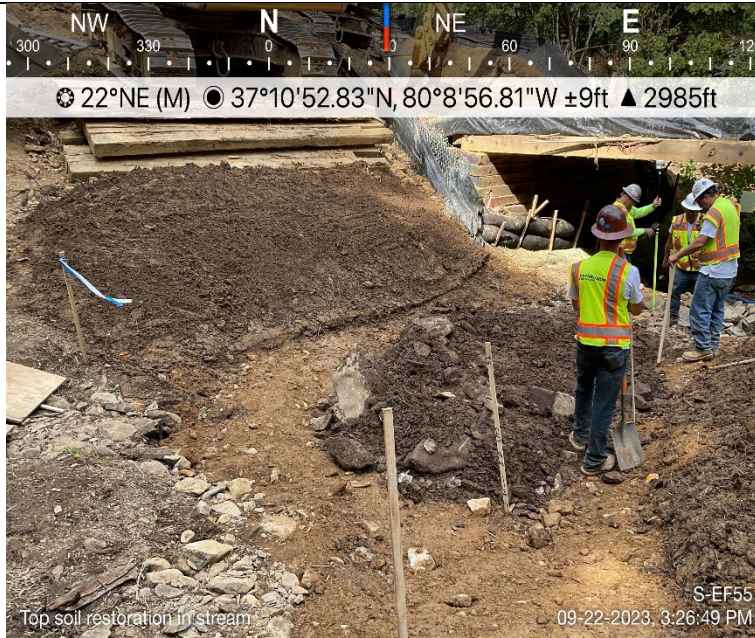
Photo Description: Restoration of topsoil and stream substrate for restoration.

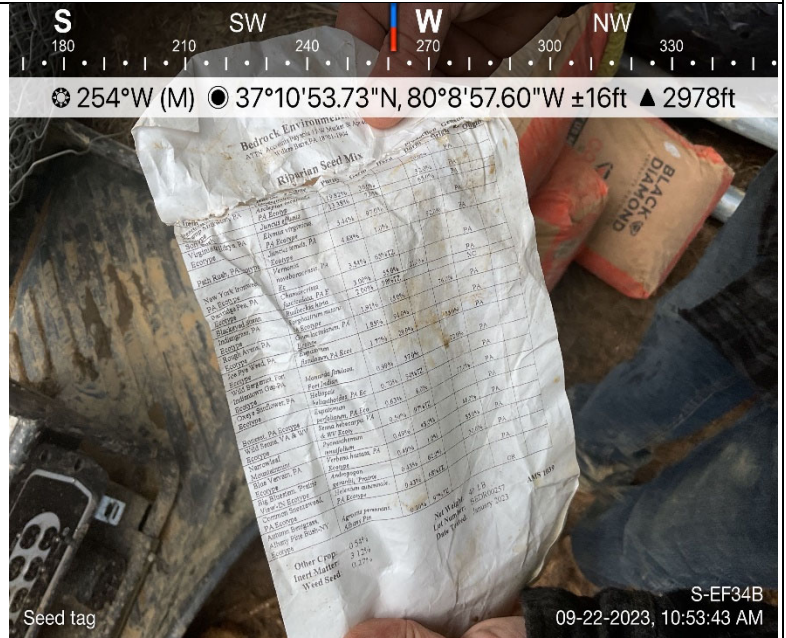
Photo Description: Riparian permanent seed mix applied to stream banks during restoration.
