Stream Biological Conditions EA Report

Project Name	H-600 Pipeline Spread D	AFE	124300132	Spread	H-600 Pipeline Spread D
Contractor	Precision	Report #	287		
Environmental Auditor	Todd Grant	Date/Time	10/10/2023 8:16 AM		
Stream ID	S-F36b	Crossing Start Date	10/11/2023	Crossing Completion Date	10/25/2023
Milepost	105.08	Pre-Con Assessment Date	10/11/2023	Post-Con Assessment Date	10/25/2023
Station	5548+02	Bankfull Width (ft.)	20.0	Riffle:Pool Complexes Present?	No
State	WV	Stream Classification	Perennial		
County	Webster	303(d) Impairment Listing	No

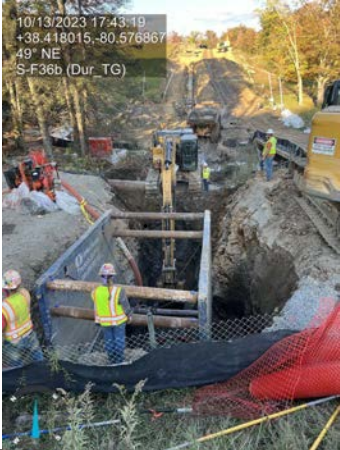
GPS Location See photo above	GPS Location See photo above
Description View of ditch excavation approaching stream S-F36b on GAS.	Description View of stream S-F36b flume pipe installed during ditch excavation.

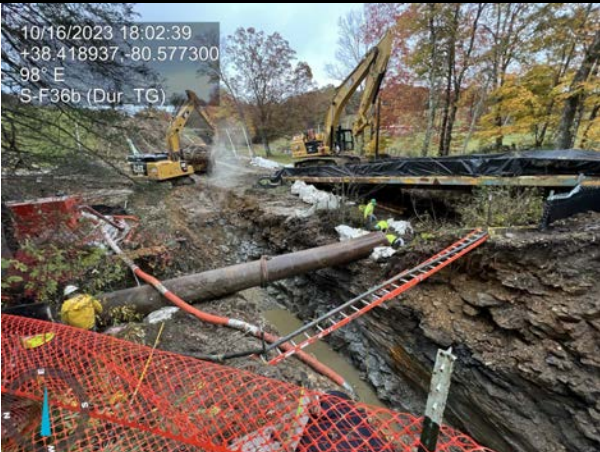
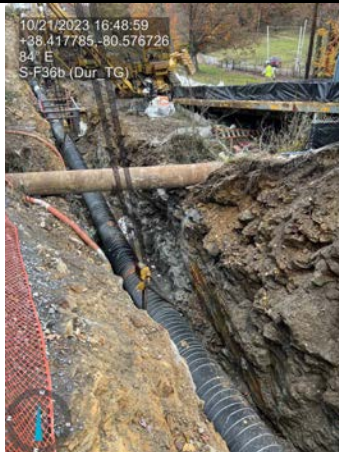
GPS Location See photo above	GPS Location See photo above
Description View of the contractor completing ditch excavation past the flume pipe of stream S-F36b on the CIS.	Description View of tie in activities under the flume pipe at stream S-F36b.

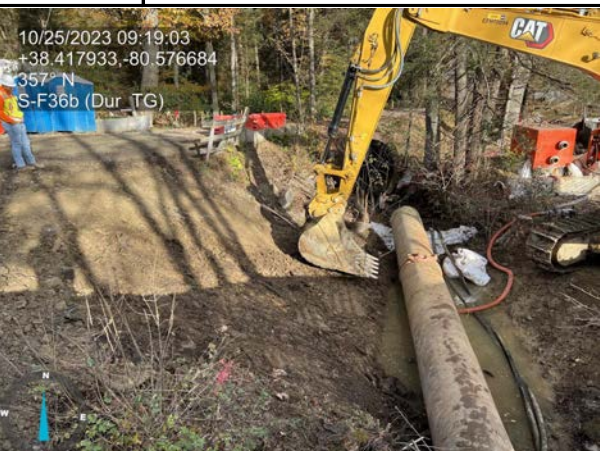
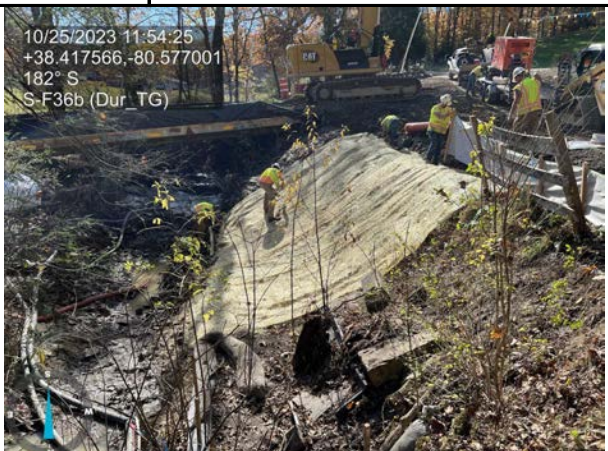
GPS Location See photo above	GPS Location See photo above
Description View of GAS streambank being restored to original contours.	Description View of GAS streambank being stabilized with erosion blanket.
