# STREAM BIOLOGICAL CONDITIONS ENVIRONMENTAL AUDITOR REPORT

<b>Stream ID:</b> S-F8	<b>Crossing Start Date:</b> 10/17/2023	<b>Crossing Completion Date:</b> 10/31/2023
<b>Milepost:</b> 268.9	<b>Pre-Con Assessment Date:</b> 10/11/2023	<b>Post-Con Assessment Date:</b> 10/31/2023
<b>Station:</b> 14208+76	<b>Stream Classification:</b> Perennial (Perennial, Intermittent, Ephemeral)	<b>Bankfull Width (ft.):</b> 30
<b>County:</b> Franklin	<b>303(d) Impairment Listing:</b> Not Impaired	<b>Riffle:Pool Complexes Present?</b> Yes

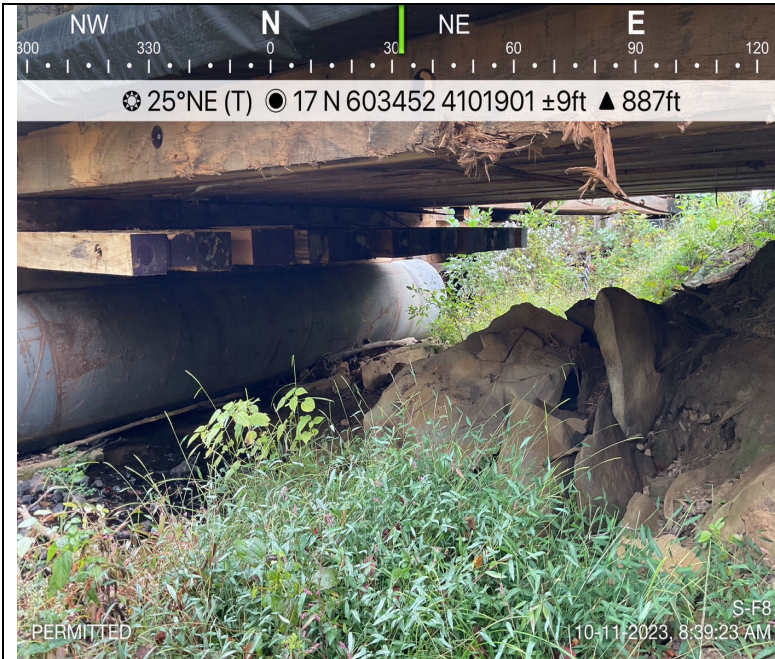
**Photo Description:** Downstream view of permitted impact area during pre-construction assessment.

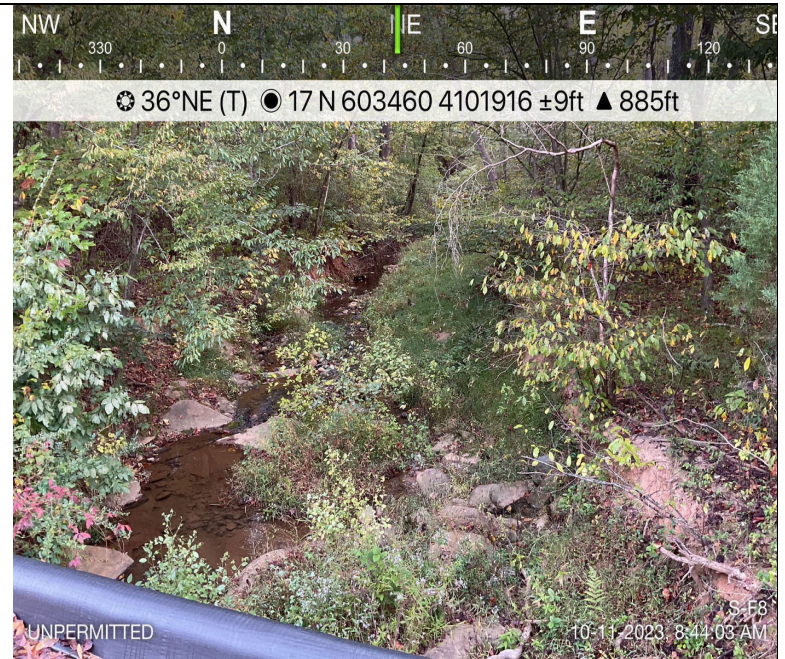
**Photo Description:** Conditions of the downstream area outside the ROW during pre-construction assessment.

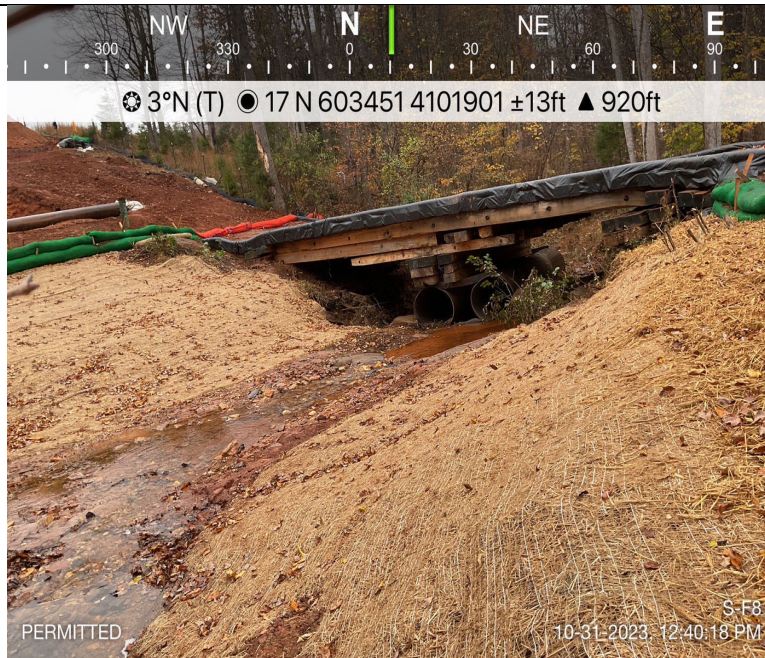
**Photo Description:** Downstream view of permitted impact area during post-construction assessment.

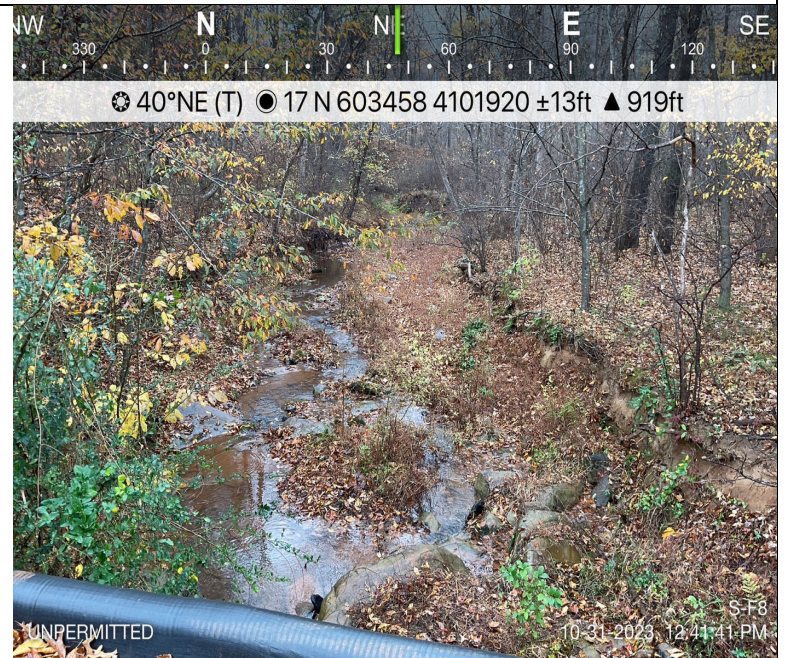
**Photo Description:** Conditions of the downstream area outside the ROW during post-construction assessment.

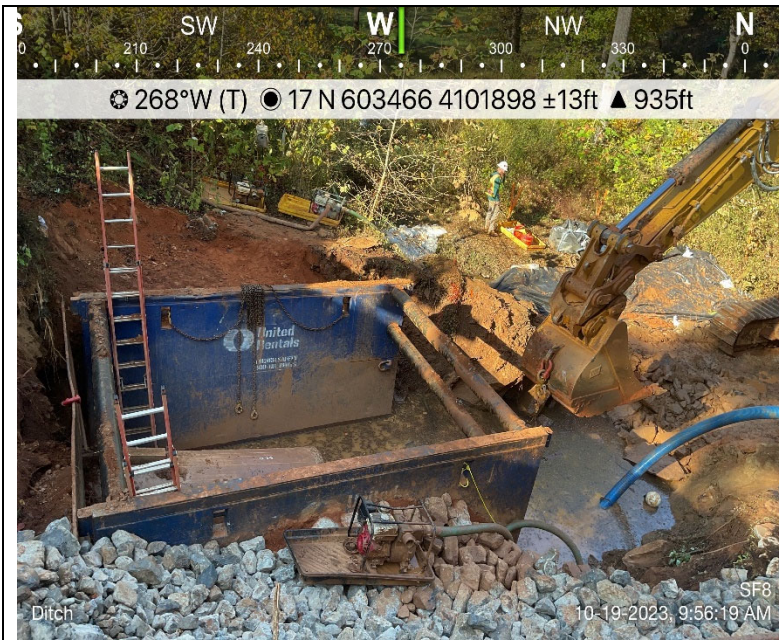
**Photo Description:** A trench box was installed, and excavation has begun.

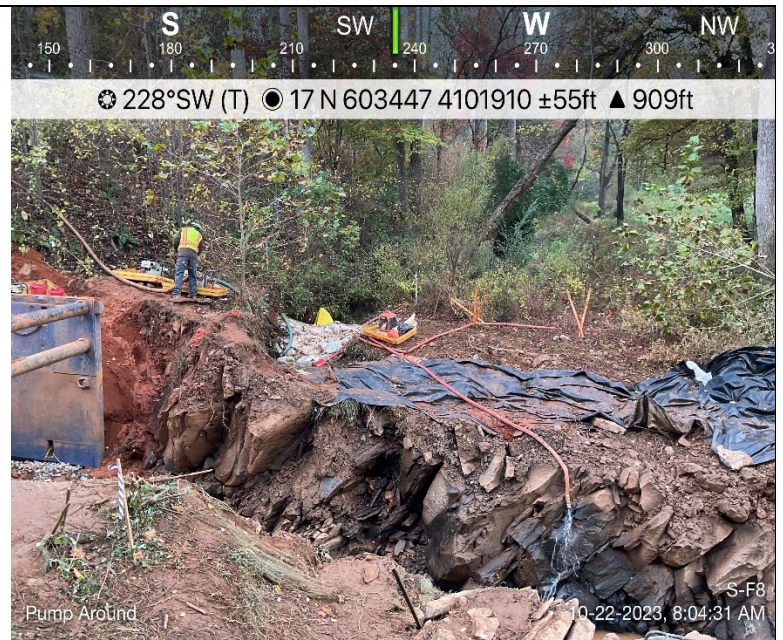
**Photo Description:** An overview of the pump around transporting water.

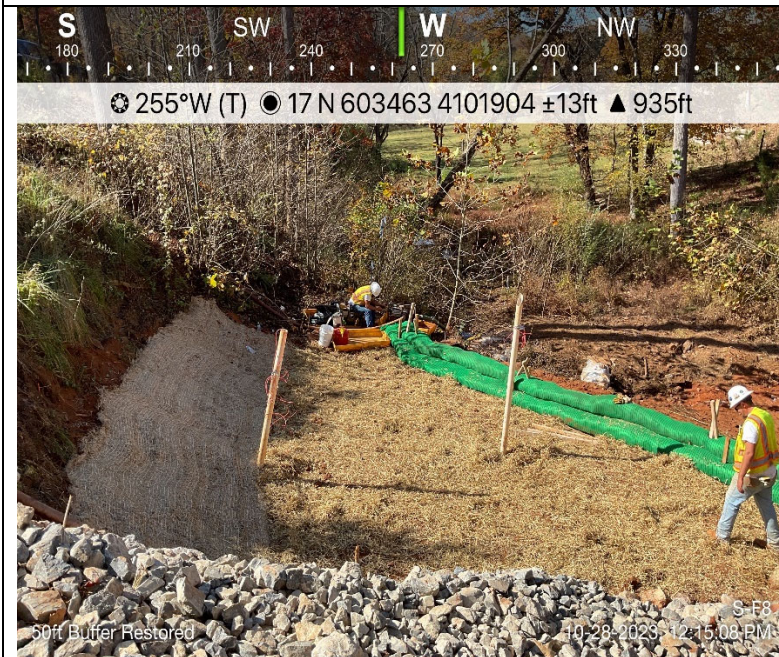
**Photo Description:** Restoration of the 50-foot buffer. Modification to right bank to account for step/eroded stream bank.

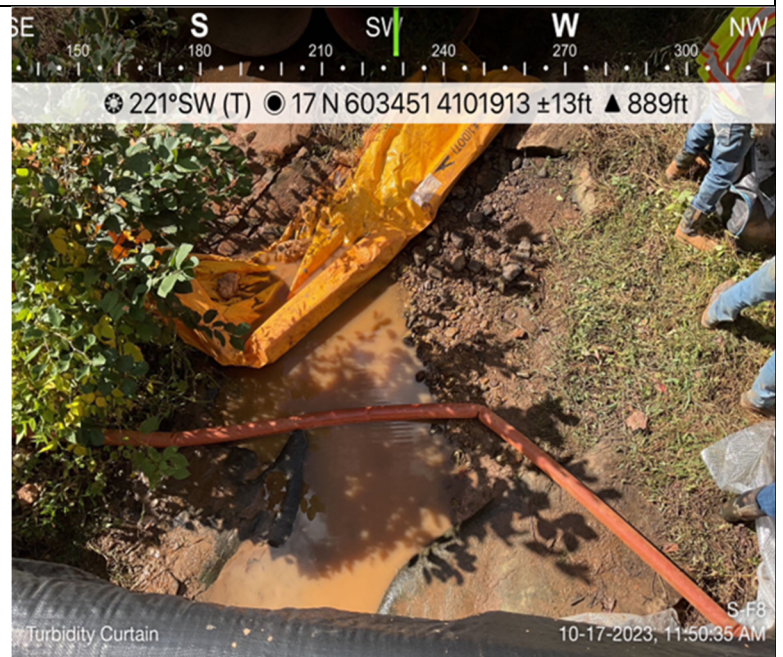
**Photo Description:** Turbidity curtain installed to control turbidity from entering the resource during trench pump-down.

Item #14 – As noted above, turbid water from trench excavation outside of the stream migrated through the undisturbed bank and mingled with stream water/flowed downstream unfiltered. This was remedied by dewatering the trench through designed dewatering stations, installation of a turbidity curtain and DEQ notification. No accumulation of sediment was observable on or off site.

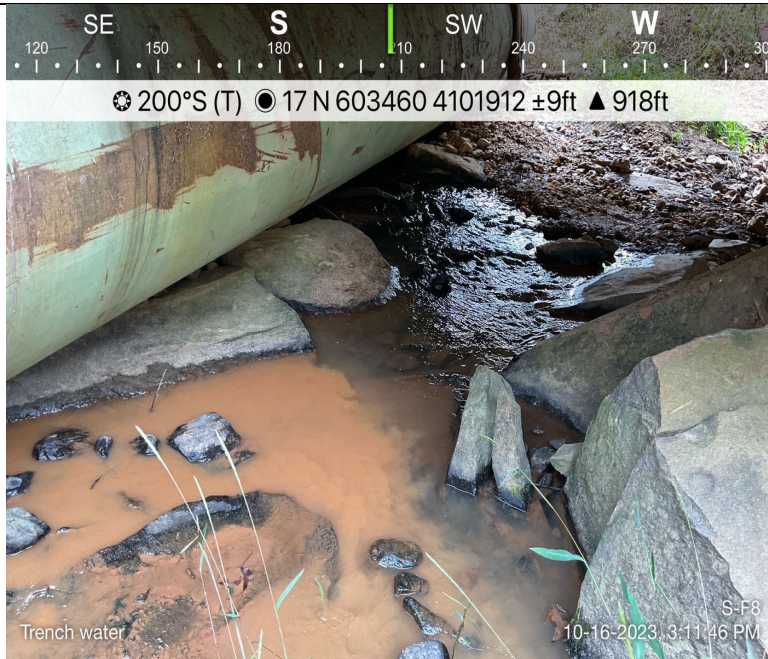
10-16-2023: The crew is demobilizing from the KL54 area. Excavation of the loose end is occurring while waiting for the blasting crew. The crew began excavating the trench for the tie-in near the road and installed a trench box. Upon excavating the trench, groundwater was encountered which became turbid and appeared to enter the stream unfiltered by controls through a subsurface connection. The crew dewatered the trench, and a turbidity curtain was installed along the seeping bank. No accumulated sediment was observed off-site and MVP notified DEQ on 10-16-2023. -T. Snideman

**Photo Description:** Turbid water emerged from stream bank during excavation of pipe loose ends in upland area.

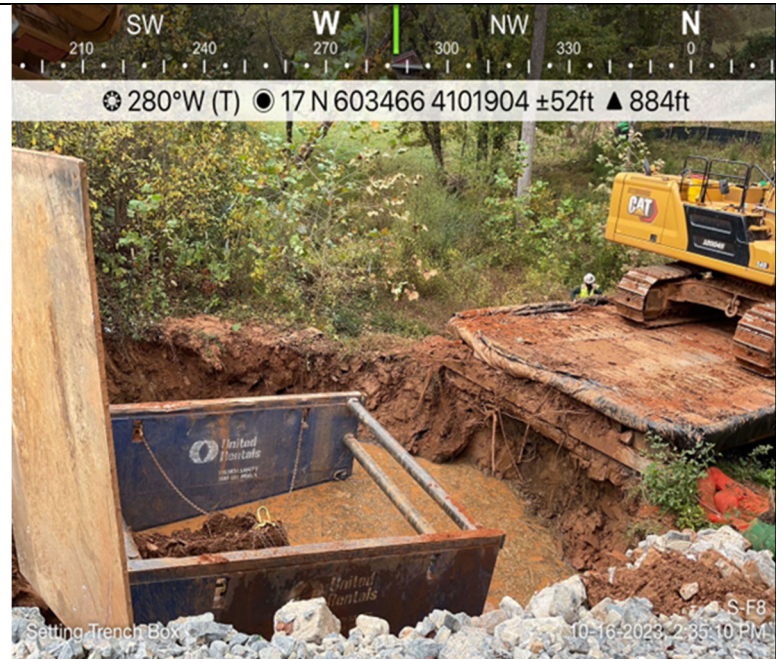
**Photo Description:** Upland trench excavation when turbid water emerged from bank into resource.

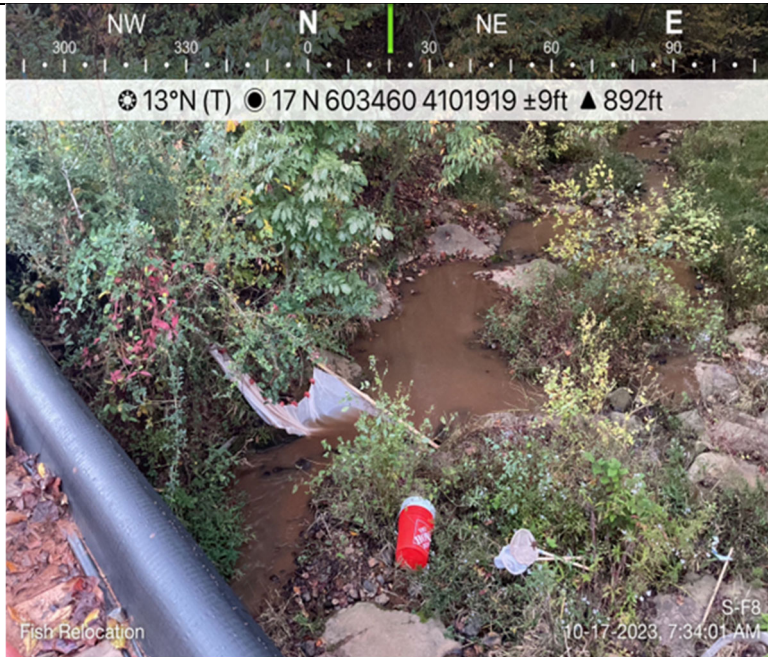
**Photo Description:** Downstream conditions of the resource after pump-down of upland trench to control turbidity. No fish kills or accumulated material was observed off-site.

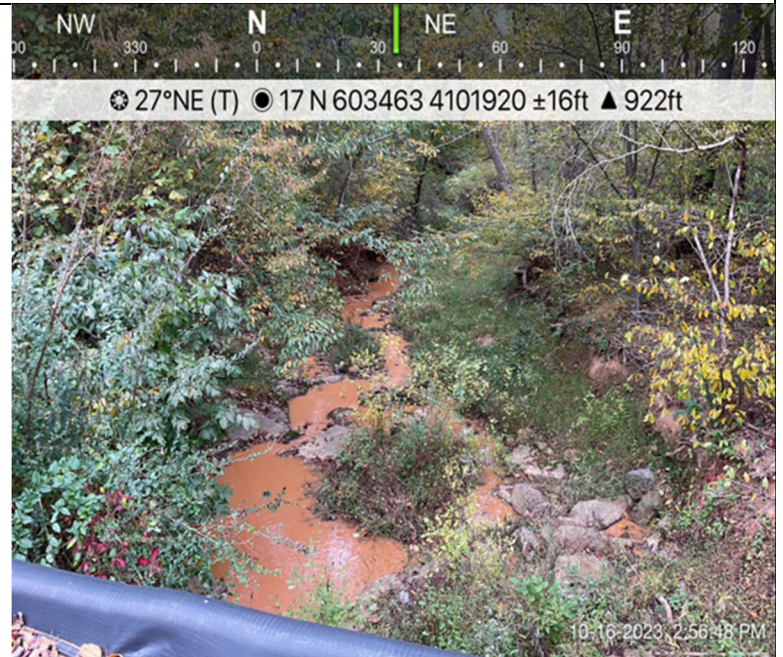
Item #14 – As noted on 10/16/2023, turbid water from trench excavation outside of the stream migrated through the undisturbed bank and mingled with stream water/flowed downstream unfiltered. This was immediately remedied by dewatering the trench through designed dewatering stations, installation of a turbidity curtain and DEQ notification. No accumulation of sediment was observable on or off site.

**Photo Description:** Downstream conditions of resource during turbid water release through streambank.
