STREAM BIOLOGICAL CONDITIONS ENVIRONMENTAL AUDITOR REPORT

Stream ID: S-G11	Crossing Start Date: 10/09/2023	Crossing Completion Date: 10/12/2023
Milepost: 285.3	Pre-Con Assessment Date: 10/07/2023	Post-Con Assessment Date: 10/12/2023
Station: 15072+86	Stream Classification: Intermittent (Perennial, Intermittent, Ephemeral)	Bankfull Width (ft.): 6
County: Pittsylvania	303(d) Impairment Listing: Not Impaired	Riffle:Pool Complexes Present? No

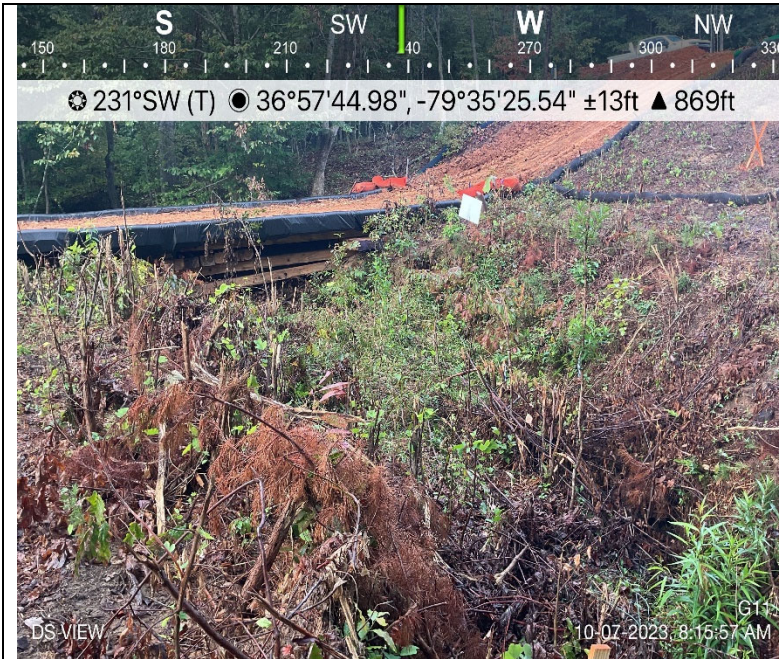
Photo Description: Downstream view of permitted impact area during pre-construction assessment.

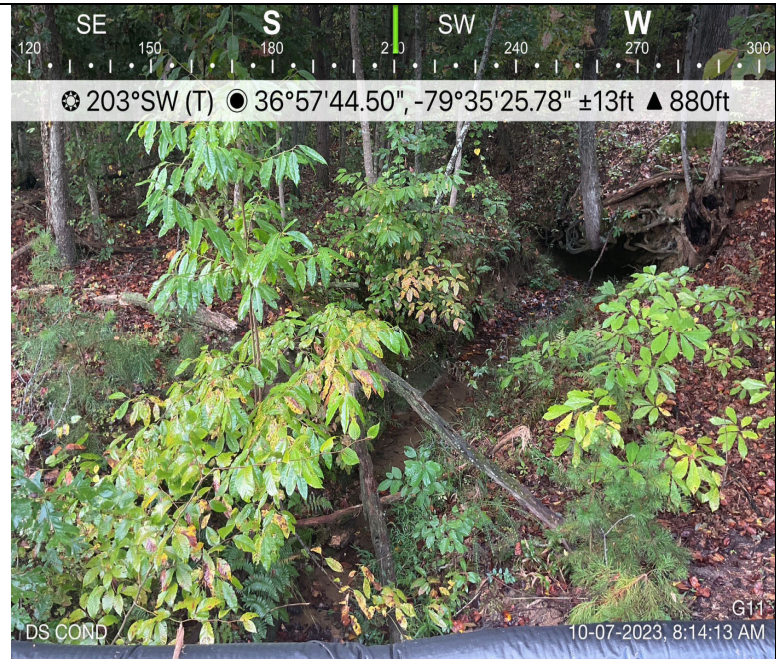
Photo Description: Conditions of the downstream area outside the ROW during pre-construction assessment.

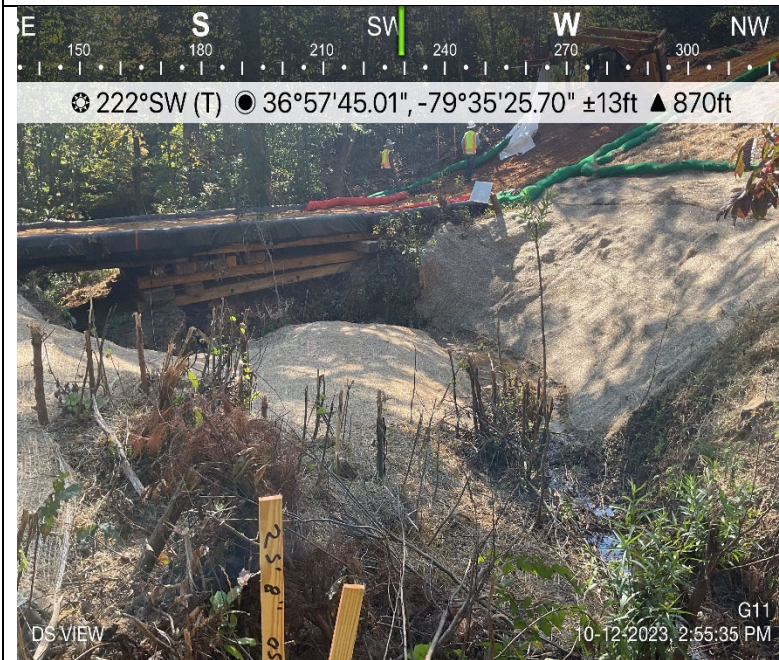
Item #16: Channel banks disturbed by construction were restored to stable configuration, however areas not disturbed by pipe installation adjacent to the impact area remain in pre-existing, eroded conditions.

Photo Description: Downstream view of permitted impact area during post-construction assessment.

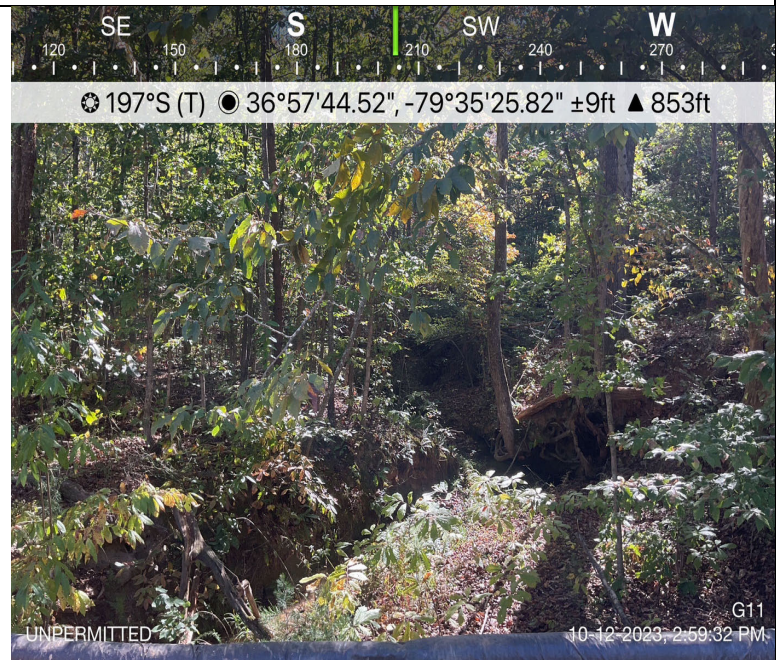
Photo Description: Conditions of the downstream area outside the ROW during post-construction assessment.

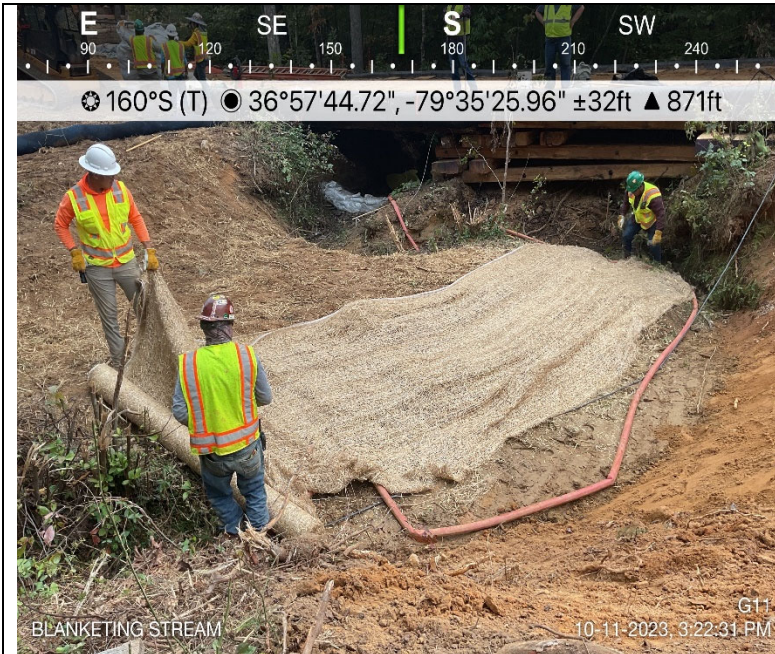
Photo Description: Erosion control matting installation during restoration.

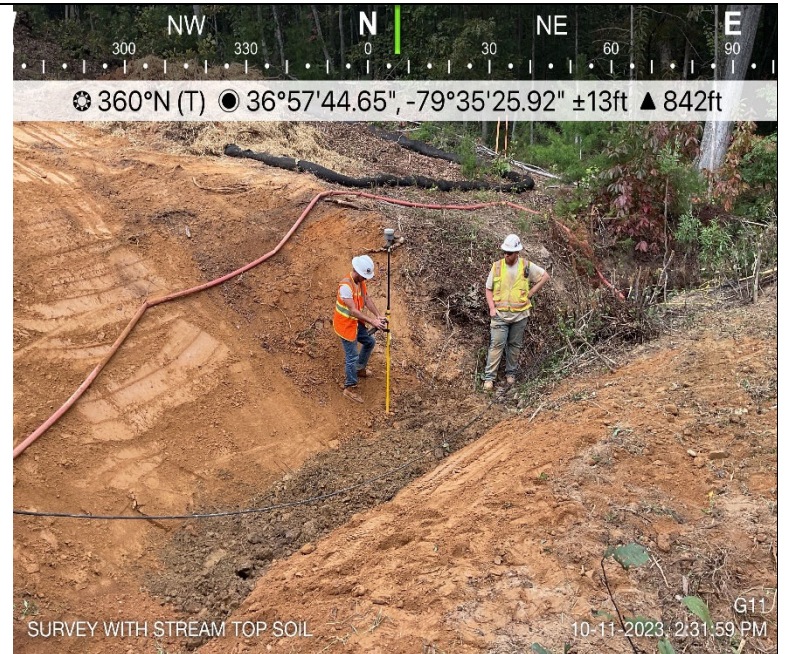
Photo Description: Survey team on-site providing restoration as-built support.

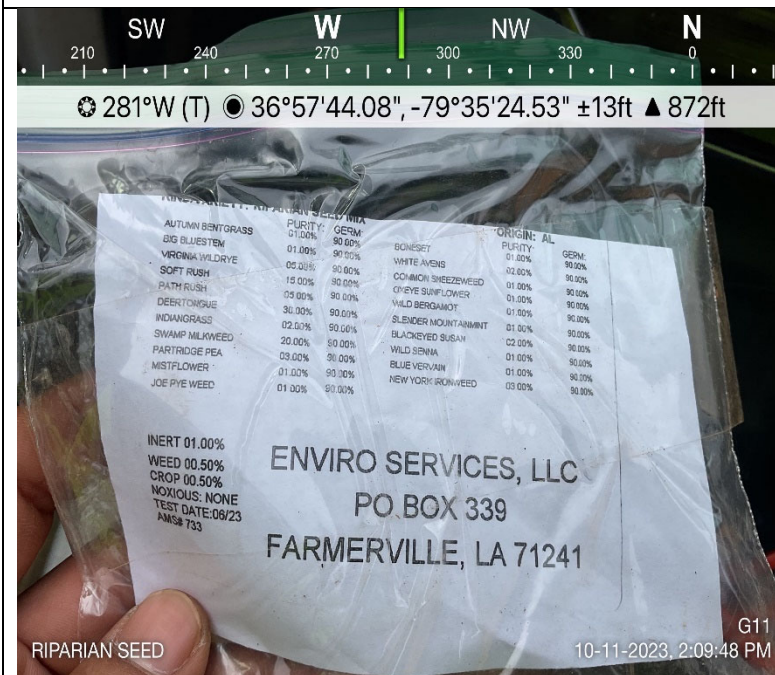
Photo Description: Riparian seed mix used during restoration.

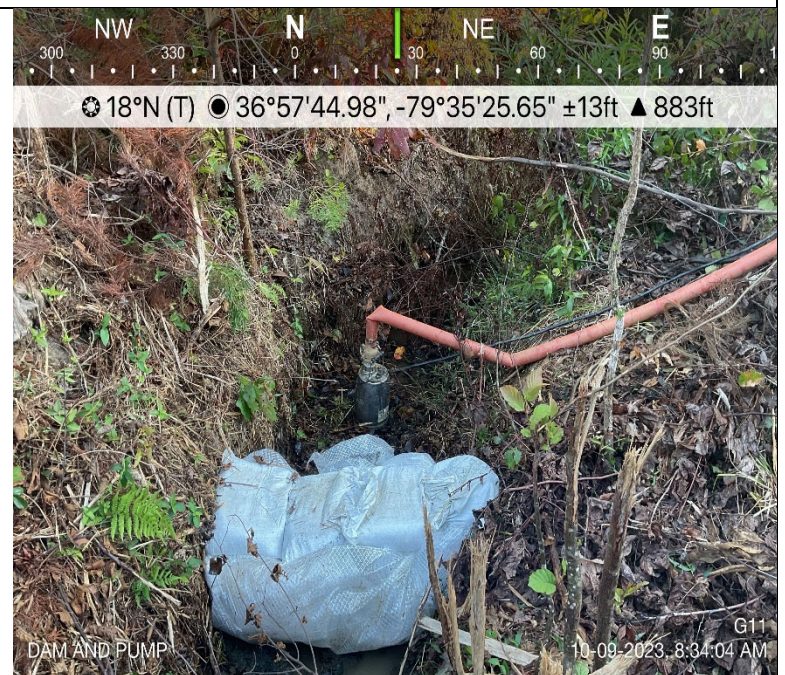
Photo Description: Dam and pump around crossing installed and functional throughout crossing activity.
