STREAM BIOLOGICAL CONDITIONS ENVIRONMENTAL AUDITOR REPORT

Stream ID: S-G15	Crossing Start Date: 11/02/2023	Crossing Completion Date: 11/03/2023
Milepost: 282.6	Pre-Con Assessment Date: 10/31/2023	Post-Con Assessment Date: 11/06/2023
Station: 14932+89	Stream Classification: Intermittent (Perennial, Intermittent, Ephemeral)	Bankfull Width (ft.): 9
County: Franklin	303(d) Impairment Listing: Not Impaired	Riffle:Pool Complexes Present? No

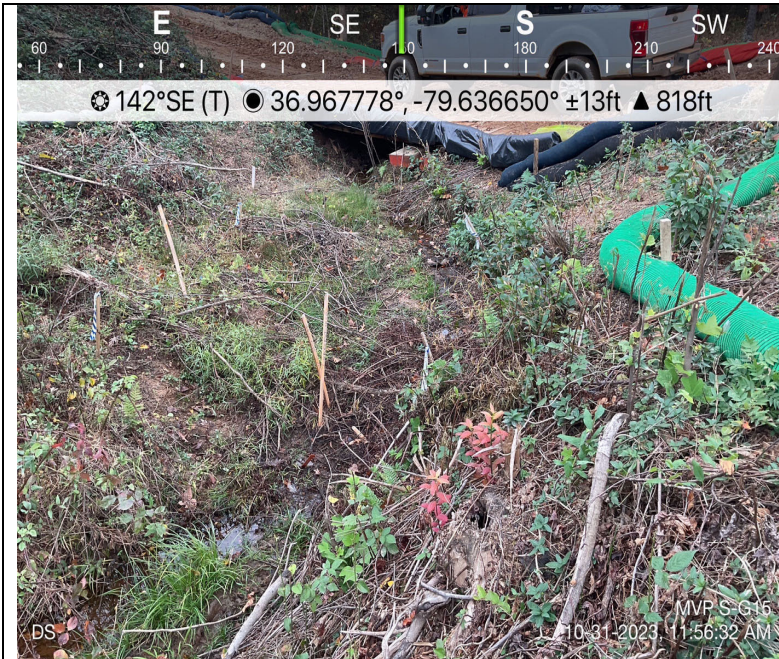
Photo Description: Downstream view of permitted impact area during pre-construction assessment.

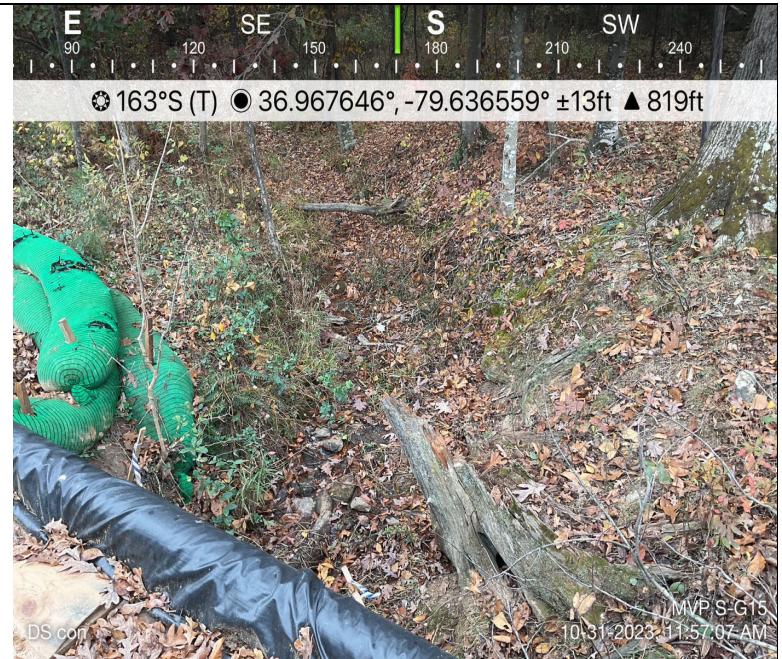
Photo Description: Conditions of the downstream area outside the ROW during pre-construction assessment.

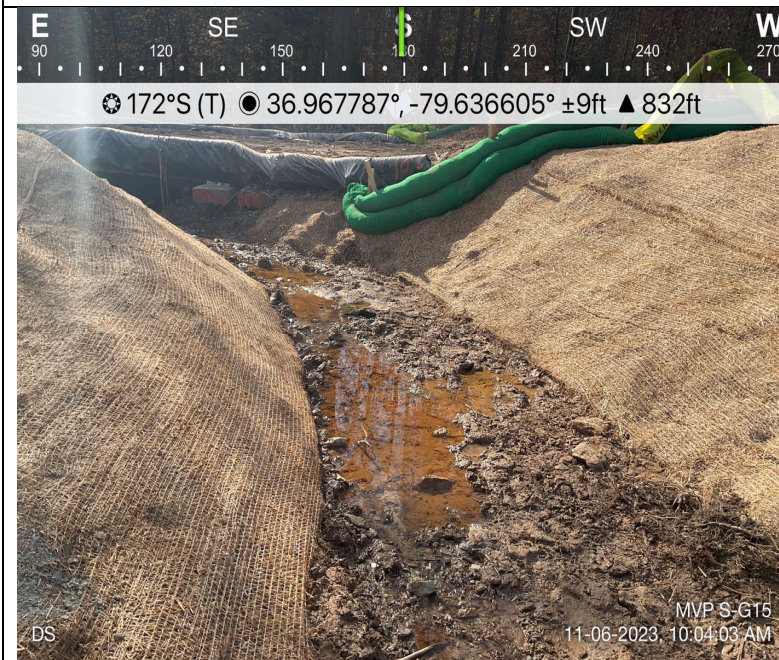
Photo Description: Downstream view of permitted impact area during post-construction assessment.

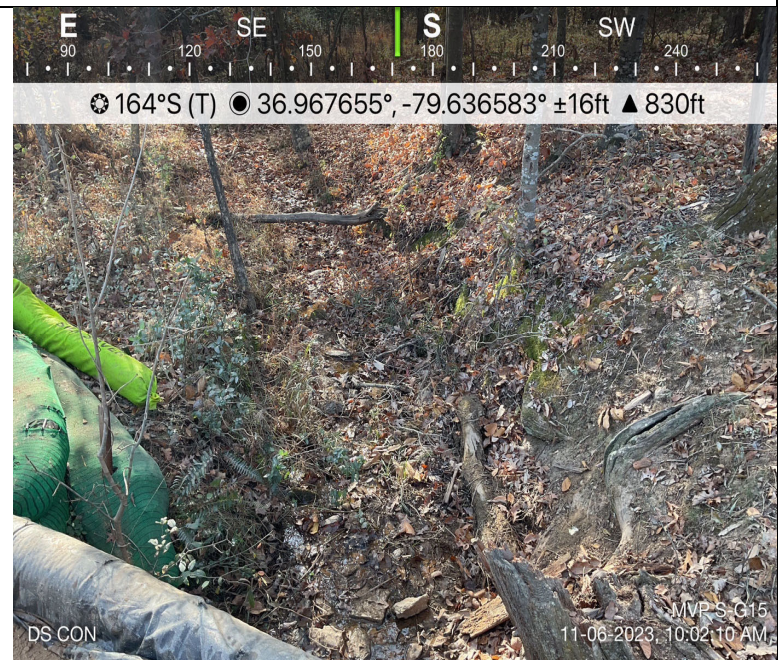
Photo Description: Conditions of the downstream area outside the ROW during post-construction assessment.

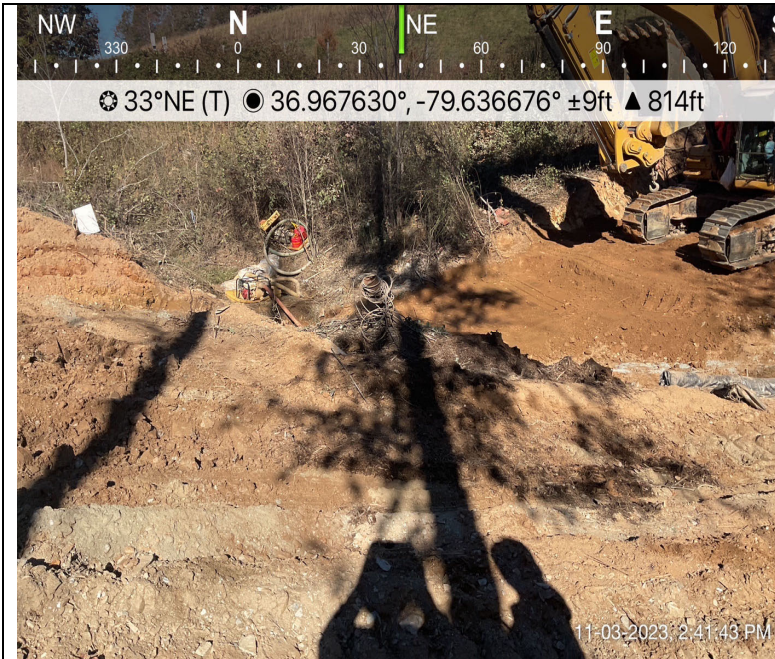
Photo Description: Dam and pump installed for duration of crossing.

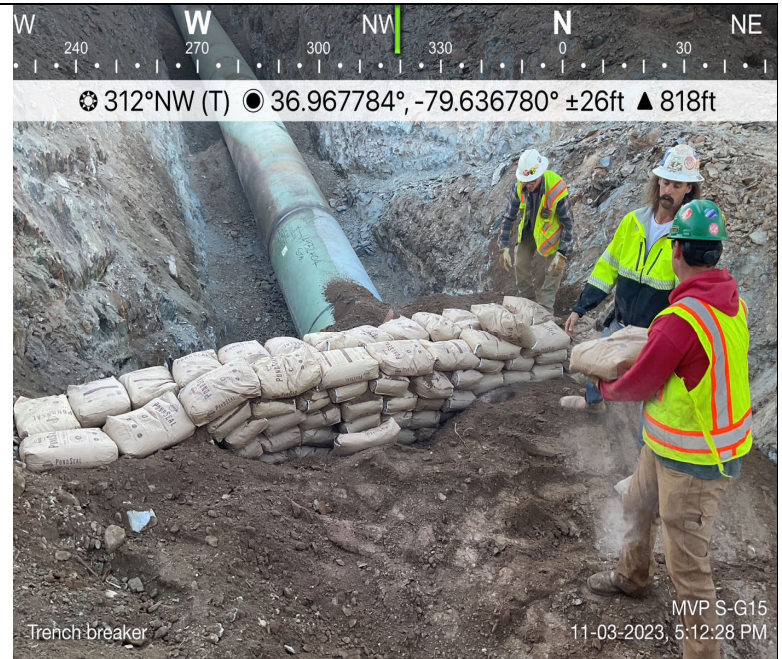
Photo Description: Trench breaker installation outside of stream banks.

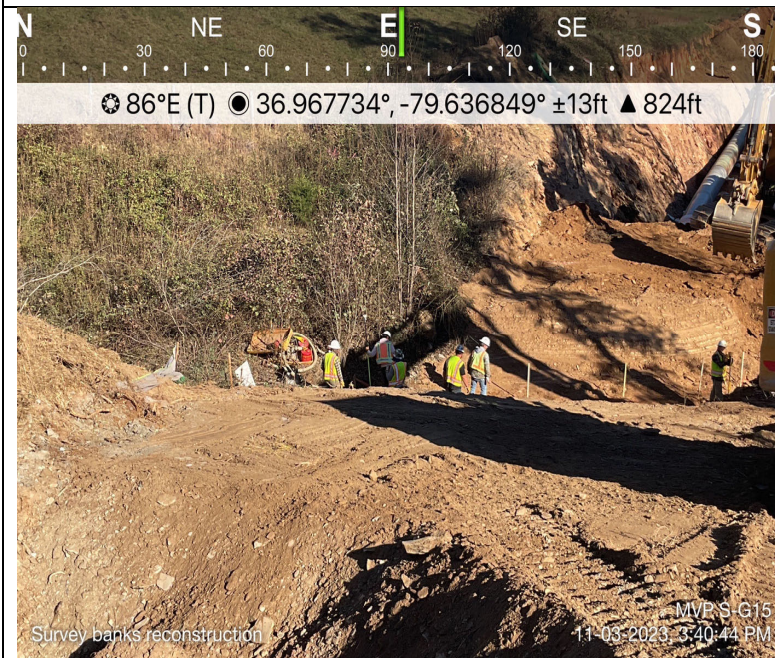
Photo Description: Survey on-site for restoration activities.

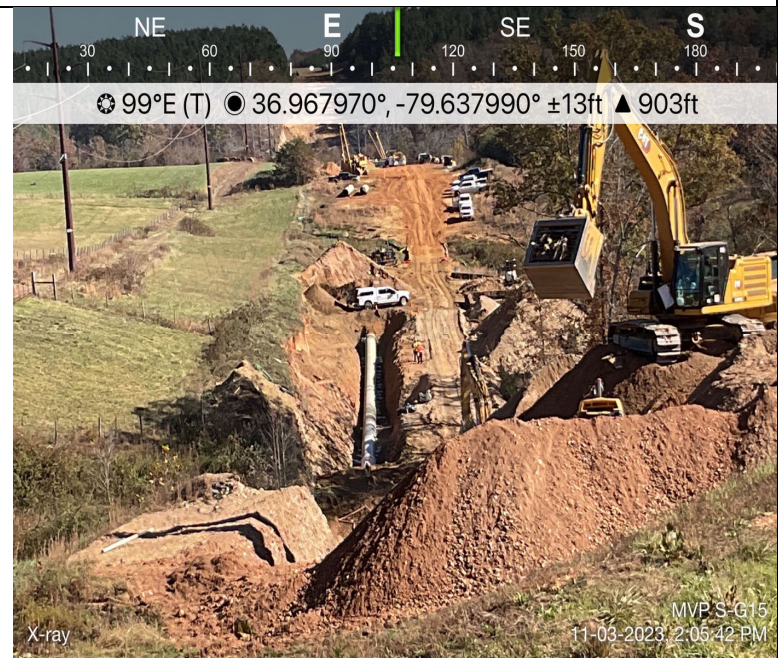
Photo Description: X-Ray QC of pipe welds.
