STREAM BIOLOGICAL CONDITIONS ENVIRONMENTAL AUDITOR REPORT

Stream ID: S-G22	Crossing Start Date: 10/04/2023	Crossing Completion Date: 10/05/2023
Milepost: 274.2	Pre-Con Assessment Date: 09/30/2023	Post-Con Assessment Date: 10/05/2023
Station: 14486+87	Stream Classification: Perennial (Perennial, Intermittent, Ephemeral)	Bankfull Width (ft.): 12
County: Franklin	303(d) Impairment Listing: Not Impaired	Riffle:Pool Complexes Present? No

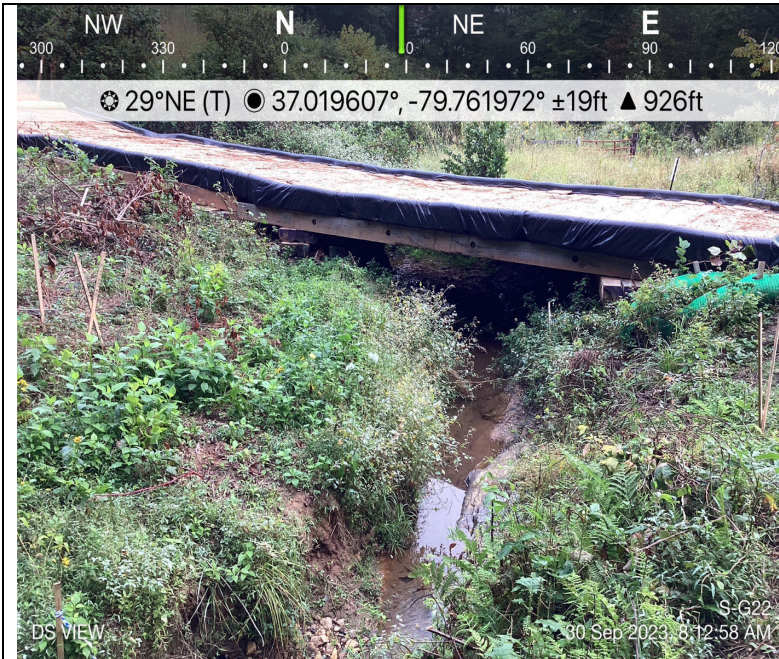
Photo Description: Downstream view of permitted impact area during pre-construction assessment.

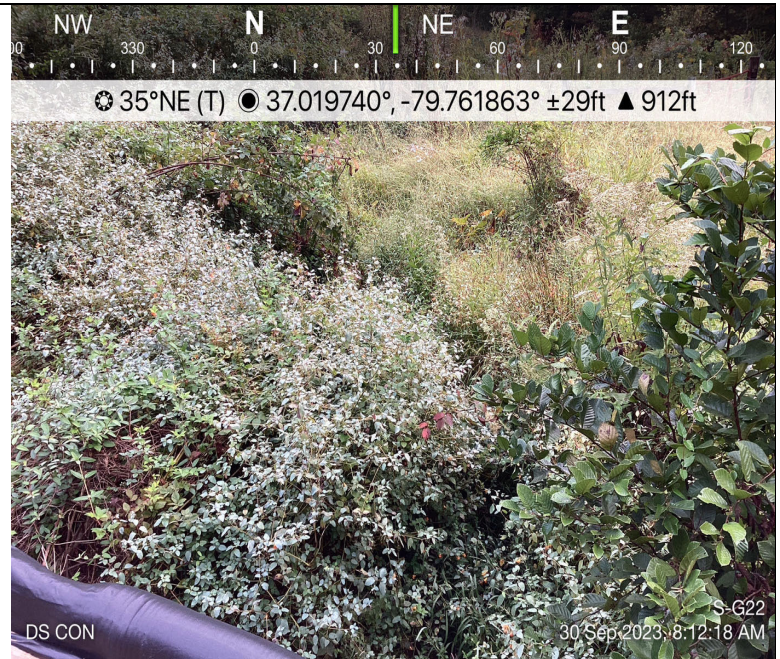
Photo Description: Conditions of the downstream area outside the ROW during pre-construction assessment.

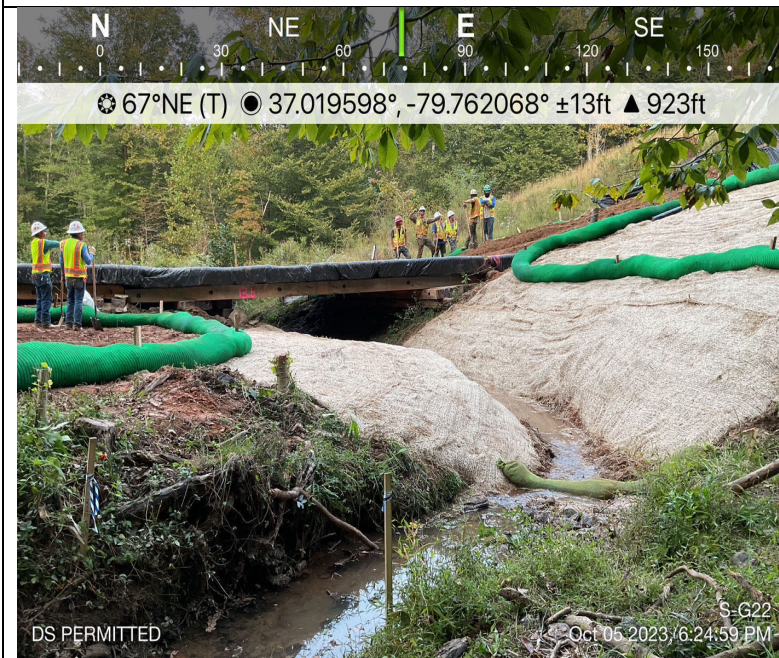
Photo Description: Downstream view of permitted impact area during post-construction assessment.

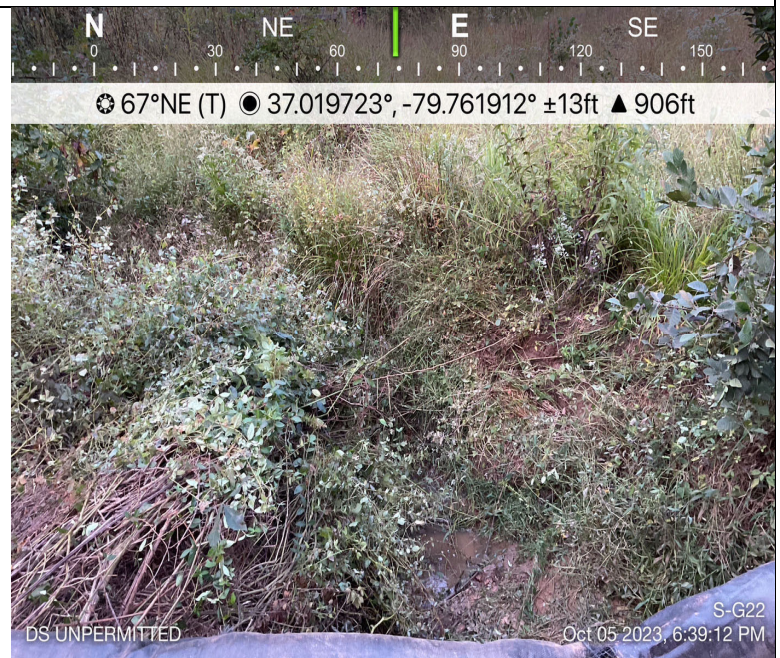
Photo Description: Conditions of the downstream area outside the ROW during post-construction assessment.

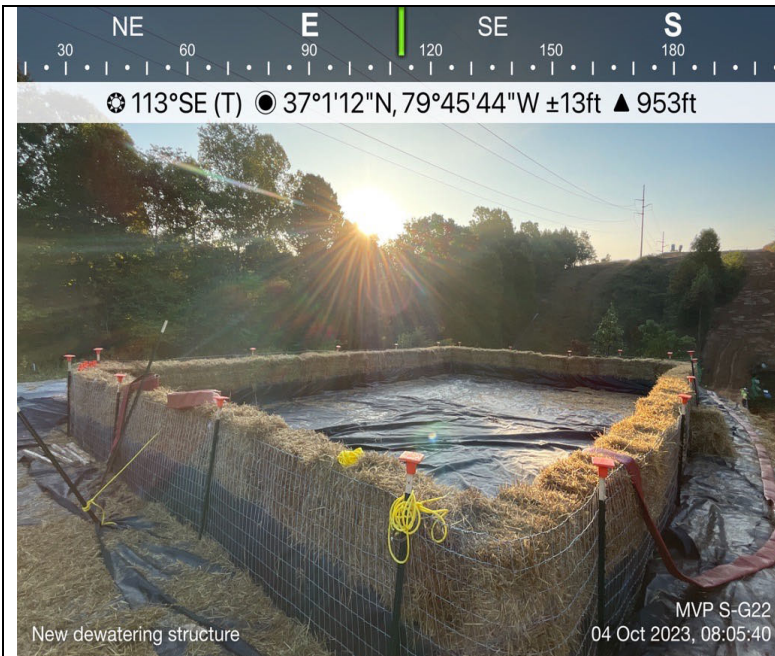
10-3-2023: Built a new dewatering structure because the previous one was not installed per specifications. Pumps are ready to be installed for the crossing tomorrow. Rock shield applied to pipe section that will be installed for the stream section. -A. Thorpe

Photo Description: Dewatering structure installed for crossing.

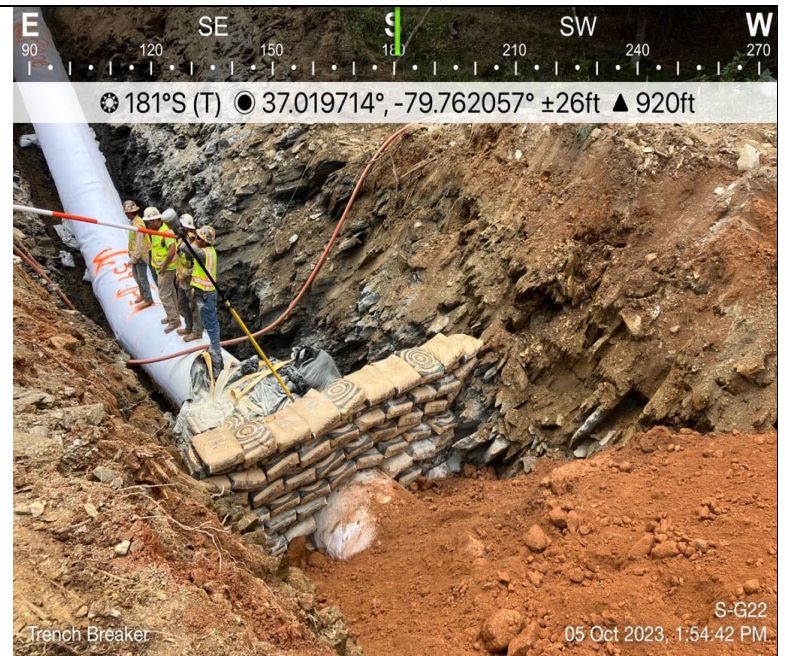
Photo Description: Trench breaker installation.

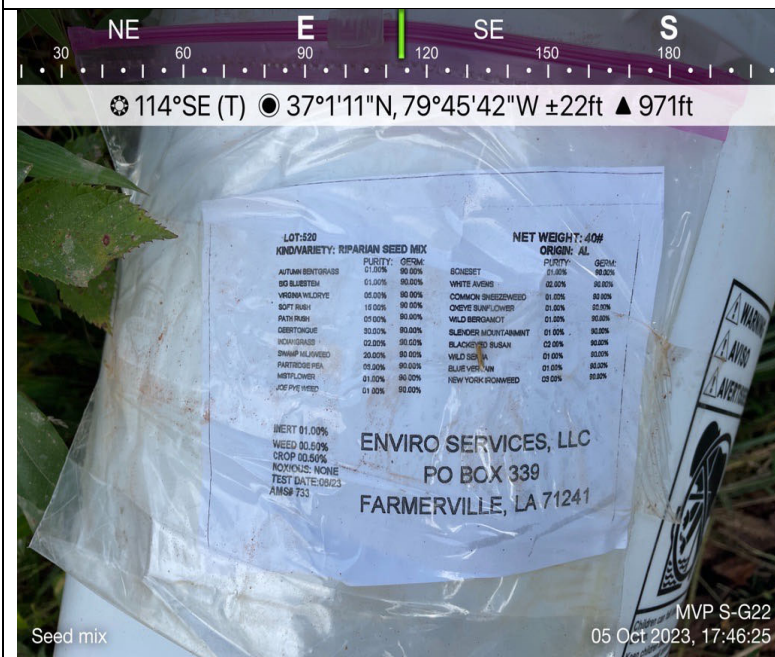
Photo Description: Riparian seed mix used for restoration.

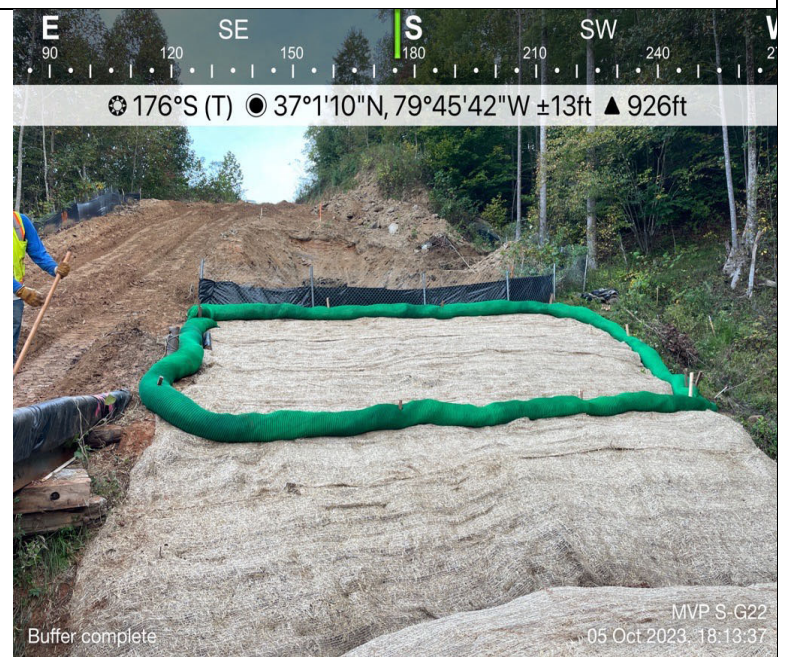
Photo Description: Completed GAS buffer zones and erosion control matting installed.
