STREAM BIOLOGICAL CONDITIONS ENVIRONMENTAL AUDITOR REPORT

| Stream ID: S-G24 | Crossing Start Date: 08/22/2023 | Crossing Completion Date: 09/20/2023 |
| Milepost: 246.5 | Pre-Con Assessment Date: 08/21/2023 | Post-Con Assessment Date: 09/20/2023 |

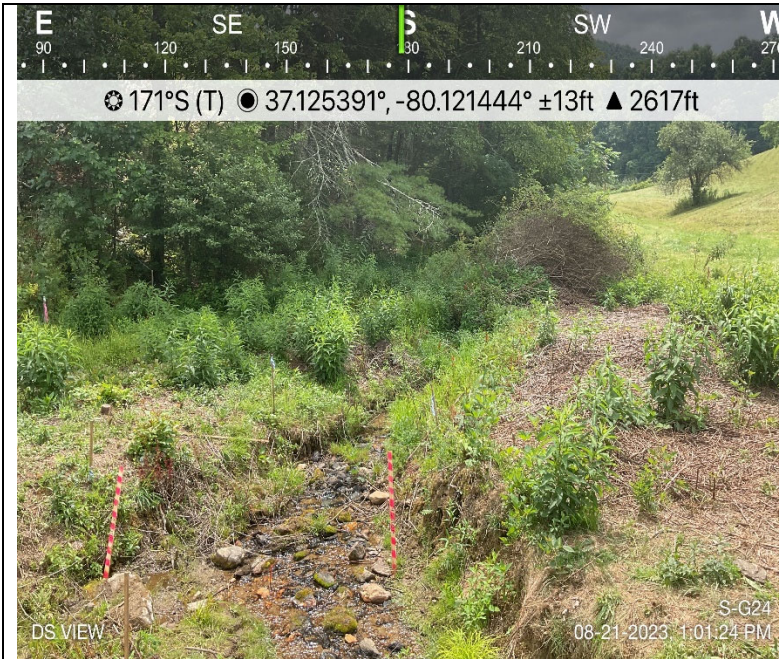
Photo Description: Downstream view of permitted impact area during pre-construction assessment.

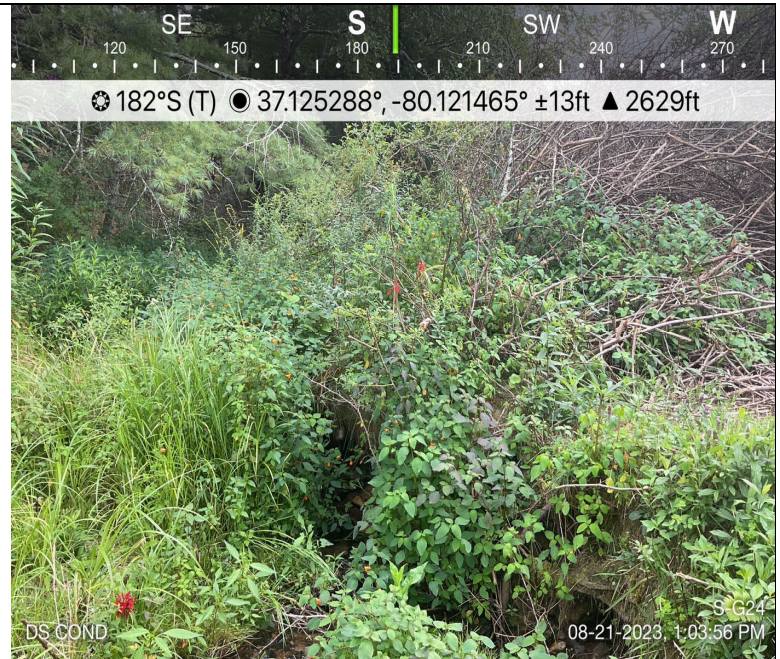
Photo Description: Conditions of the downstream area outside the ROW during pre-construction assessment.

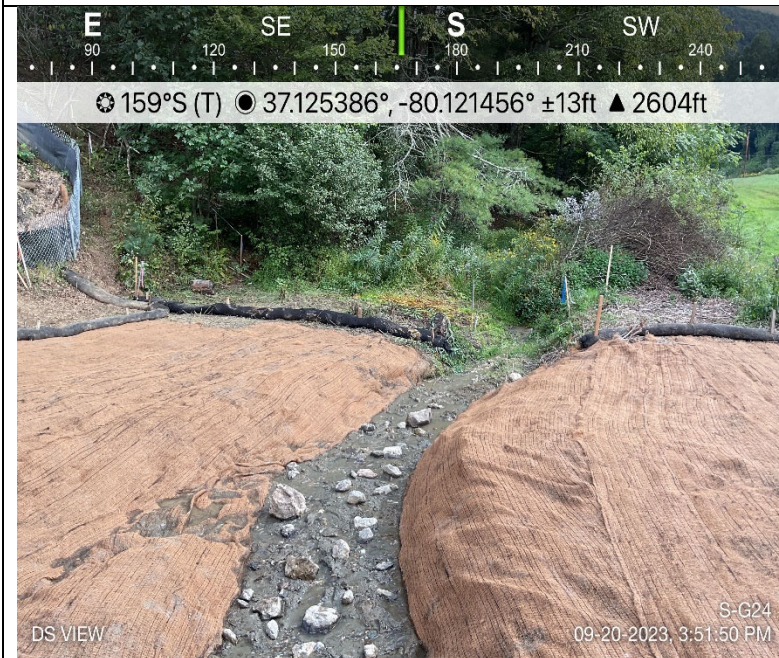
Photo Description: Downstream view of permitted impact area during post-construction assessment.

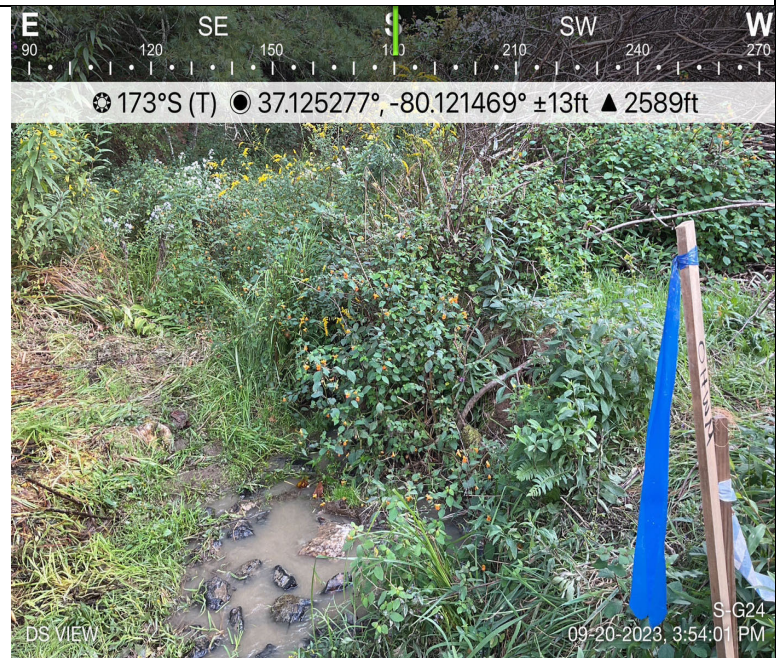
Photo Description: Conditions of the downstream area outside the ROW during post-construction assessment. Typo in photo, "DS COND", not DS VIEW.

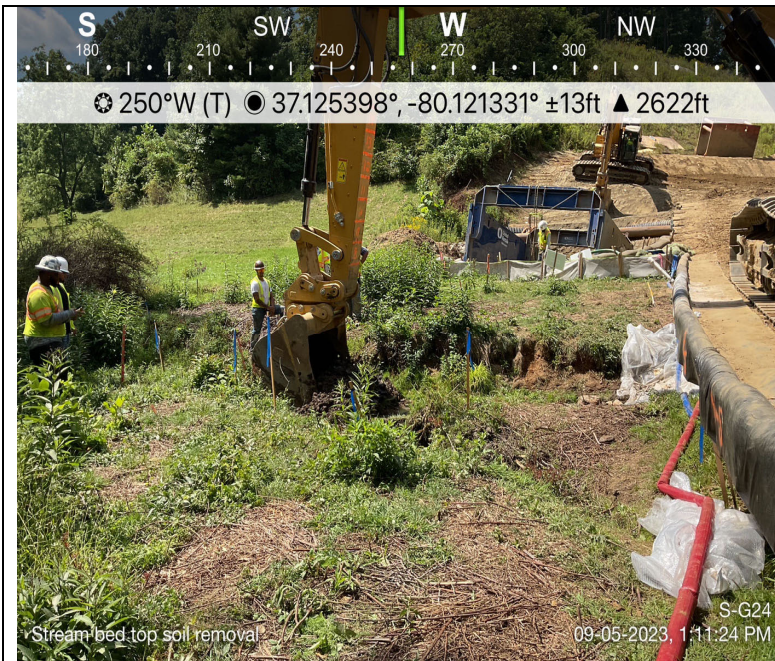
Photo Description: Stripping of topsoil and stream substrate for stockpiling.

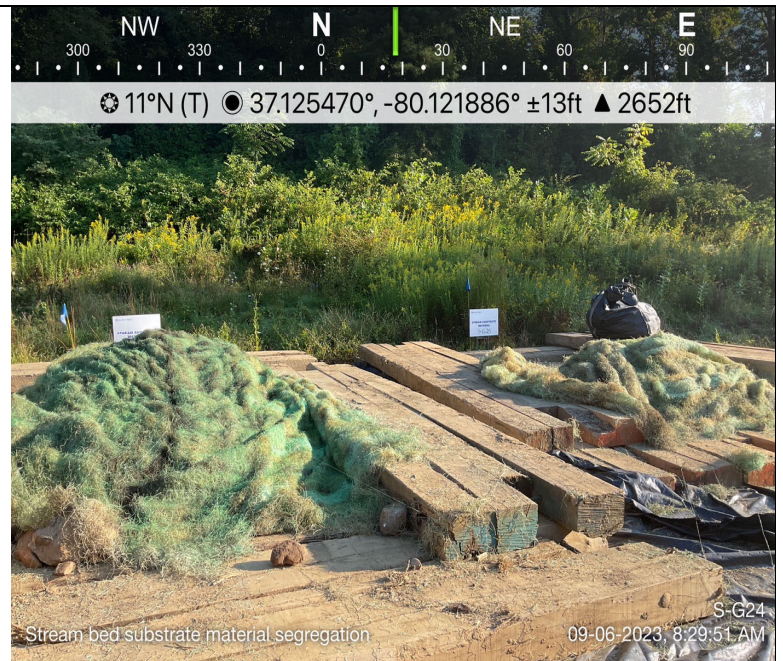
Photo Description: Streambed substrate segregated and stockpiled on timber mats.

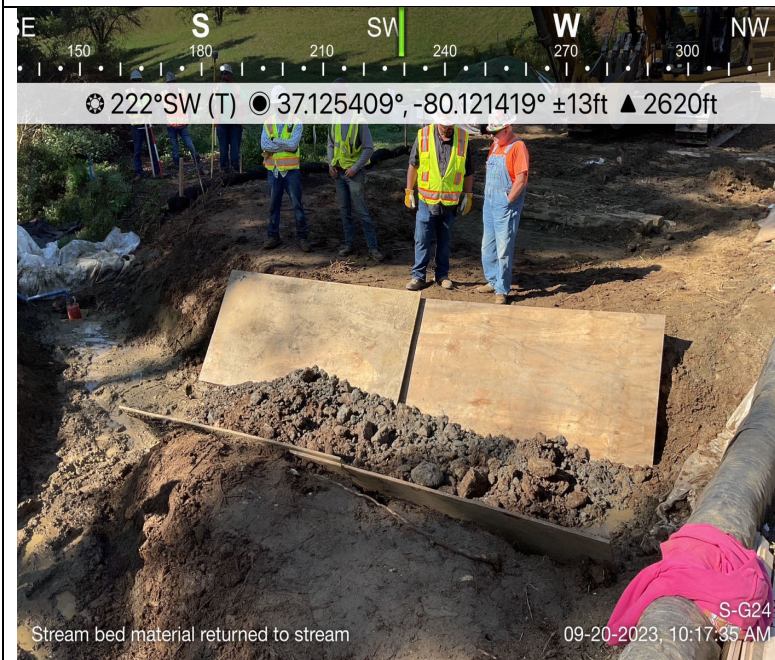
Photo Description: Rough backfill and grading of stream channels.

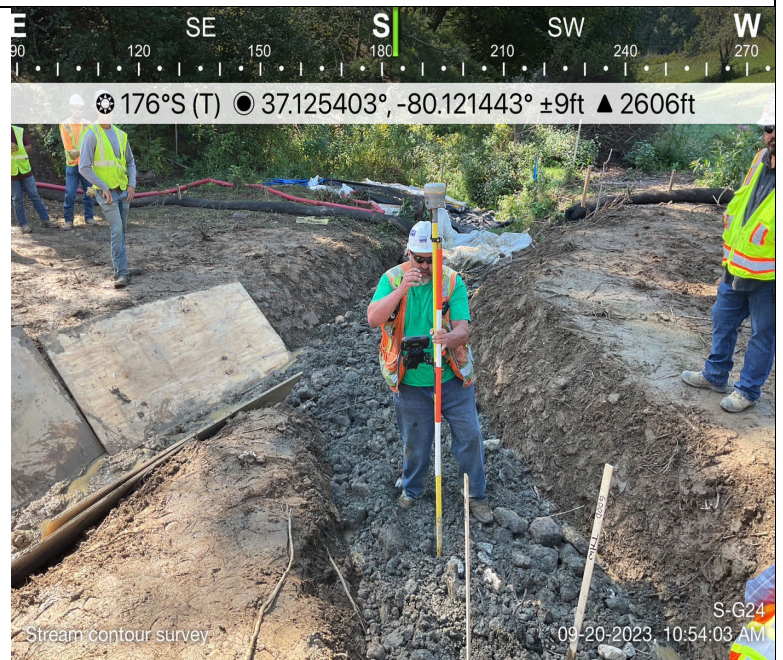
Photo Description: Survey crew on-site assisting with stream contours during restoration.
