STREAM BIOLOGICAL CONDITIONS ENVIRONMENTAL AUDITOR REPORT

Stream ID: S-G25	Crossing Start Date: 08/23/2023	Crossing Completion Date: 09/20/2023
Milepost: 246.5	Pre-Con Assessment Date: 08/21/2023	Post-Con Assessment Date: 09/20/2023
Station: 13024+08	Stream Classification: Intermittent (Perennial, Intermittent, Ephemeral)	Bankfull Width (ft.): 7
County: Franklin	303(d) Impairment Listing: Not Impaired	Riffle:Pool Complexes Present? No

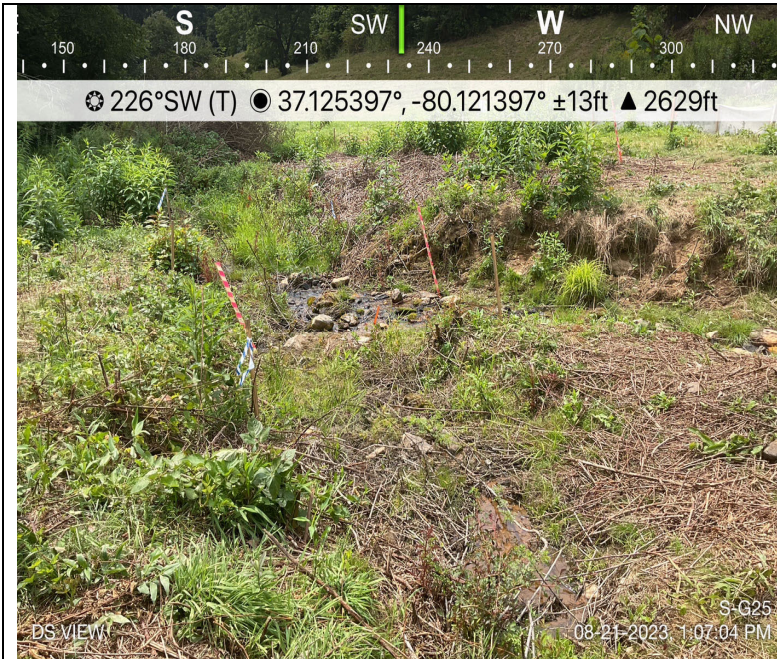
Photo Description: Downstream view of permitted impact area during pre-construction assessment. S-G25 converges with S-G24 within the impact area, which then flows off the ROW.

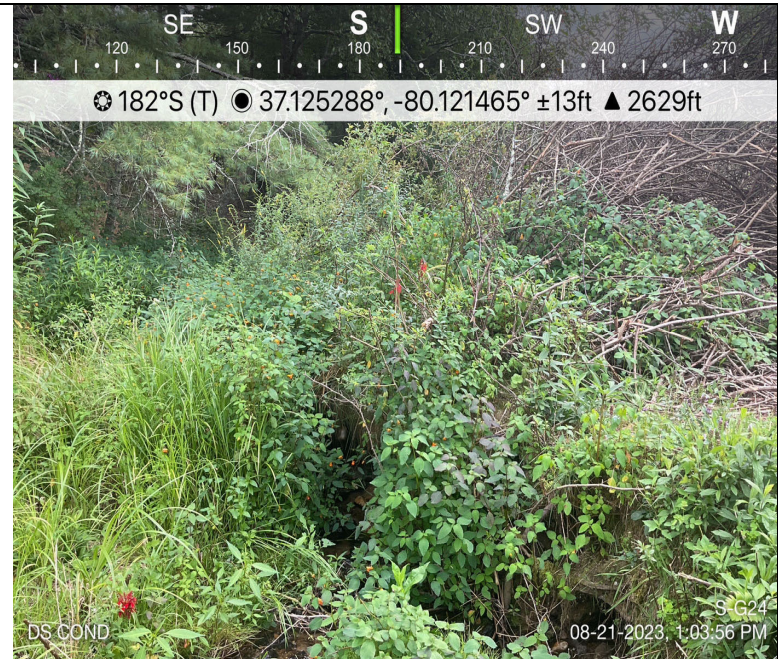
Photo Description: Conditions of the downstream area outside the ROW during pre-construction assessment. S-G25 converges with S-G24 within the impact area, which then flows off the ROW.

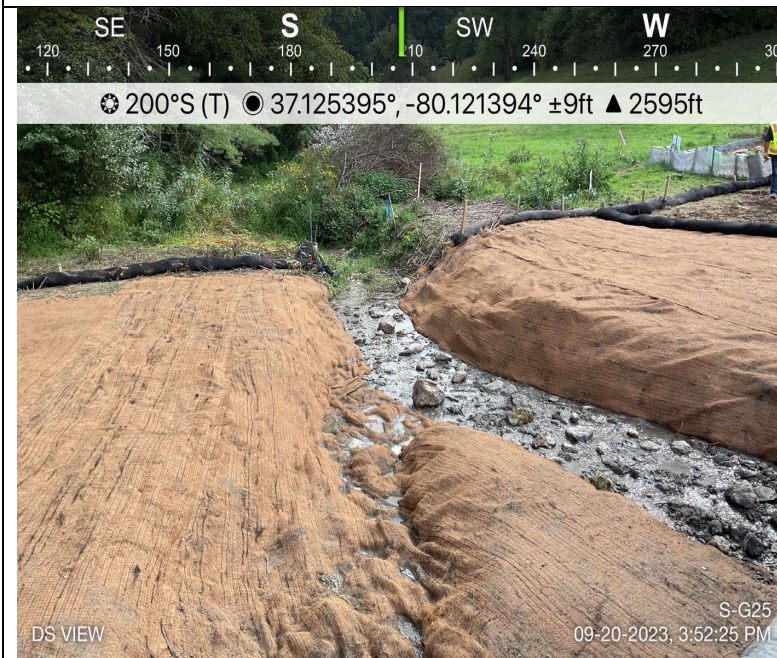
Photo Description: Downstream view of permitted impact area during post-construction assessment. S-G25 converges with S-G24 within the impact area, which then flows off the ROW.

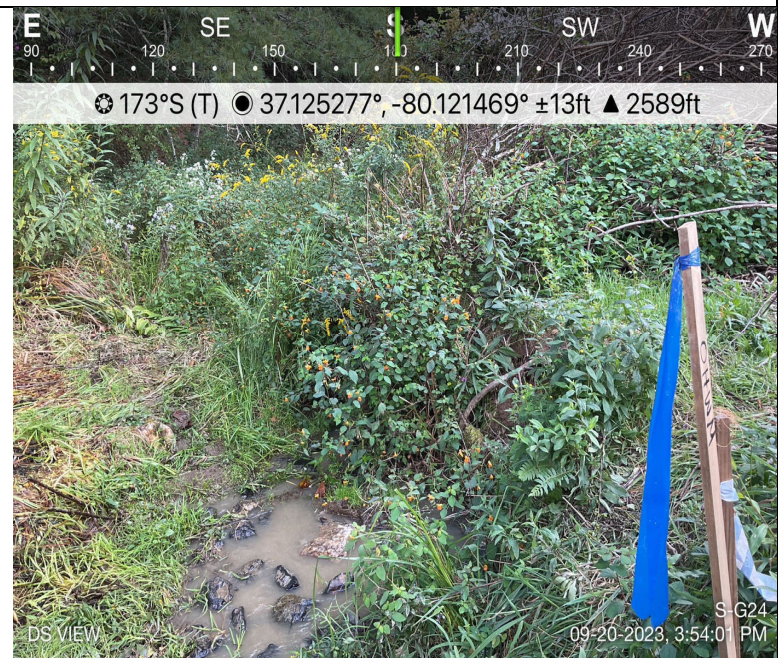
Photo Description: Conditions of the downstream area outside the ROW during post-construction assessment. S-G25 converges with S-G24 within the impact area, which then flows off the ROW. Typo in photo, "DS COND", not DS VIEW.

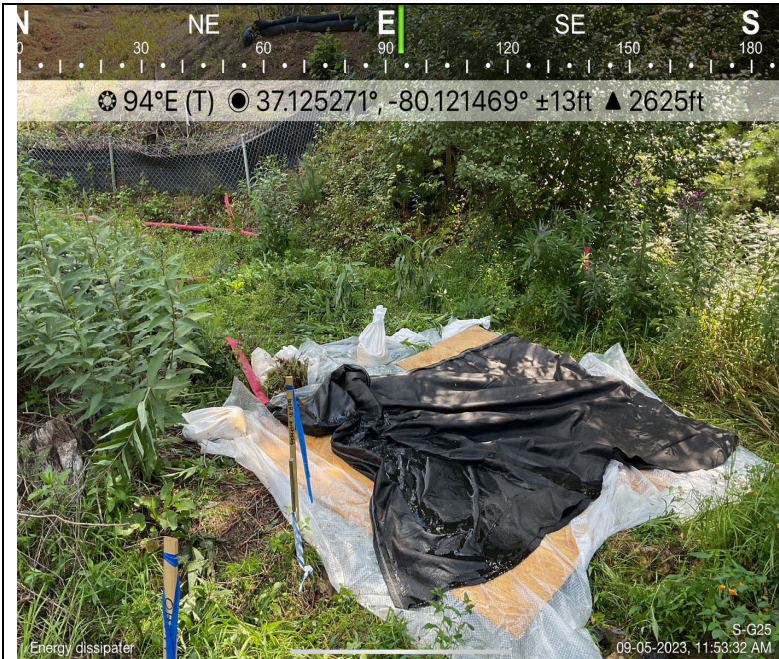
Photo Description: Dam and pump around energy dissipator installed and functioning.

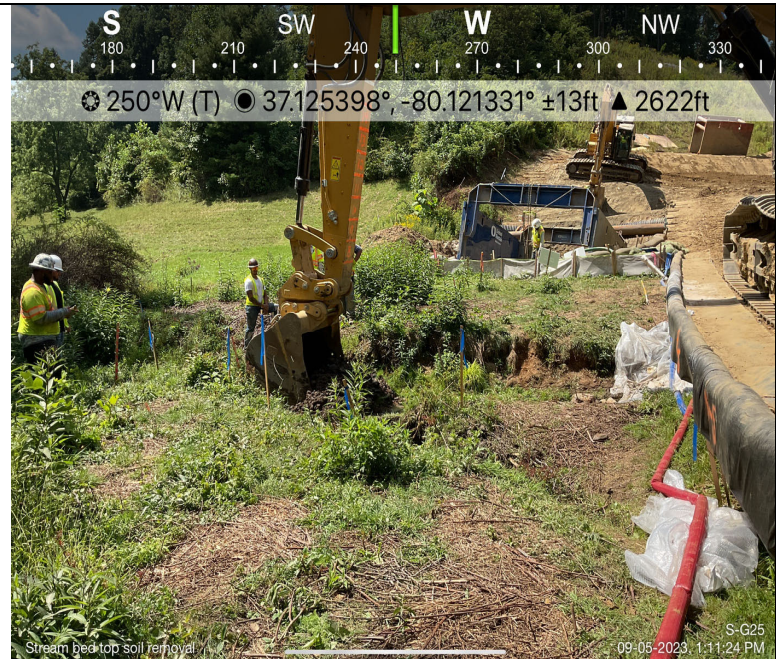
Photo Description: Topsoil removal within resource impact area.

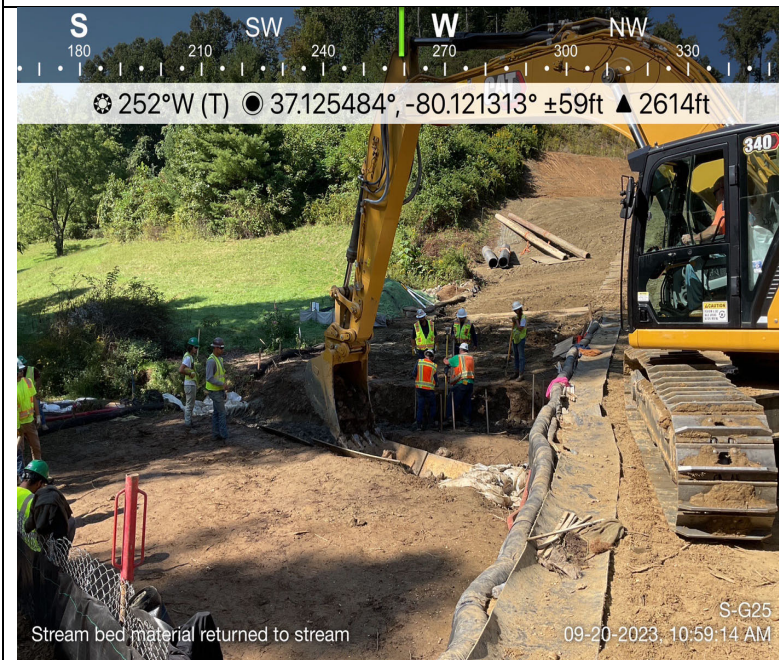
Photo Description: Restoration of streambed material into the resource.

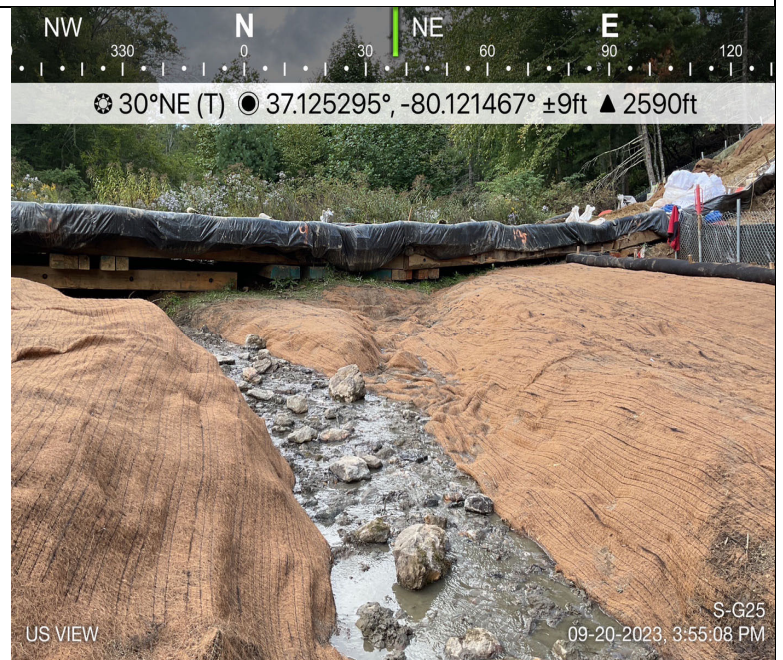
Photo Description: Upstream view of resource impact area after restoration.
