STREAM BIOLOGICAL CONDITIONS ENVIRONMENTAL AUDITOR REPORT

Stream ID: S-G8	Crossing Start Date: 09/28/2023	Crossing Completion Date: 10/03/2023
Milepost: 285.9	Pre-Con Assessment Date: 09/26/2023	Post-Con Assessment Date: 10/04/2023
Station: 15103+45	Stream Classification: Intermittent (Perennial, Intermittent, Ephemeral)	Bankfull Width (ft.): 4
County: Pittsylvania	303(d) Impairment Listing: Not Impaired	Riffle:Pool Complexes Present? No

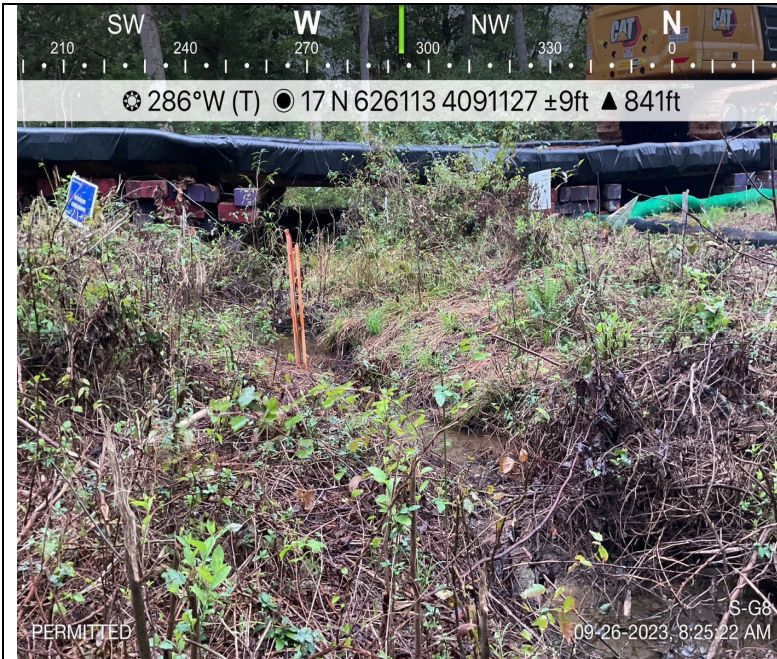
Photo Description: Downstream view of permitted impact area during pre-construction assessment.

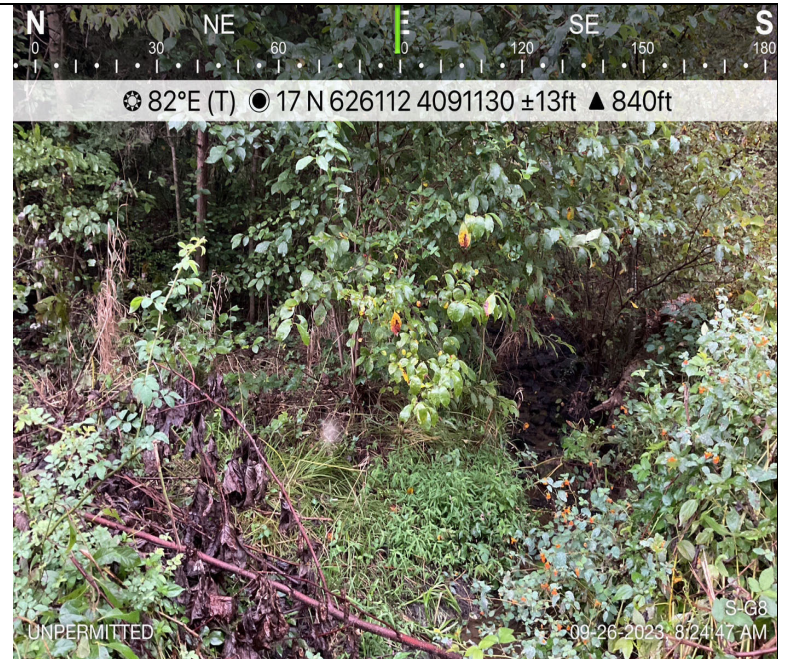
Photo Description: Conditions of the downstream area outside the ROW during pre-construction assessment.

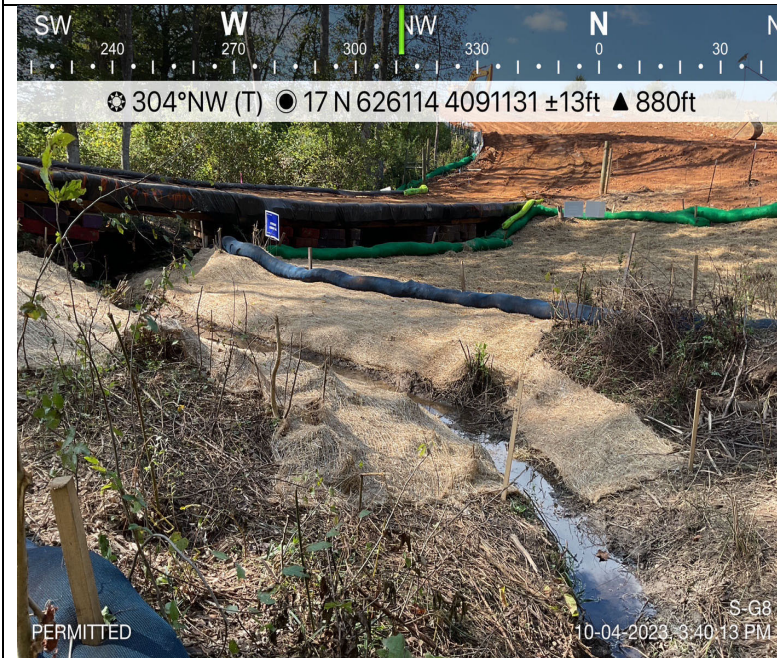
Photo Description: Downstream view of permitted impact area during post-construction assessment.

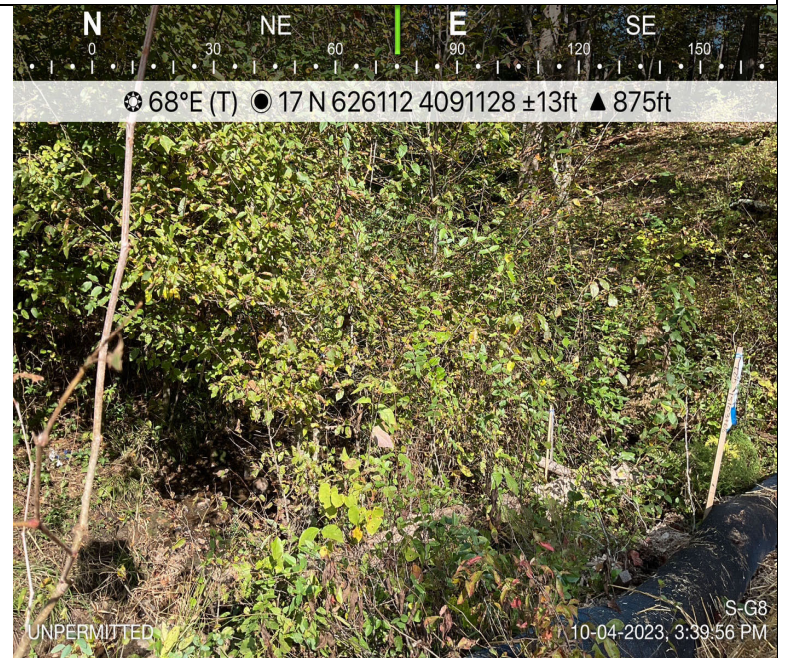
Photo Description: Conditions of the downstream area outside the ROW during post-construction assessment.

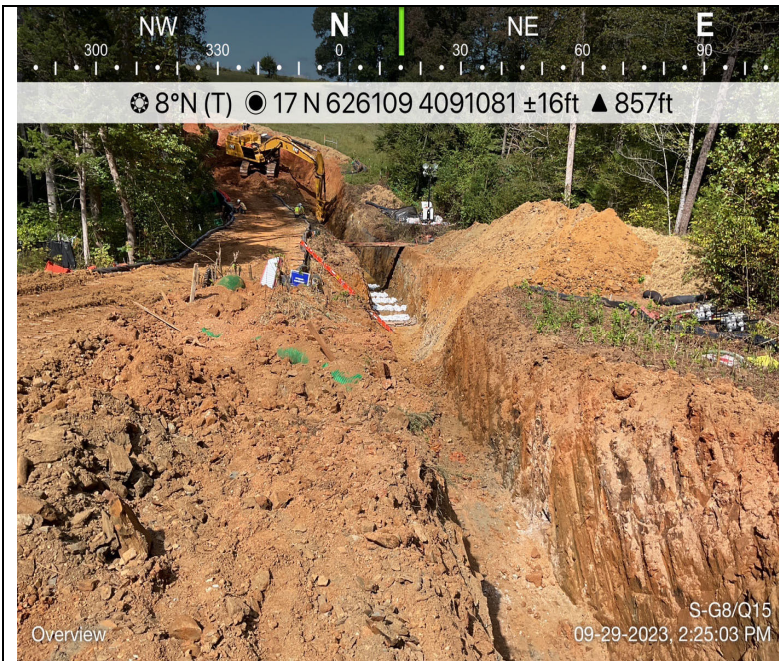
Photo Description: Installing padding for pipe.

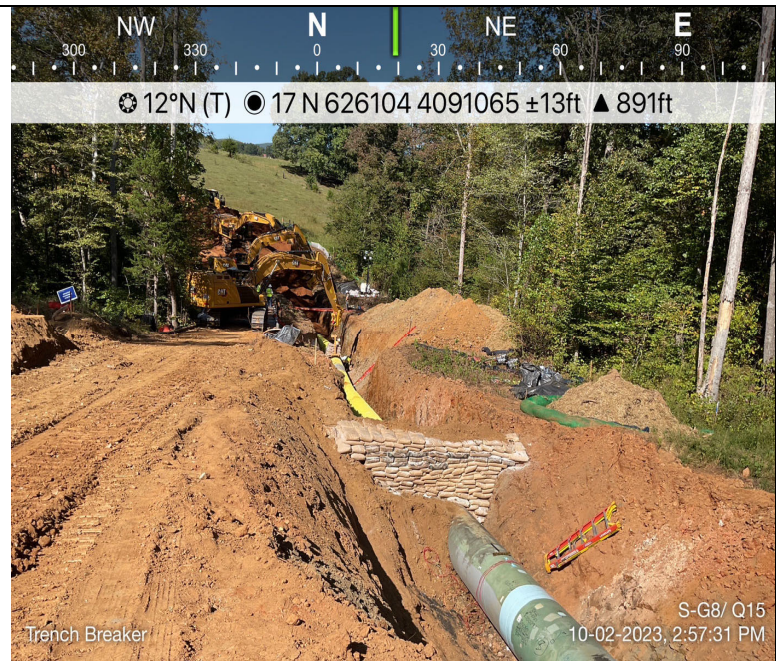
Photo Description: Trench breakers installed.

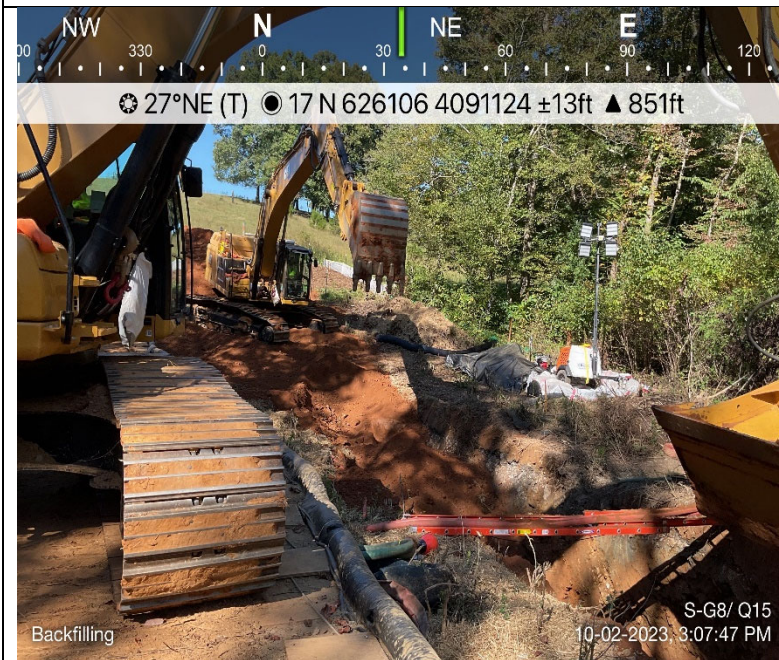
Photo Description: Backfilling of subsoil to resource area.

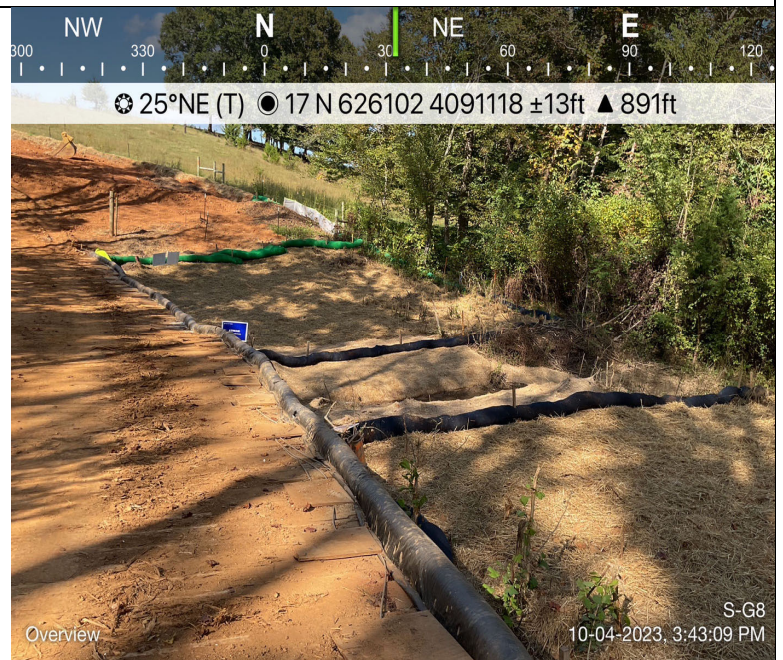
Photo Description: Overview of restored resource area post-construction.
