STREAM BIOLOGICAL CONDITIONS ENVIRONMENTAL AUDITOR REPORT

| Stream ID: S-G9 | Crossing Start Date: 10/04/2023 | Crossing Completion Date: 10/06/2023 |
| Milepost: 285.7 | Pre-Con Assessment Date: 09/26/2023 | Post-Con Assessment Date: 10/07/2023 |

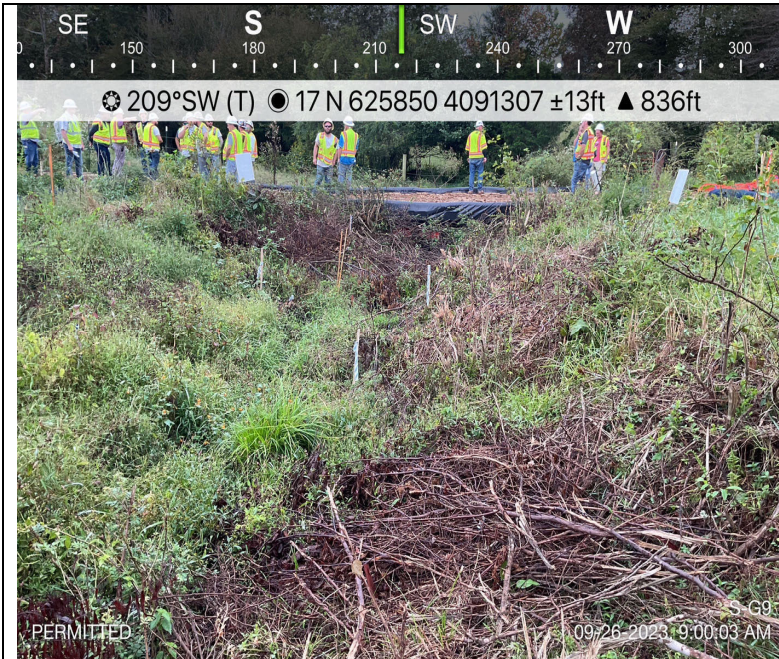
Photo Description: Downstream view of permitted impact area during pre-construction assessment.

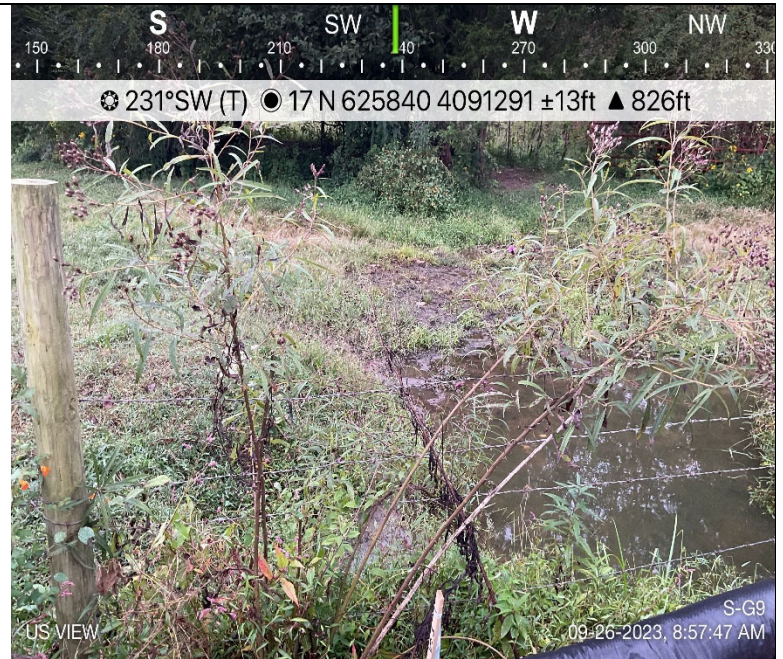
Photo Description: Conditions of the downstream area outside the ROW during pre-construction assessment.

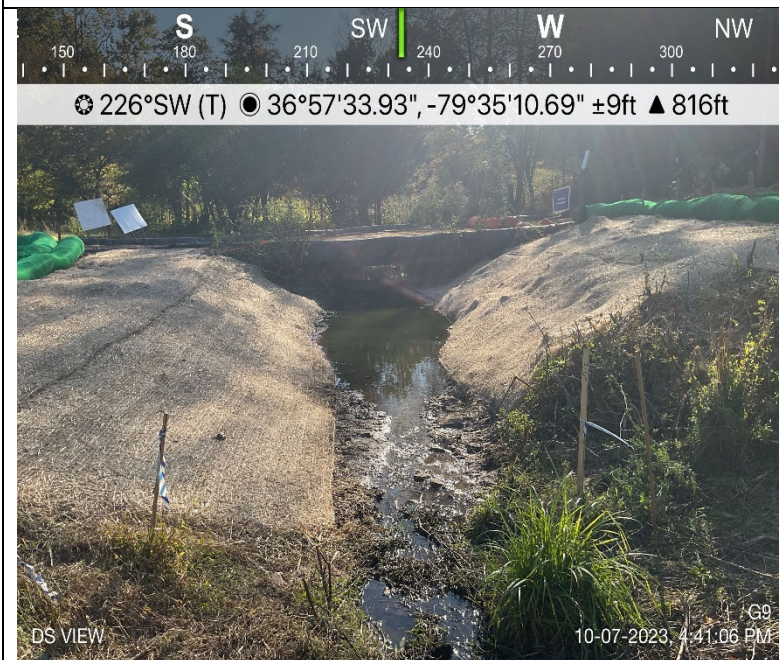
Photo Description: Downstream view of permitted impact area during post-construction assessment.

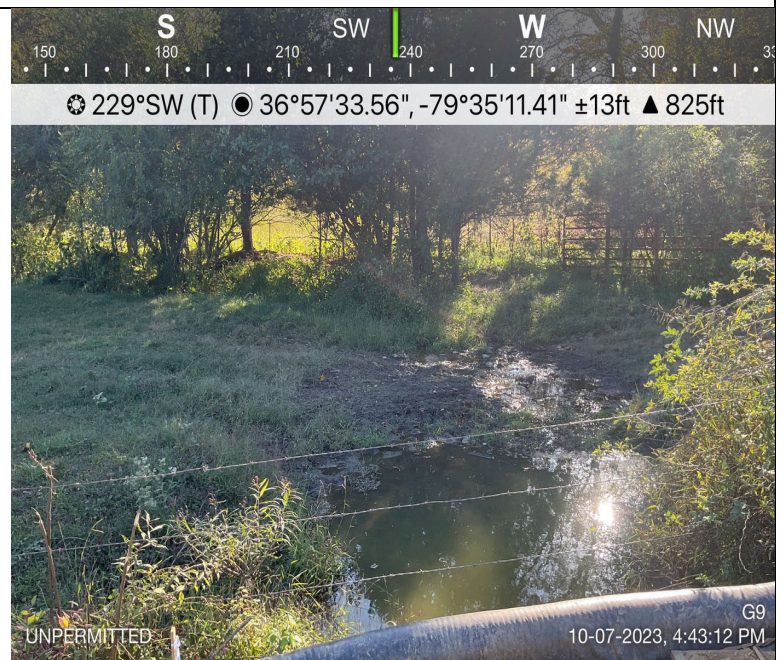
Photo Description: Conditions of the downstream area outside the ROW during post-construction assessment.

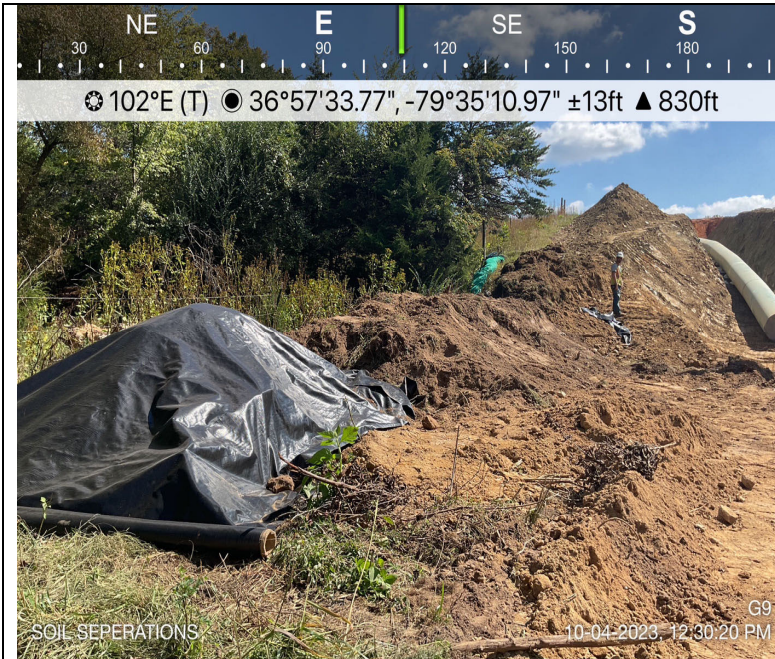
Photo Description: Stream substrate segregated and covered.

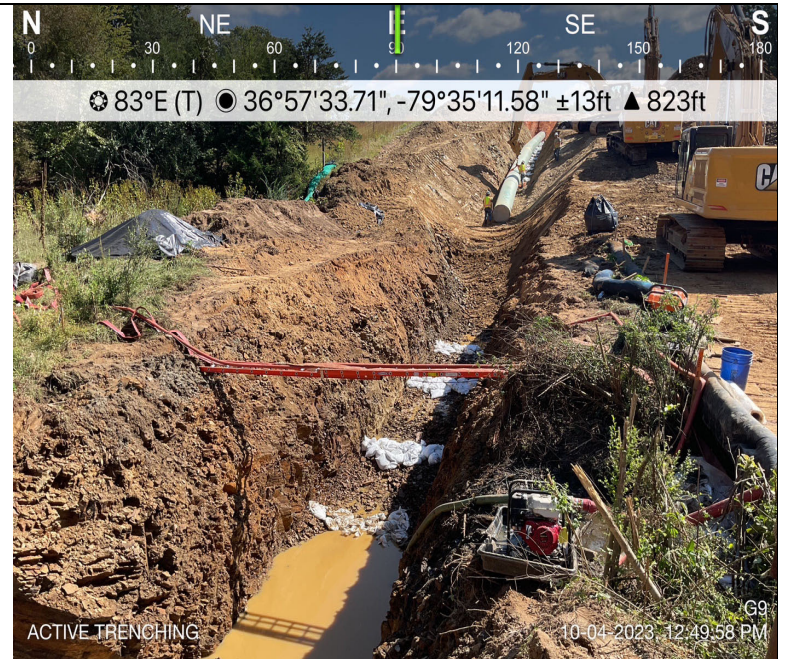
Photo Description: Dam and pump operational throughout crossing.

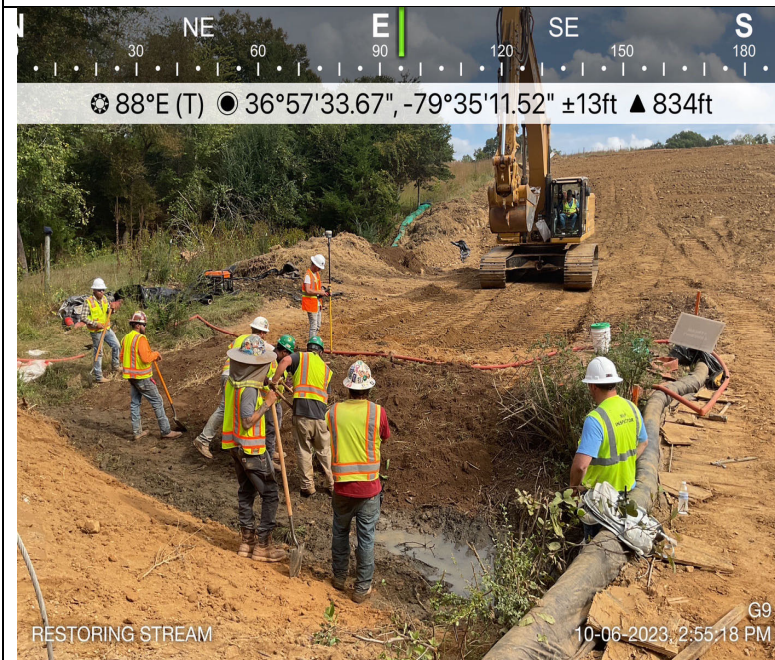
Photo Description: Surveyors and restoring stream substrate.

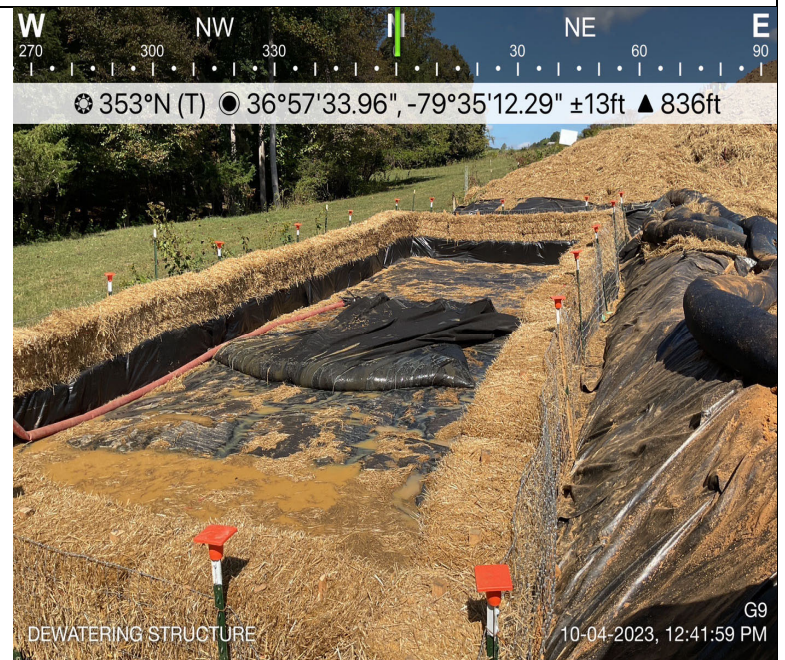
Photo Description: Dewatering structure.
