STREAM BIOLOGICAL CONDITIONS ENVIRONMENTAL AUDITOR REPORT

Stream ID: S-GH11	Crossing Start Date: 09/19/2023	Crossing Completion Date: 09/28/2023
Milepost: 252.4	Pre-Con Assessment Date: 09/15/2023	Post-Con Assessment Date: 09/29/2023
Station: 13334+17	Stream Classification: Intermittent (Perennial, Intermittent, Ephemeral)	Bankfull Width (ft.): 4
County: Franklin	303(d) Impairment Listing: Not Impaired	Riffle:Pool Complexes Present? No

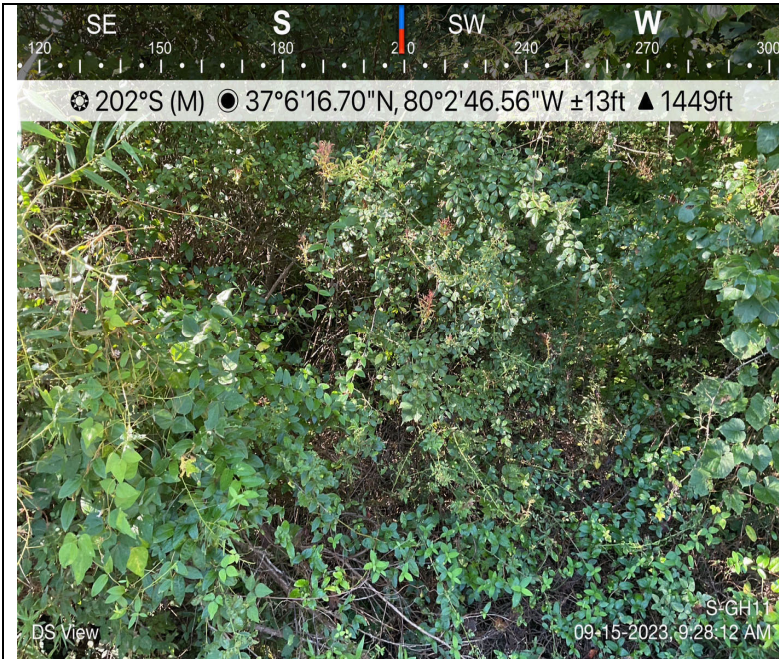
Photo Description: Downstream view of permitted impact area during pre-construction assessment.

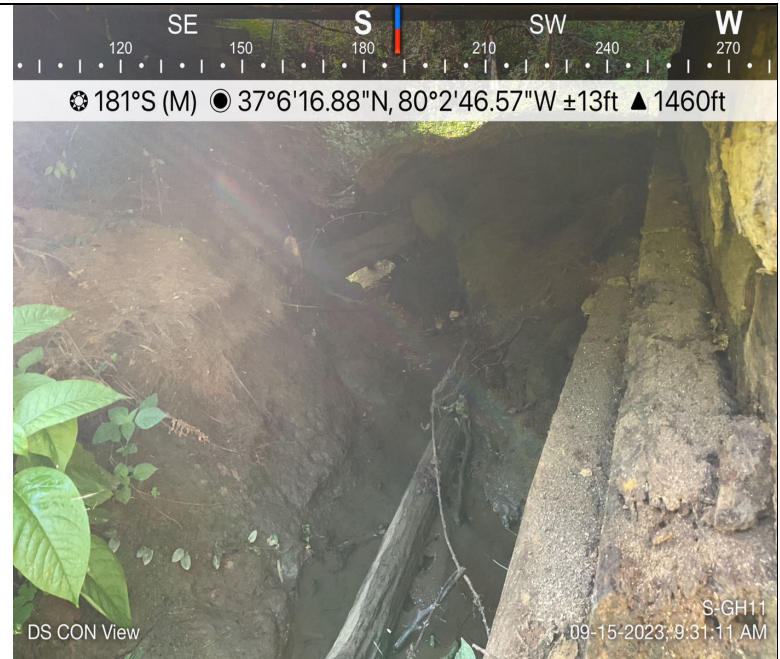
Photo Description: Conditions of the downstream area outside the ROW during pre-construction assessment.

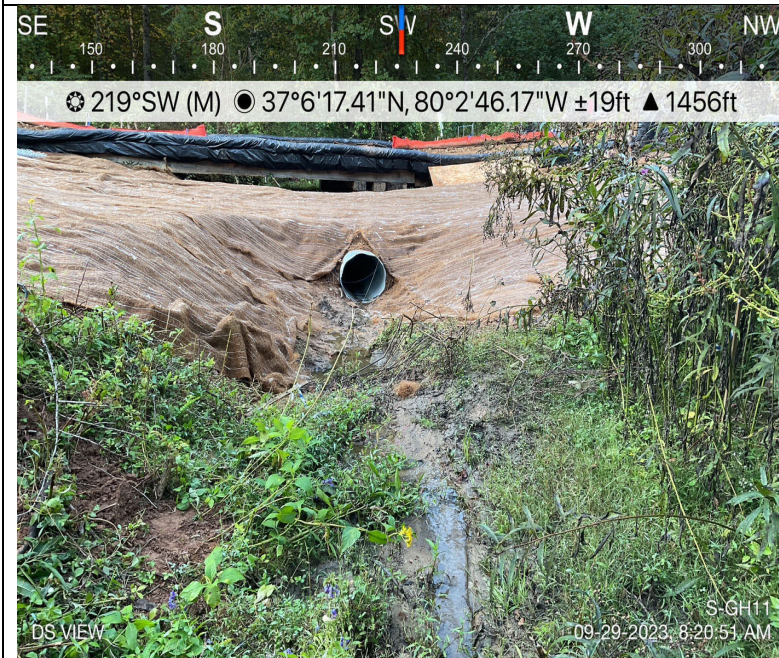
Photo Description: Downstream view of permitted impact area during post-construction assessment.

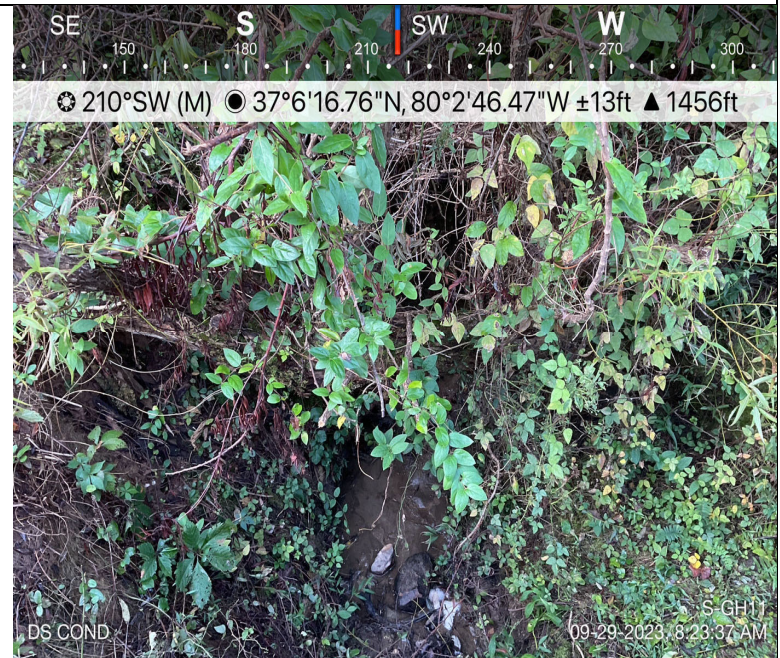
Photo Description: Conditions of the downstream area outside the ROW during post-construction assessment.

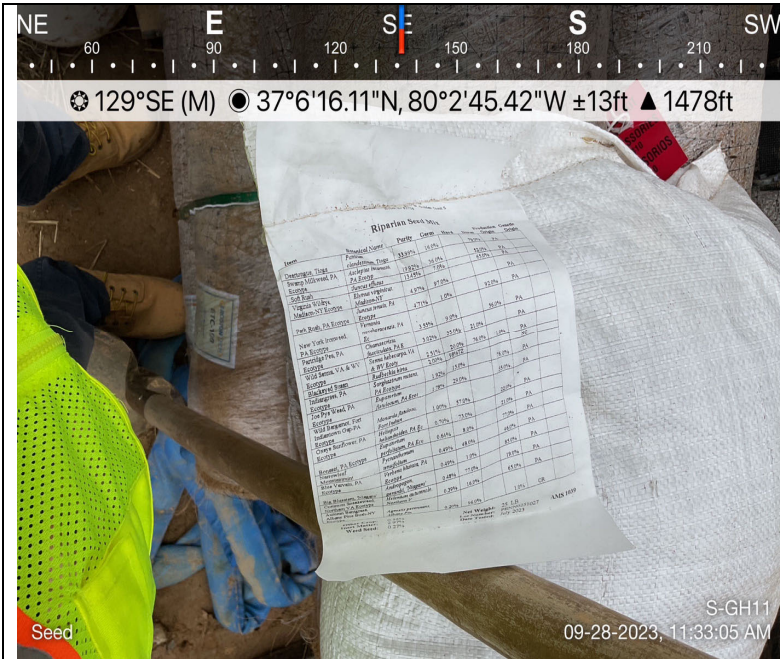
Photo Description: Seed tag for restoration of stream resource.

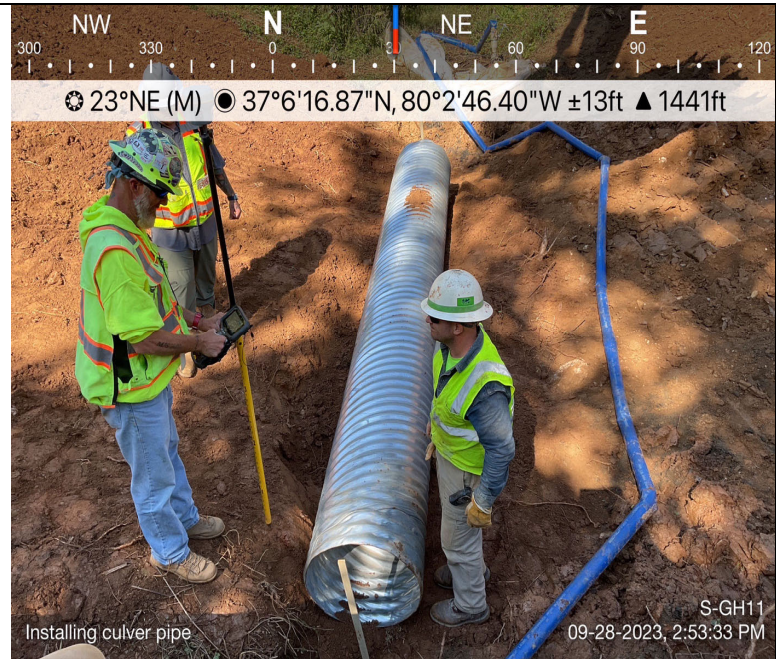
Photo Description: Reinstallation of culvert pipe to return resource to pre-existing conditions.

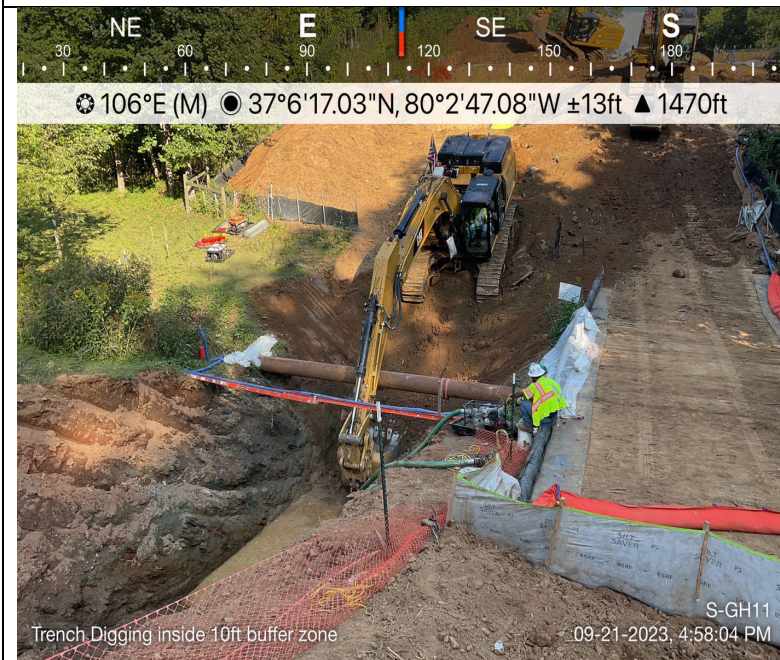
9/21/2023- Blasting completed and contractor finished trench digging. -S. Manzo

Photo Description: Trench excavation through resource.

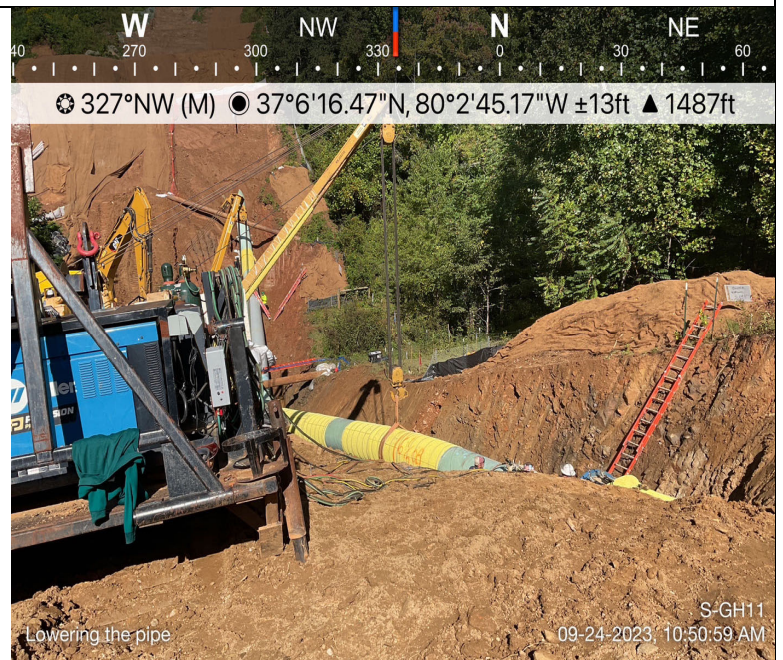
9/22/2023- Pipe was lowered into trench and welded coming-in-side center line pipe. -S. Manzo

Photo Description: Pipe lowering in.
