STREAM BIOLOGICAL CONDITIONS ENVIRONMENTAL AUDITOR REPORT

Stream ID: S-GH14	Crossing Start Date: 10/12/2023	Crossing Completion Date: 10/19/2023
Milepost: 252.2	Pre-Con Assessment Date: 10/06/2023	Post-Con Assessment Date: 10/19/2023
Station: 13325+30	Stream Classification: Perennial (Perennial, Intermittent, Ephemeral)	Bankfull Width (ft.): 4
County: Franklin	303(d) Impairment Listing: Not Impaired	Riffle:Pool Complexes Present? No

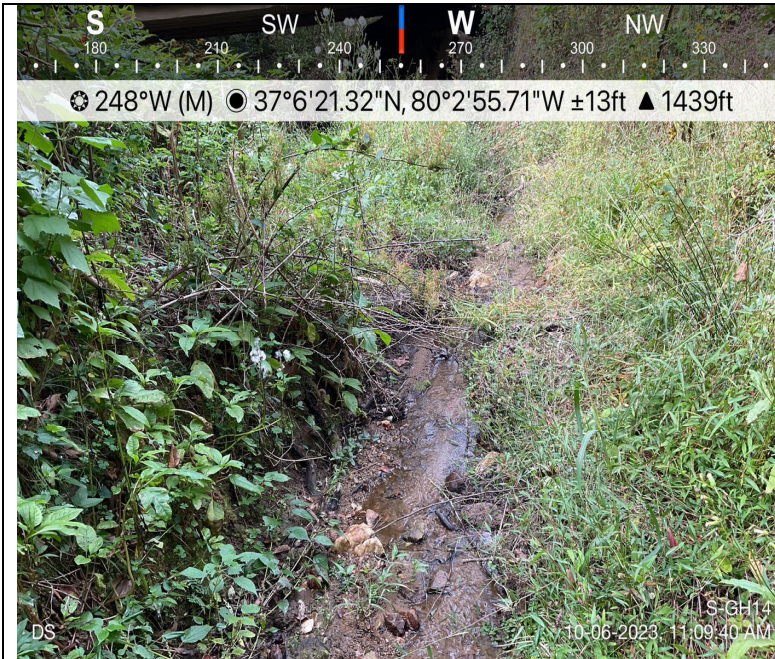
Photo Description: Downstream view of permitted impact area during pre-construction assessment.

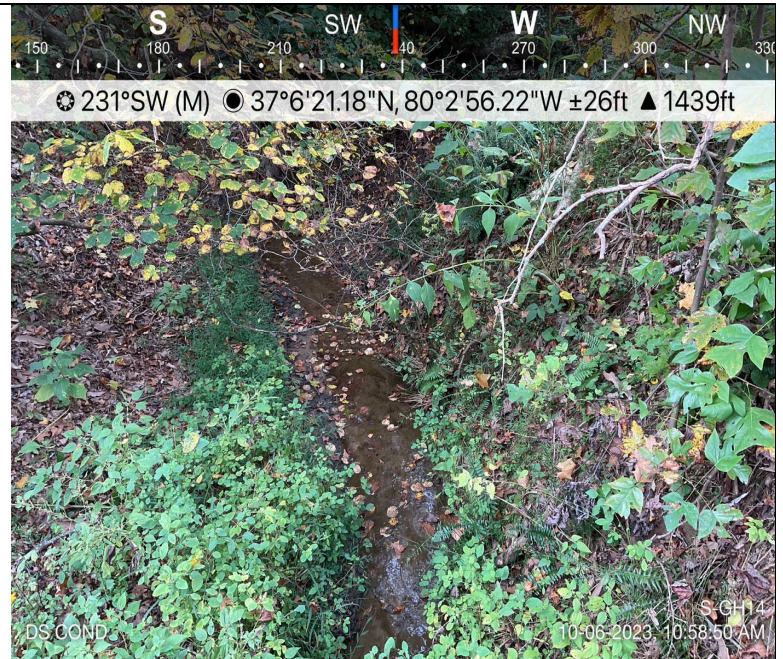
Photo Description: Conditions of the downstream area outside the ROW during pre-construction assessment.

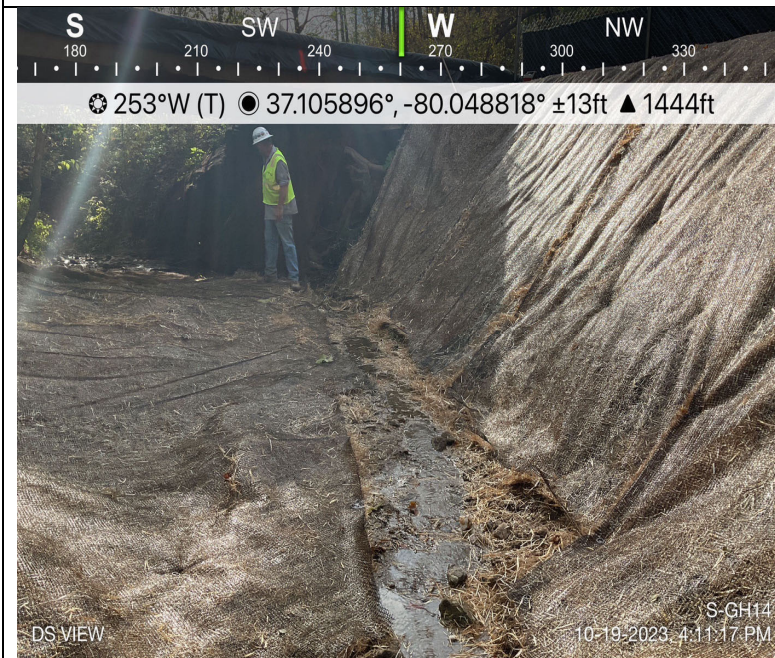
Photo Description: Downstream view of permitted impact area during post-construction assessment.

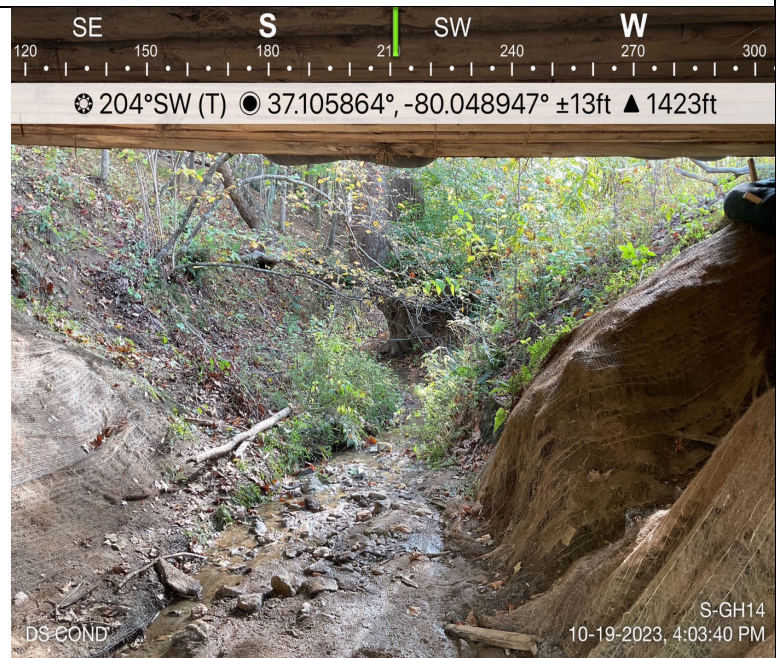
Photo Description: Conditions of the downstream area outside the ROW during post-construction assessment.

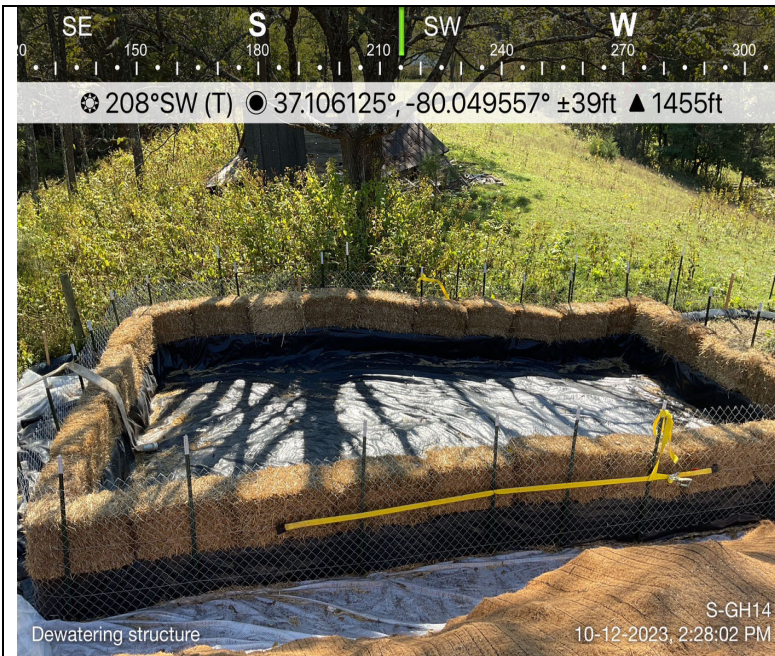
Photo Description: Dewatering structure.

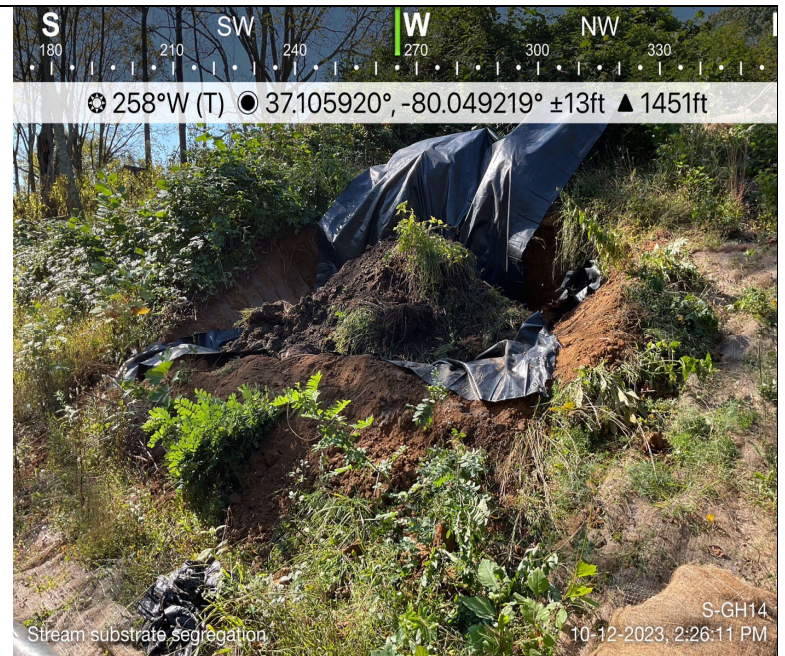
Photo Description: Stream substrate segregation.

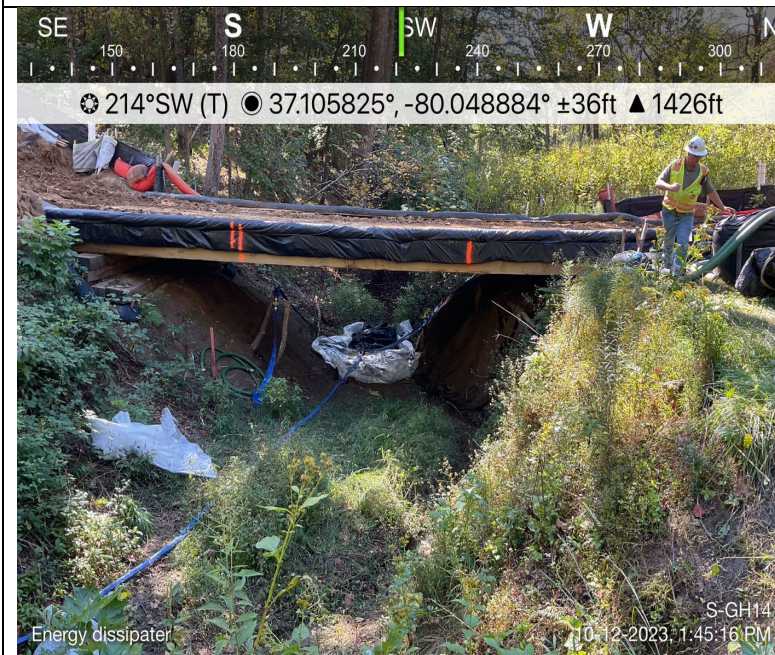
Photo Description: Energy dissipater.

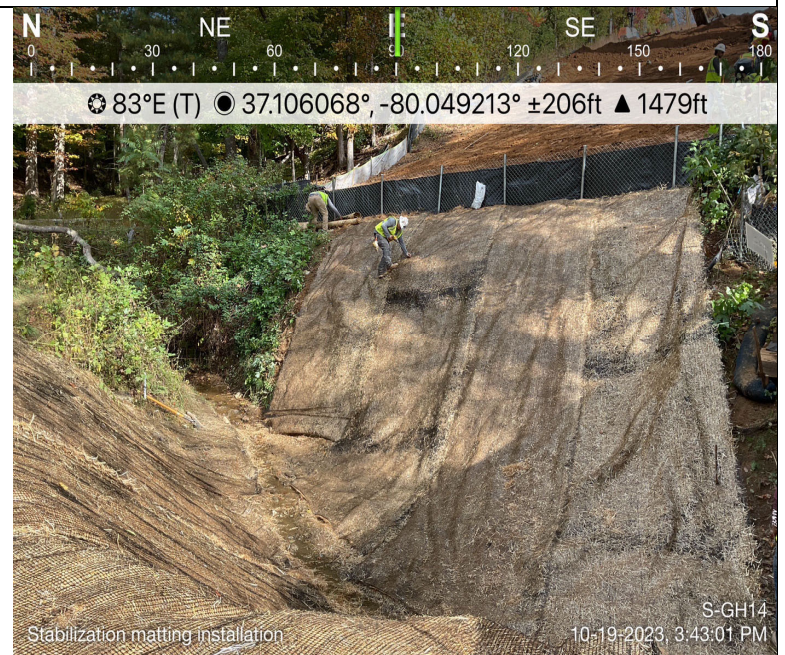
Photo Description: Heavy duty stabilization matting and high velocity screw pins.
