STREAM BIOLOGICAL CONDITIONS ENVIRONMENTAL AUDITOR REPORT

Stream ID: S-GH40	Crossing Start Date: 09/27/2023	Crossing Completion Date: 09/29/2023
Milepost: 273.2	Pre-Con Assessment Date: 09/19/2023	Post-Con Assessment Date: 09/29/2023
Station: 14434+14	Stream Classification: Ephemeral (Perennial, Intermittent, Ephemeral)	Bankfull Width (ft.): 3
County: Franklin	303(d) Impairment Listing: Not Impaired	Riffle:Pool Complexes Present? No

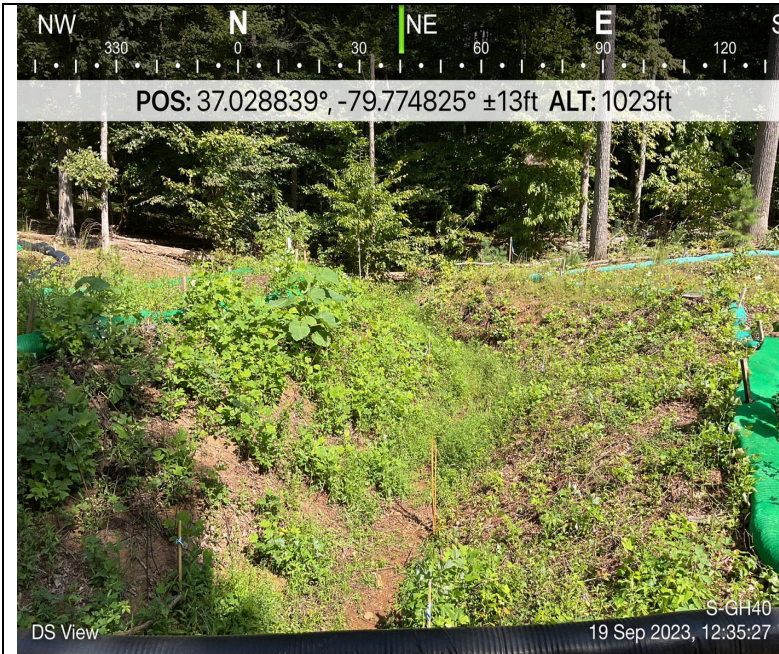
Photo Description: Downstream view of permitted impact area during pre-construction assessment.

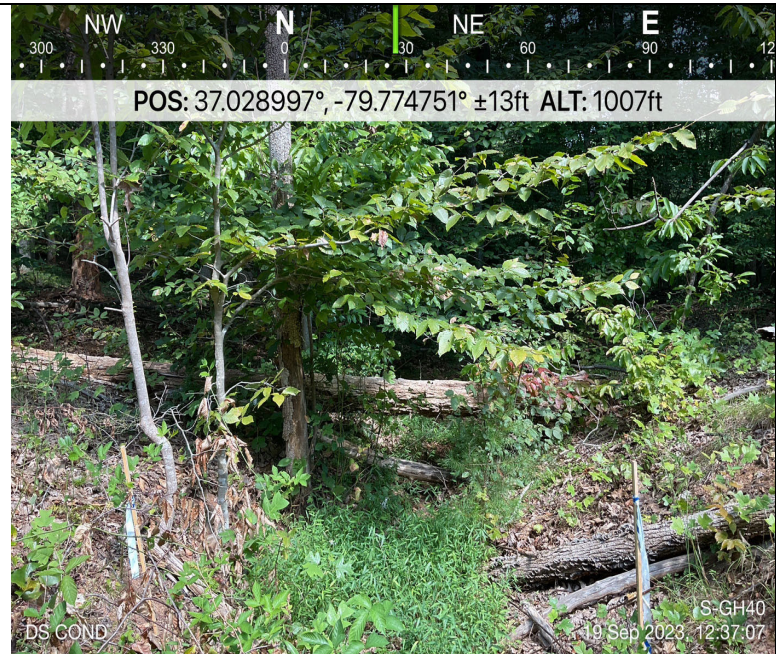
Photo Description: Conditions of the downstream area outside the ROW during pre-construction assessment.

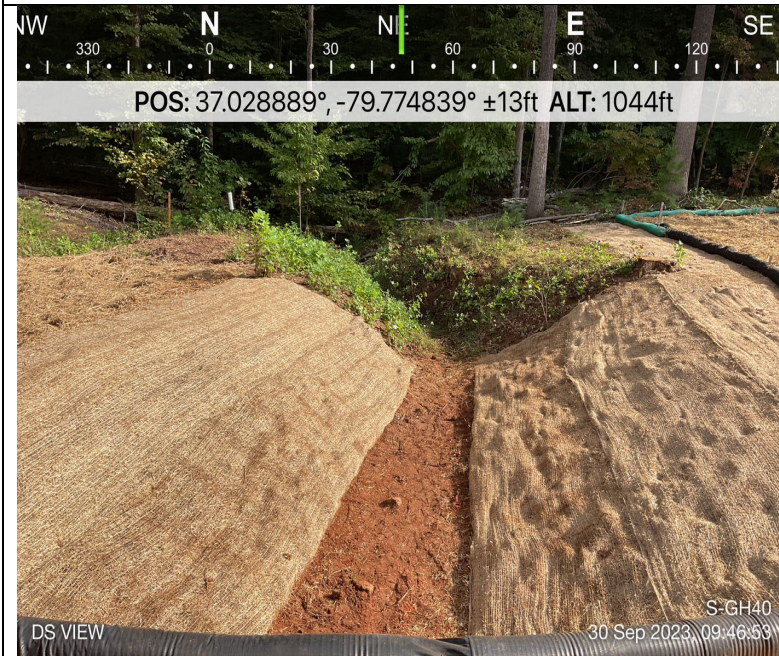
Photo Description: Downstream view of permitted impact area during post-construction assessment.

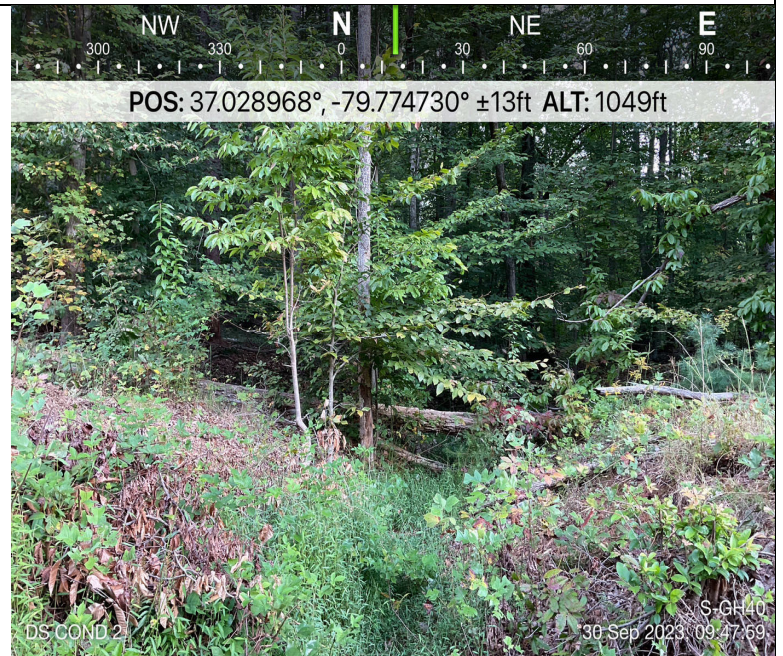
Photo Description: Conditions of the downstream area outside the ROW during post-construction assessment.

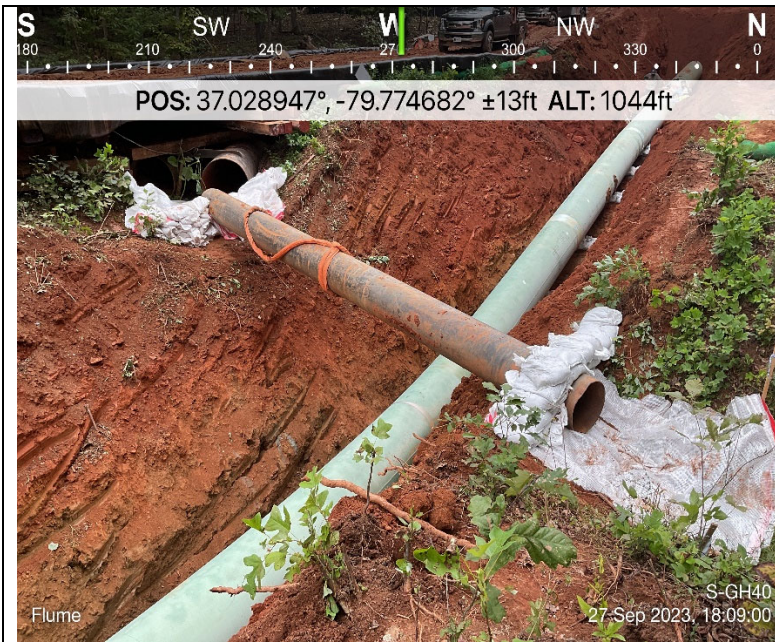
Photo Description: Flume crossing installed and functioning throughout crossing.

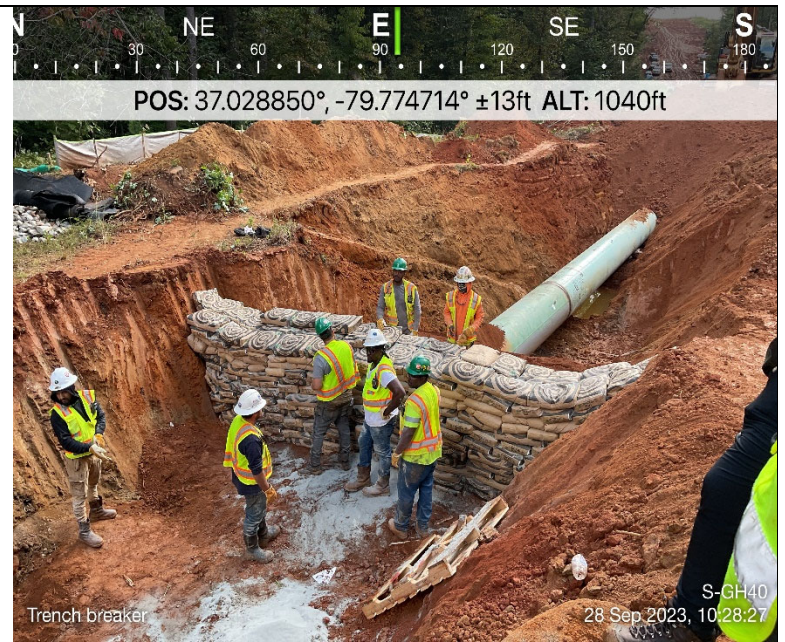
9-28-2023: Finished pipe installation and backfilled. Two trench breakers installed within 25ft of the resource at 18" below surface. Stream and 10ft buffer restored. 50ft buffer to be restored 9-29-23. -S. Canfield

Photo Description: Trenchbreaker installations

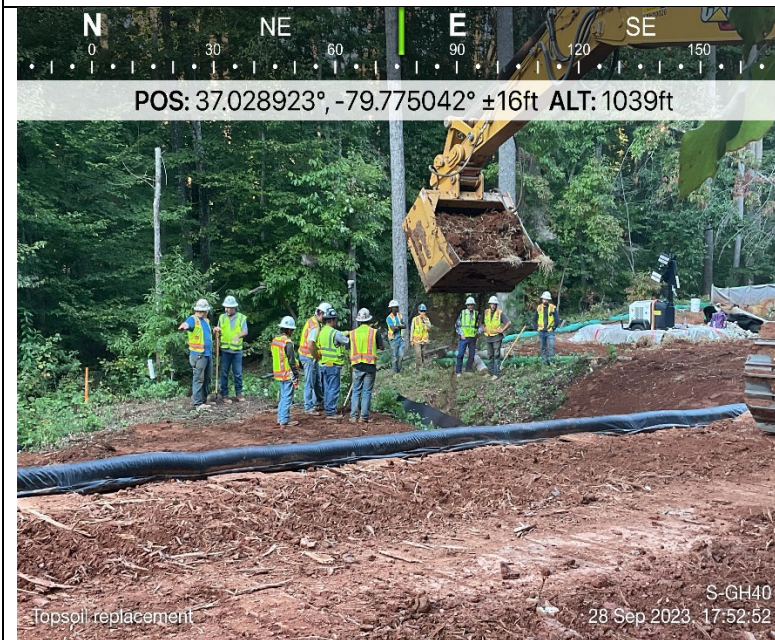
Photo Description: Topsoil restoration.

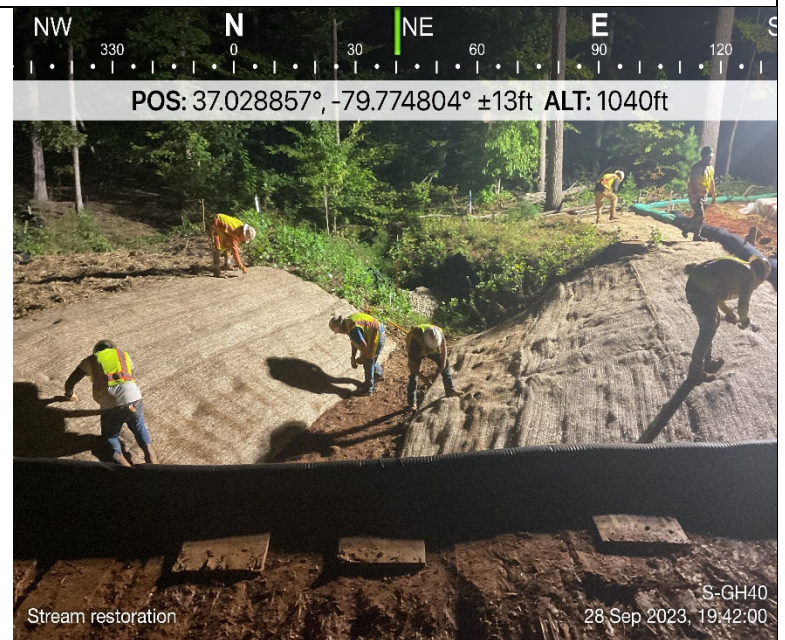
Photo Description: Restoration crews staking in erosion control matting along the streambanks.
