STREAM BIOLOGICAL CONDITIONS ENVIRONMENTAL AUDITOR REPORT

Stream ID: S-H23	Crossing Start Date: 11/06/2023	Crossing Completion Date: 11/07/2023
Milepost: 280.2	Pre-Con Assessment Date: 11/04/2023	Post-Con Assessment Date: 11/07/2023
Station: 14806+00	Stream Classification: Ephemeral (Perennial, Intermittent, Ephemeral)	Bankfull Width (ft.): 5
County: Franklin	303(d) Impairment Listing: Not Impaired	Riffle:Pool Complexes Present? No

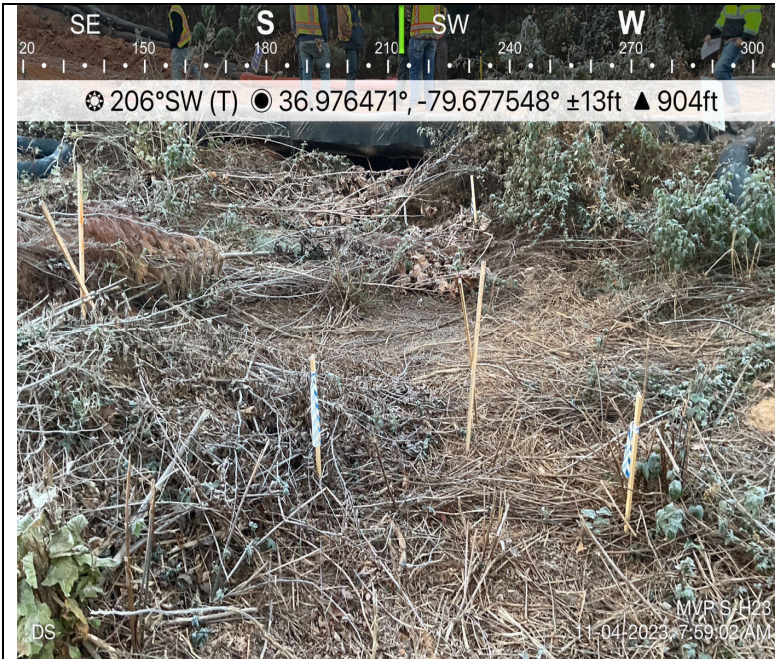
Photo Description: Downstream view of permitted impact area during pre-construction assessment.

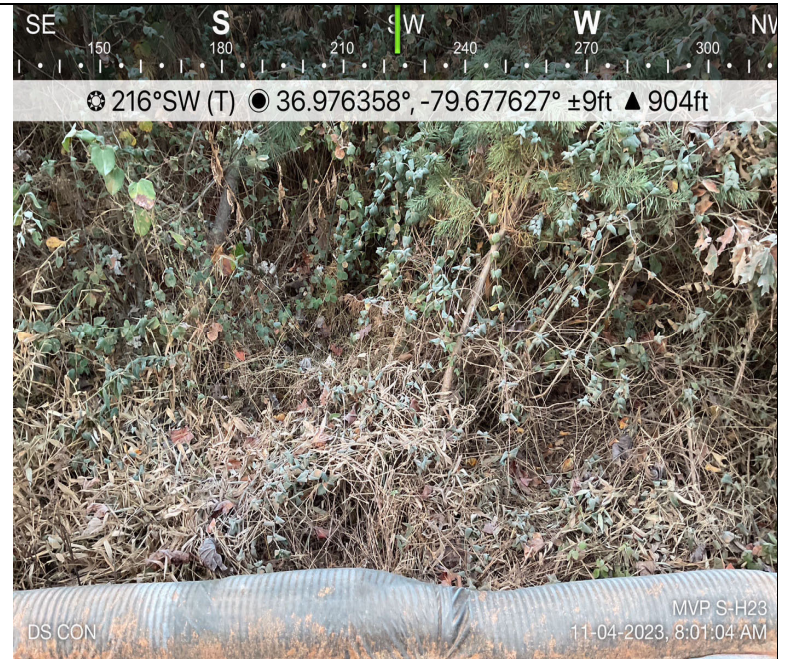
Photo Description: Conditions of the downstream area outside the ROW during pre-construction assessment.

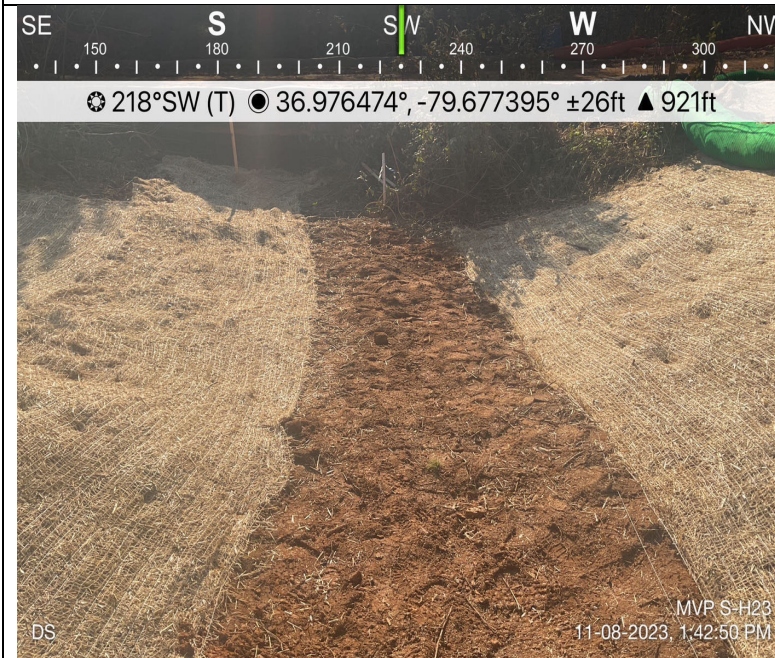
Photo Description: Downstream view of permitted impact area during post-construction assessment.

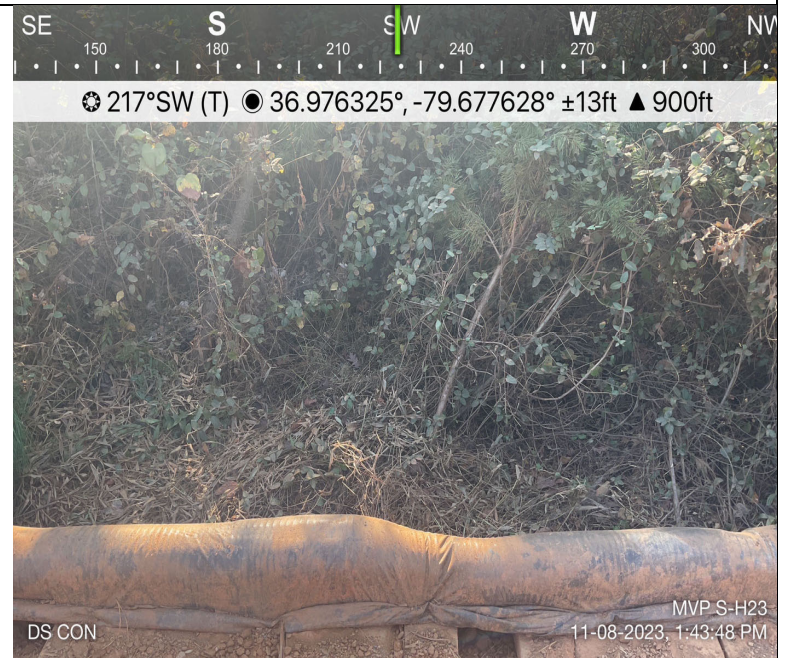
Photo Description: Conditions of the downstream area outside the ROW during post-construction assessment.

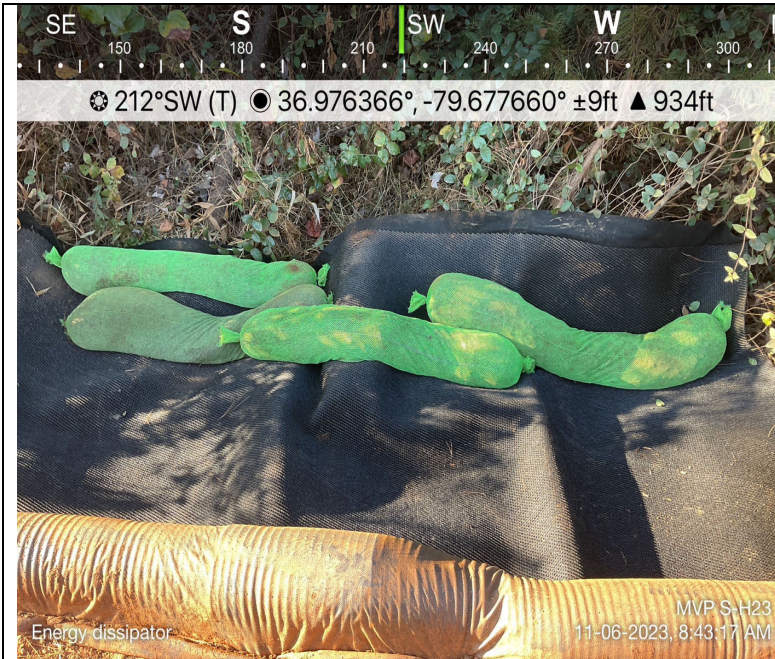
Photo Description: An energy dissipater was constructed during construction.

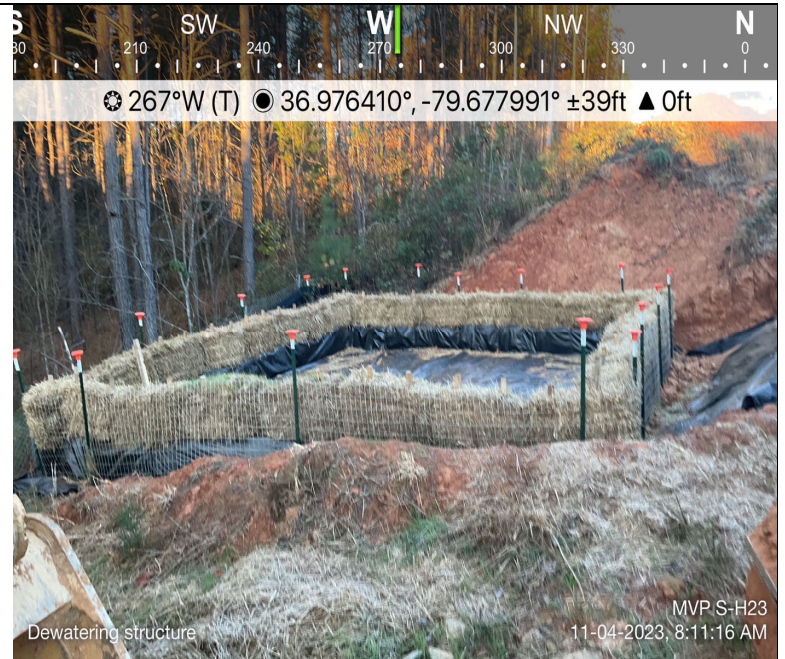
Photo Description: An overview of the dewatering structure.

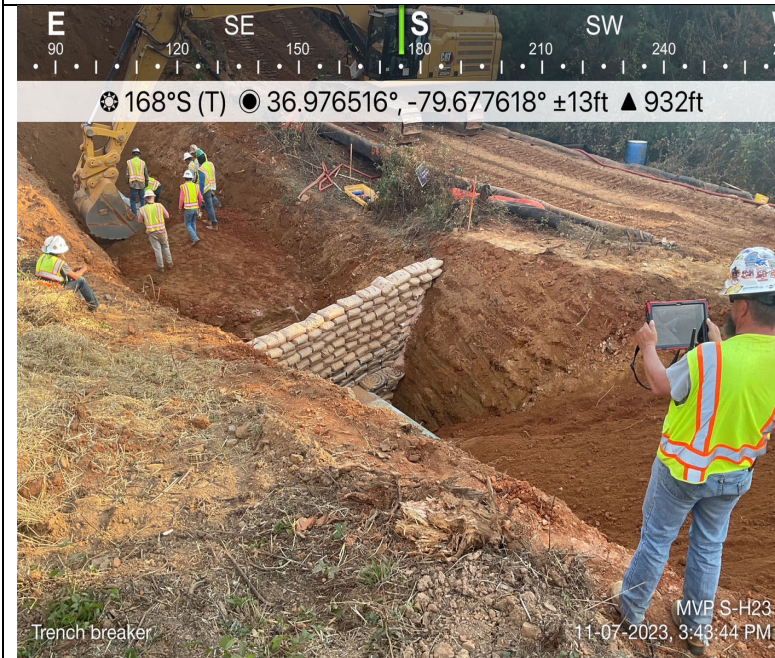
Photo Description: A trench breaker installed for the resource.

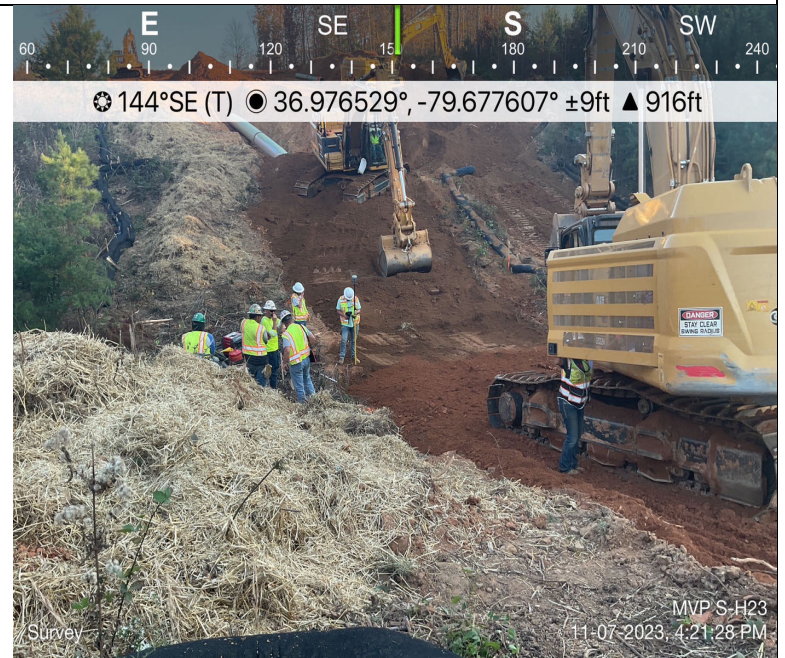
Photo Description: The survey crew taking elevations which were used during reconstruction.
