# STREAM BIOLOGICAL CONDITIONS ENVIRONMENTAL AUDITOR REPORT

<b>Stream ID:</b> S-H27	<b>Crossing Start Date:</b> 10/23/2023	<b>Crossing Completion Date:</b> 10/25/2023
<b>Milepost:</b> 279.2	<b>Pre-Con Assessment Date:</b> 10/13/2023	<b>Post-Con Assessment Date:</b> 10/26/2023
<b>Station:</b> 14749+85	<b>Stream Classification:</b> Ephemeral (Perennial, Intermittent, Ephemeral)	<b>Bankfull Width (ft.):</b> 10
<b>County:</b> Franklin	<b>303(d) Impairment Listing:</b> Not Impaired	<b>Riffle:Pool Complexes Present?</b> No

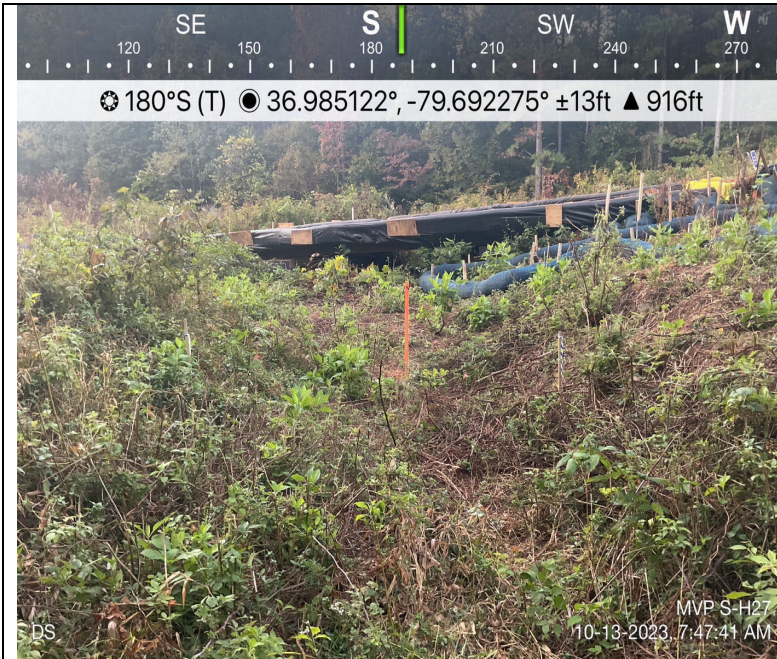
**Photo Description:** Downstream view of permitted impact area during pre-construction assessment.

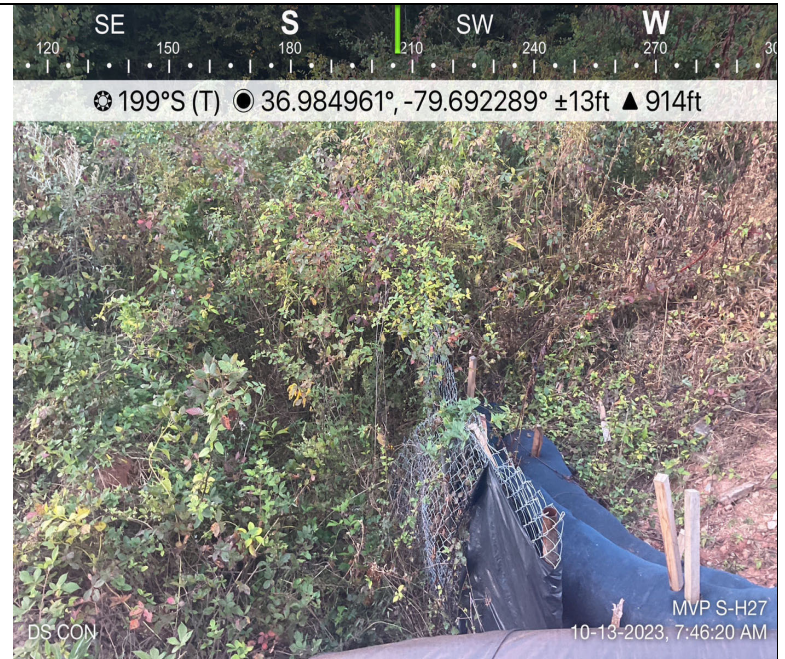
**Photo Description:** Conditions of the downstream area outside the ROW during pre-construction assessment.

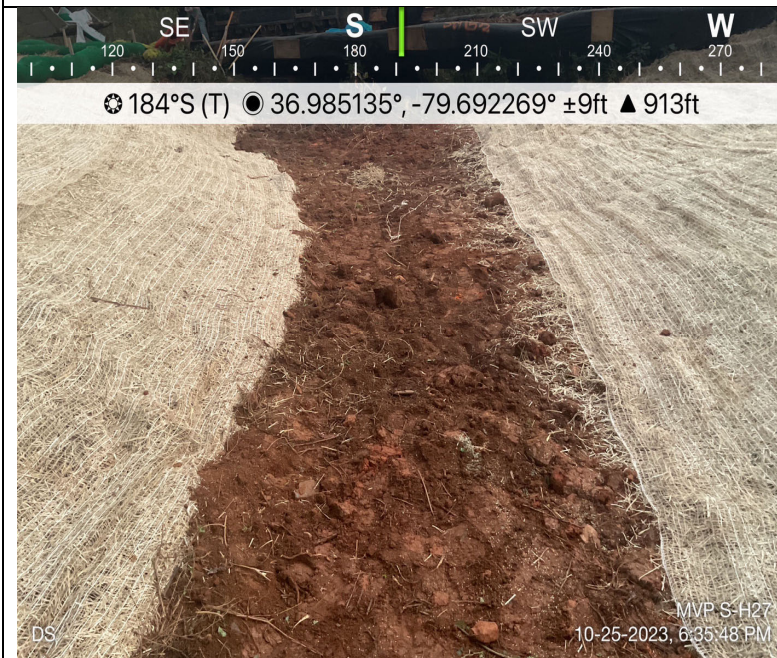
**Photo Description:** Downstream view of permitted impact area during post-construction assessment.

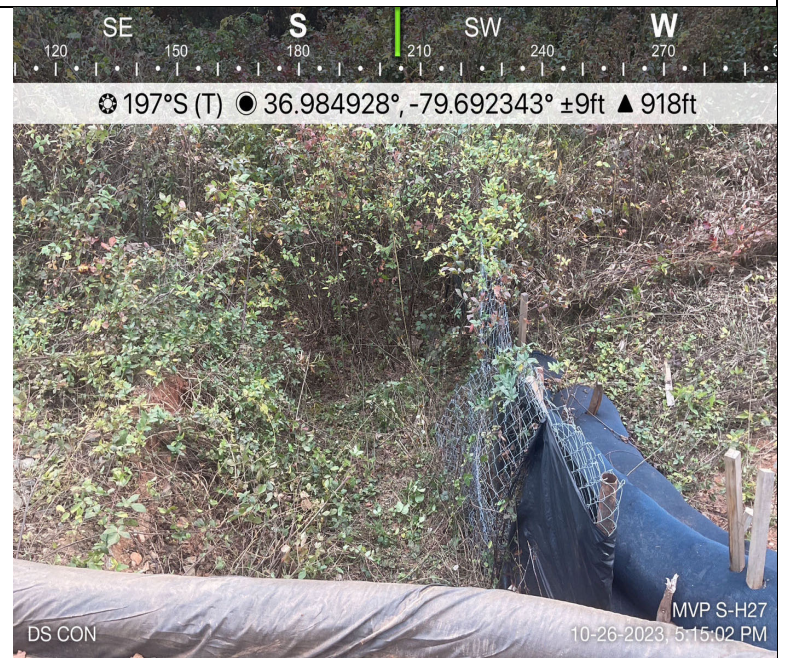
**Photo Description:** Conditions of the downstream area outside the ROW during post-construction assessment.

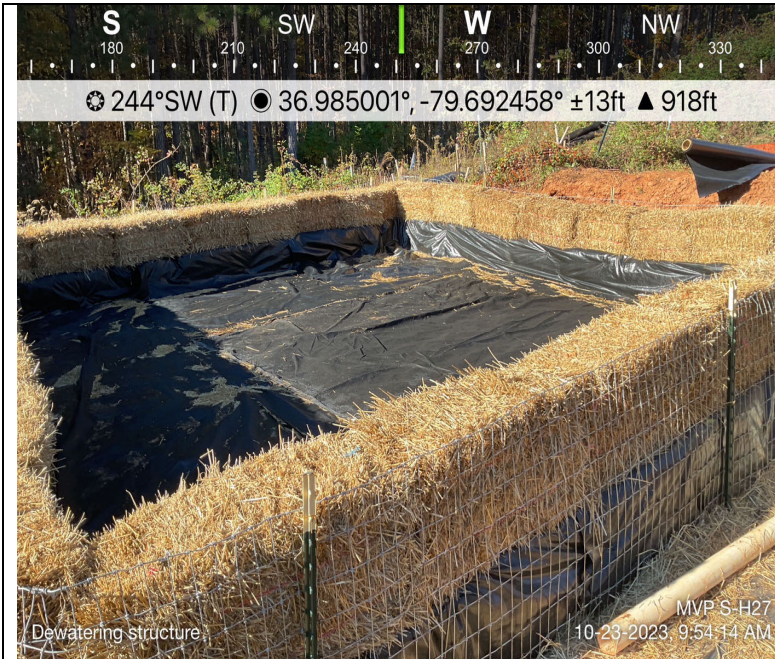
**Photo Description:** Overview of the dewatering structure.

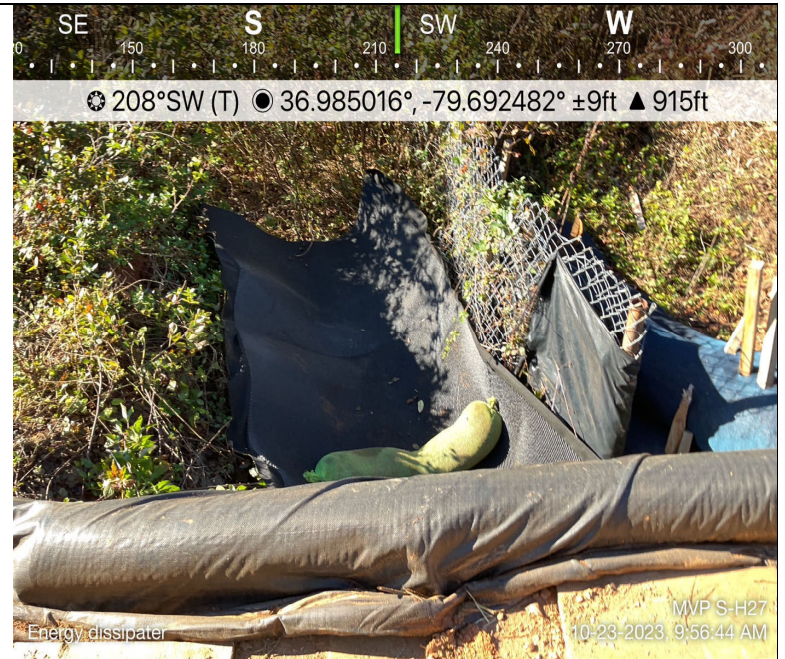
**Photo Description:** Energy dissipater installed on site.

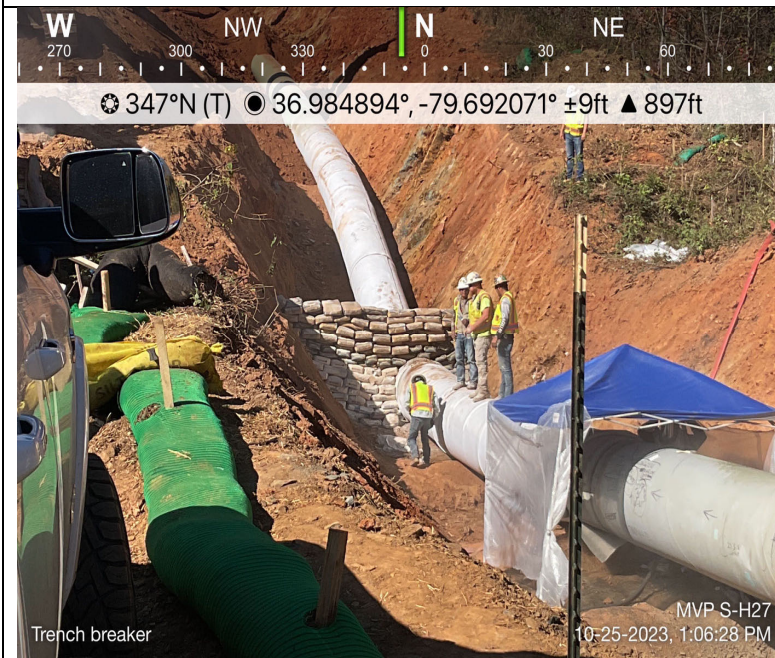
**Photo Description:** Installation of a trench breaker.

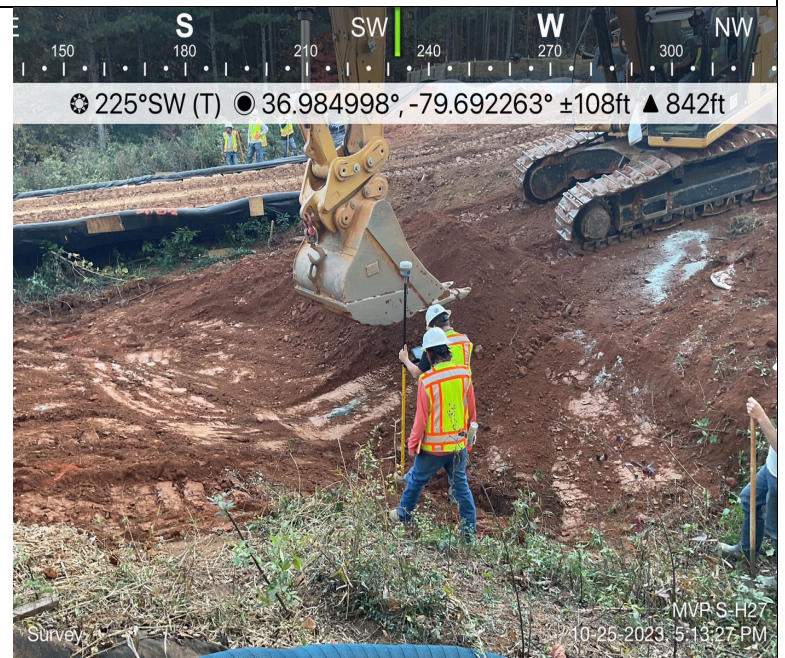
**Photo Description:** Survey conducted during site restoration in attempt to restore pre-construction contours of resource.
