Stream Biological Conditions EA Report

Project Name	H-600 Pipeline Spread E	AFE	124300134	Spread	H-600 Pipeline Spread E
Contractor	Price Gregory	Report #	275		
Environmental Auditor	Allyson Kincaid	Date/Time	10/2/2023 10:27 AM		
Stream ID	S-H71	Crossing Start Date	10/2/2023	Crossing Completion Date	10/19/2023
Milepost	131.49	Pre-Con Assessment Date	10/2/2023	Post-Con Assessment Date	10/19/2023
Station	6942+67	Bankfull Width (ft.)	9.3	Riffle:Pool Complexes Present?	No
State	WV	Stream Classification	Perennial		
County	Nicholas	303(d) Impairment Listing	No

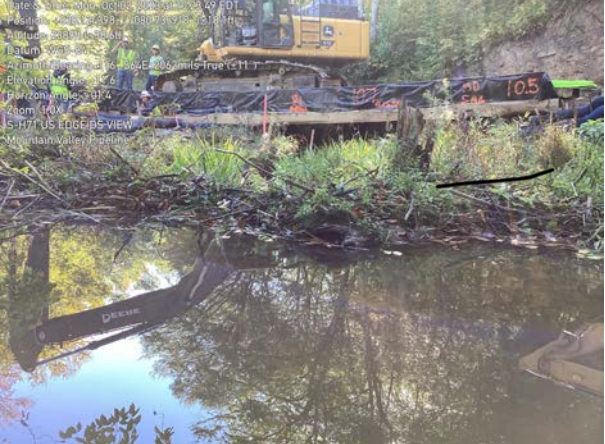
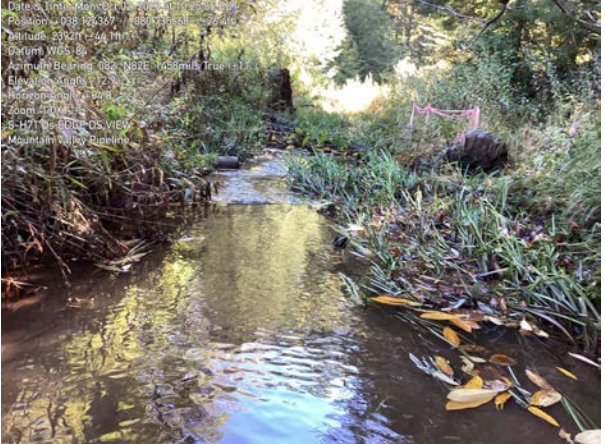
GPS Location See Photo	GPS Location See Photo
Description Downstream view of permitted impact area during pre-construction assessment.	Description Downstream view of unimpacted area during pre-construction assessment.

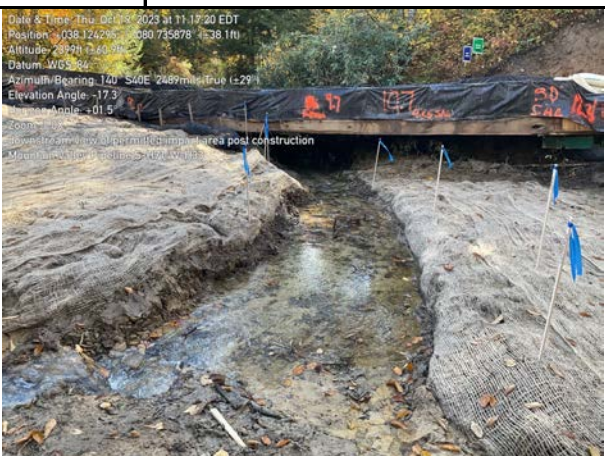
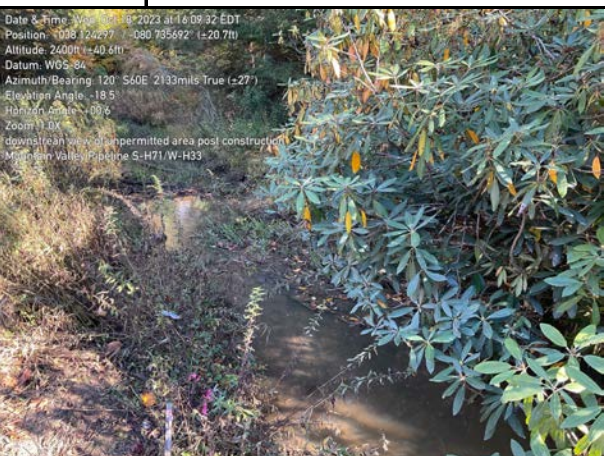
GPS Location See Photo	GPS Location See Photo
Description Downstream view of permitted impact area during post-construction assessment.	Description Downstream view of unimpacted area during post-construction assessment.

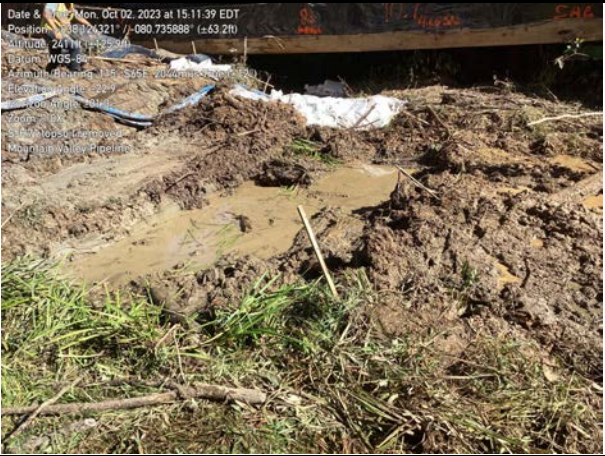
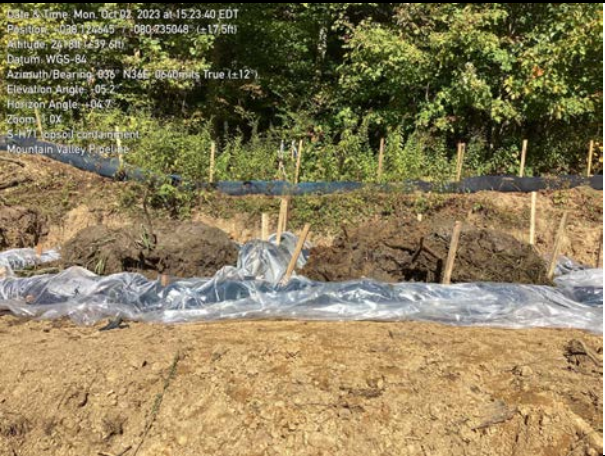
GPS Location See Photo	GPS Location See Photo
Description Photo 1: Removal of stream substrate	Description Photo 2: Stream substrate and topsoil isolated outside of resource area.

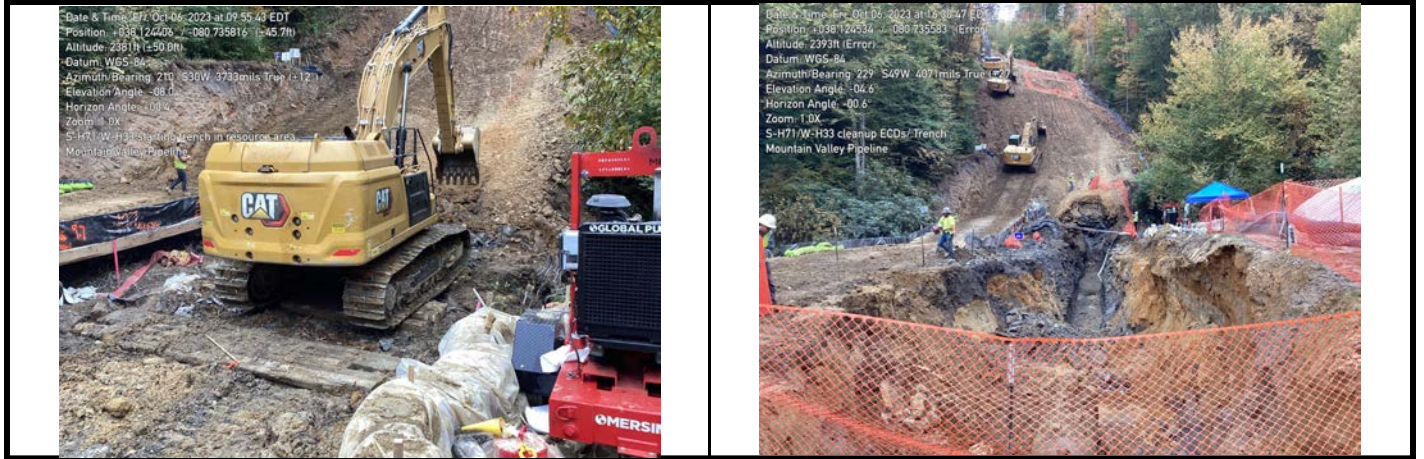
GPS Location See Photo	GPS Location See Photo
Description Photo 3: Begin trenching in resource area.	Description Photo 4: Trench through resource area.

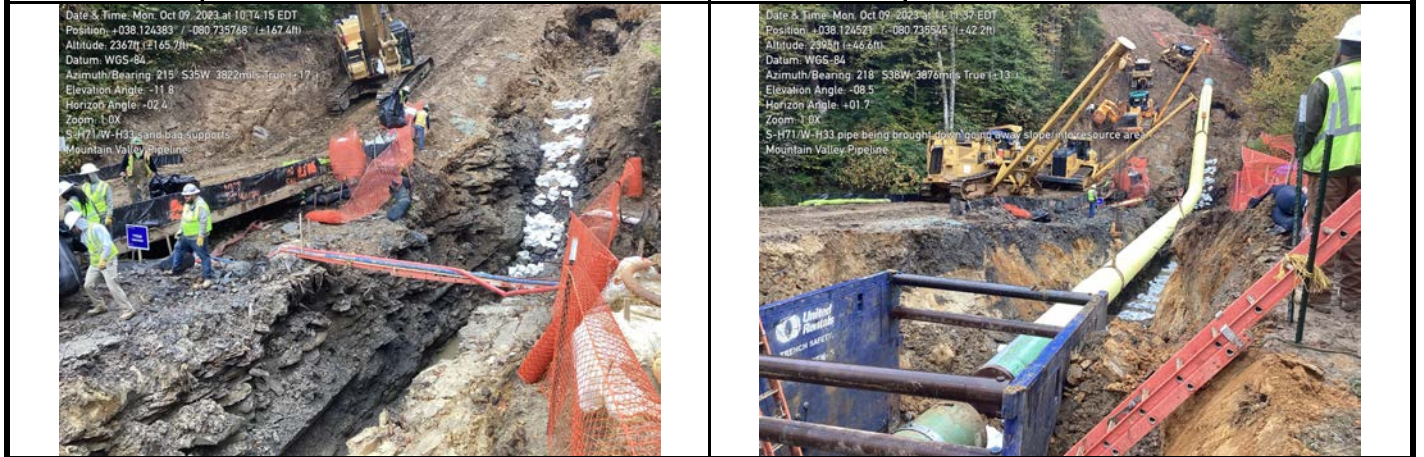
GPS Location See Photo	GPS Location See Photo
Description Photo 5: Padding placed in trench.	Description Photo 6: Placing pipe in resource area.

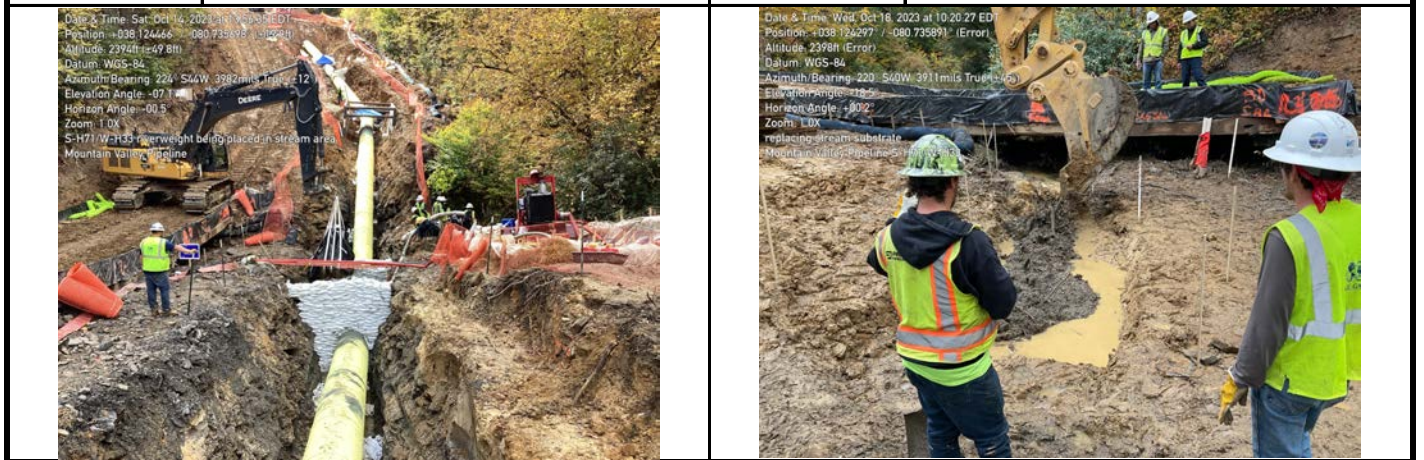
GPS Location See Photo	GPS Location See Photo
Description Photo 7: Placement of river weights in resource area.	Description Photo 8: Restoring stream substrate.
