# Stream Biological Conditions EA Report

<b>Project Name</b>	H-600 Pipeline Spread F	<b>AFE</b>	124300135	<b>Spread</b>	H-600 Pipeline Spread F
<b>Contractor</b>	Price Gregory	<b>Report #</b>	328		
<b>Environmental Auditor</b>	Allyson Kincaid	<b>Date/Time</b>	10/30/2023 9:48 AM		
<b>Stream ID</b>	S-119	<b>Crossing Start Date</b>	11/1/2023	<b>Crossing Completion Date</b>	11/11/2023
<b>Milepost</b>	163.00	<b>Pre-Con Assessment Date</b>	10/31/2023	<b>Post-Con Assessment Date</b>	11/11/2023
<b>Station</b>	8606+40	<b>Bankfull Width (ft.)</b>	18.1	<b>Riffle:Pool Complexes Present?</b>	No
<b>State</b>	WV	<b>Stream Classification</b>	Perennial		
<b>County</b>	Summers	<b>303(d) Impairment Listing</b>	No

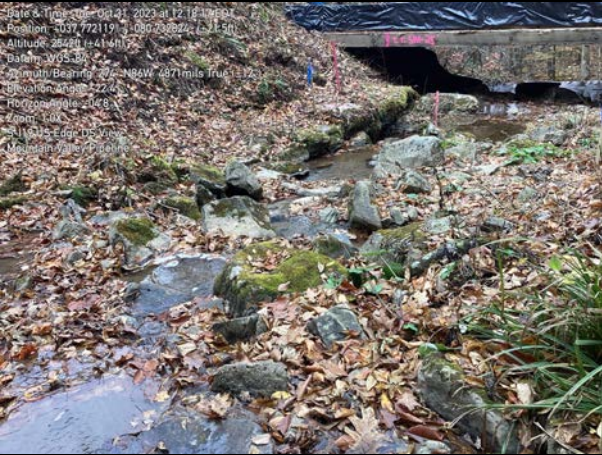
<p><small>Date &amp; Time: Sun Oct 31 2023 at 12:18:00 EDT Position: 437.772119, -80.232722 (-2.15m) Altitude: 2545ft (-41.6ft) Datum: WGS-84 Azimuth Bearing: 297.866W 527mils True (-12) Elevation Angle: 11.6 Horizon Angle: 11.6 Zoom: 1.0X S119 Edge DS View Mountain Valley Pipeline</small></p>		  <p><small>Date &amp; Time: Sun Oct 31 2023 at 12:50:50 EDT Position: 437.772124, -80.232958 (-2.37m) Altitude: 2545ft (-41.6ft) Datum: WGS-84 Azimuth Bearing: 297.866W 527mils True (-12) Elevation Angle: 11.6 Horizon Angle: 11.6 Zoom: 1.0X S119 DS Edge DS View Mountain Valley Pipeline</small></p>			
<b>GPS Location</b>	See Photo	<b>GPS Location</b>	See Photo		
<b>Description</b>	Downstream view of permitted impact area during pre-construction assessment.	<b>Description</b>	Downstream view of unimpacted area during pre-construction assessment.

<p><small>Date &amp; Time: Sat Nov 11 2023 at 13:27:30 EST Position: 437.772060, -80.232911 (-2.36m) Altitude: 2546ft (-41.6ft) Datum: WGS-84 Azimuth Bearing: 297.863W 528mils True (-12) Elevation Angle: -17.9 Horizon Angle: -17.9 Zoom: 1.0X S119 Upstream, downstream view Mountain Valley Pipeline</small></p>

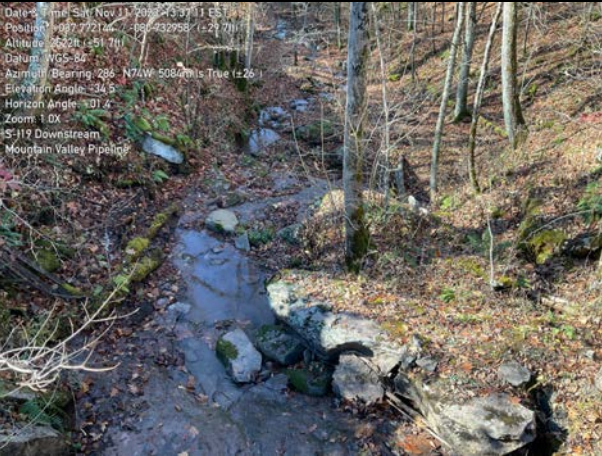
<p><small>Date &amp; Time: Sat Nov 11 2023 at 13:31:11 EST Position: 437.772124, -80.232958 (-2.37m) Altitude: 2545ft (-41.6ft) Datum: WGS-84 Azimuth Bearing: 298.874W 508mils True (-12) Elevation Angle: 24.5 Horizon Angle: 24.5 Zoom: 1.0X S119 Downstream Mountain Valley Pipeline</small></p>			
<b>GPS Location</b>	See Photo	<b>GPS Location</b>	See Photo		
<b>Description</b>	Downstream view of permitted impact area during post-construction assessment.	<b>Description</b>	Downstream view of unimpacted area during post-construction assessment.		
  <p><small>Date &amp; Time: Wed Nov 08 2023 at 10:03:00 EDT Position: 437.772036, -80.232911 (-2.36m) Altitude: 2541ft (-40.8ft) Datum: WGS-84 Azimuth Bearing: 298.866W 524mils True (-12) Elevation Angle: -18.6 Horizon Angle: -18.6 Zoom: 1.0X S119 Stream substrate removal Mountain Valley Pipeline</small></p>		  <p><small>Date &amp; Time: Thu Nov 02 2023 at 13:33:00 EDT Position: 437.792715, -80.209609 (-2.0959m) Altitude: 2594ft (-40.8ft) Datum: WGS-84 Azimuth Bearing: 287.878W 5013mils True (-12) Elevation Angle: 14.5 Horizon Angle: 14.5 Zoom: 1.0X S119 pipe over source for welding purposes within 100' buffer Mountain Valley Pipeline</small></p>

<b>GPS Location</b>	See Photo	<b>GPS Location</b>	See Photo		
<b>Description</b>	Photo 1: Removing stream substrate.	<b>Description</b>	Photo 2: Pipe above ground in aquatic resource area where was welded to additional sections prior to placement.

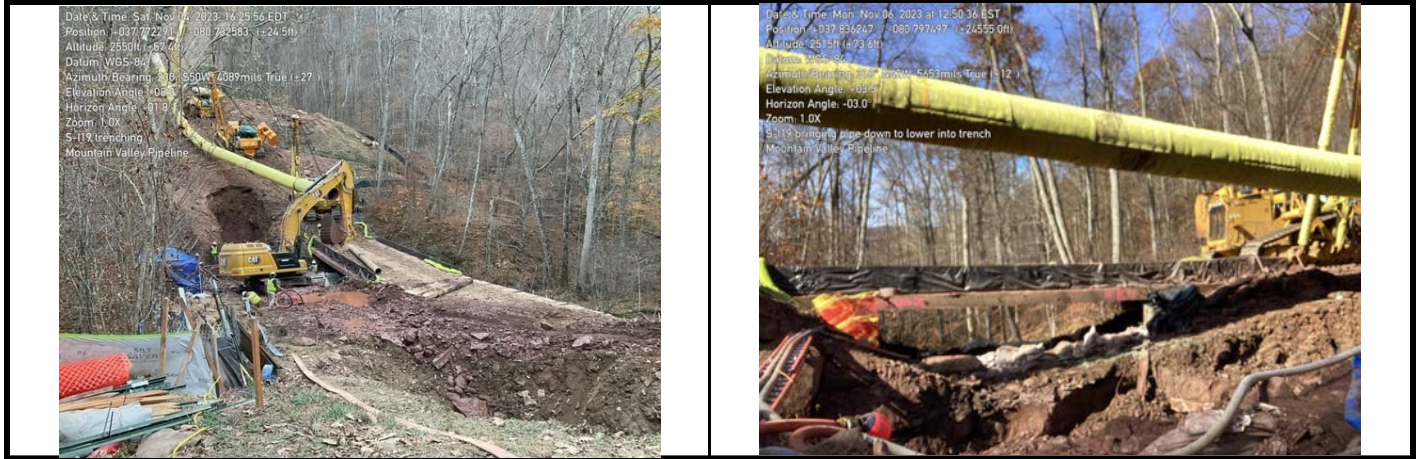
<b>GPS Location</b>	See Photo	<b>GPS Location</b>	See Photo
<b>Description</b>	Photo 3: Trenching through aquatic resource area.	<b>Description</b>	Photo 4: Lowering pipe into trench.

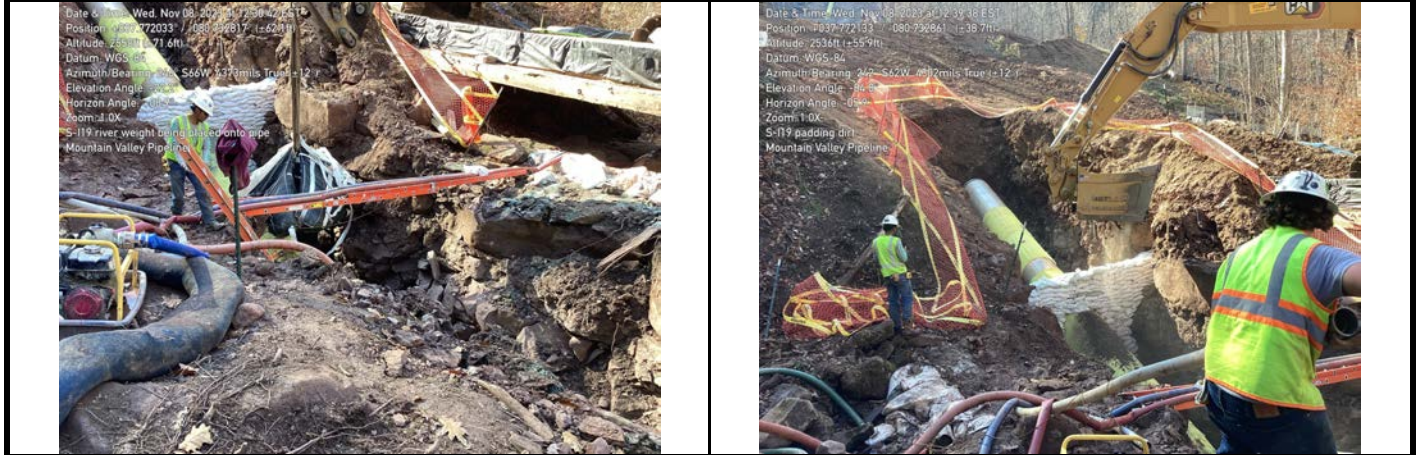
<b>GPS Location</b>	See Photo	<b>GPS Location</b>	See Photo
<b>Description</b>	Photo 5: Constructing trench breakers and adding river weights in aquatic resource area.	<b>Description</b>	Photo 6: Sifting padding dirt in aquatic resource area.

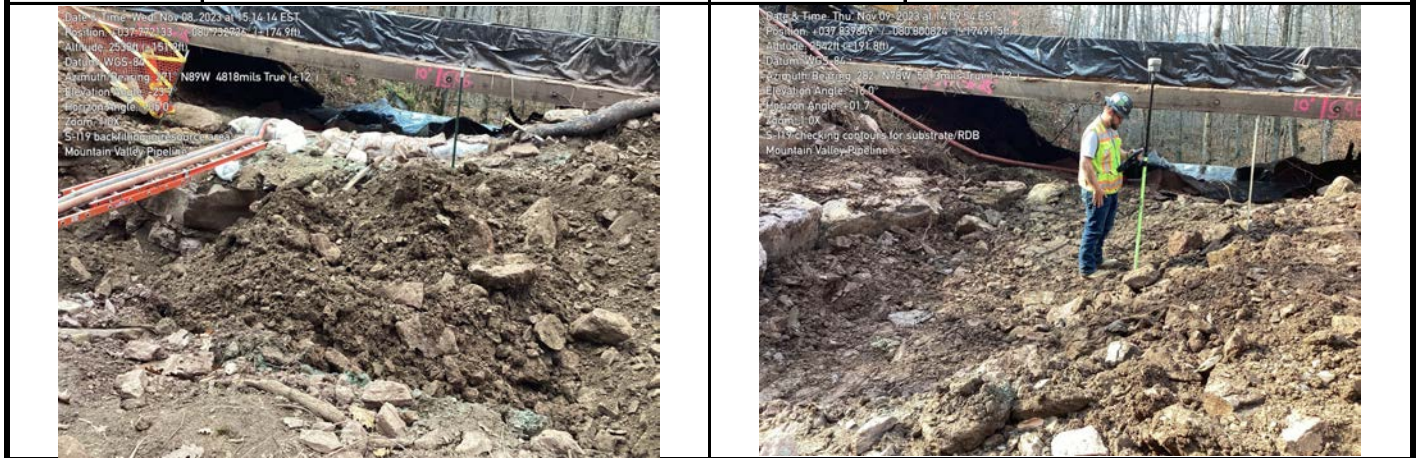
<b>GPS Location</b>	See Photo	<b>GPS Location</b>	See Photo
<b>Description</b>	Photo 7: Backfilling in aquatic resource area.	<b>Description</b>	Photo 8: Survey marking contour elevations.
