Stream Biological Conditions EA Report

| Project Name | H-600 Pipeline Spread E | AFE | 124300134 | Spread | H-600 Pipeline Spread E |
| Stream ID | S-I22 | Crossing Start Date | 9/7/2023 | Crossing Completion Date | 10/18/2023 |

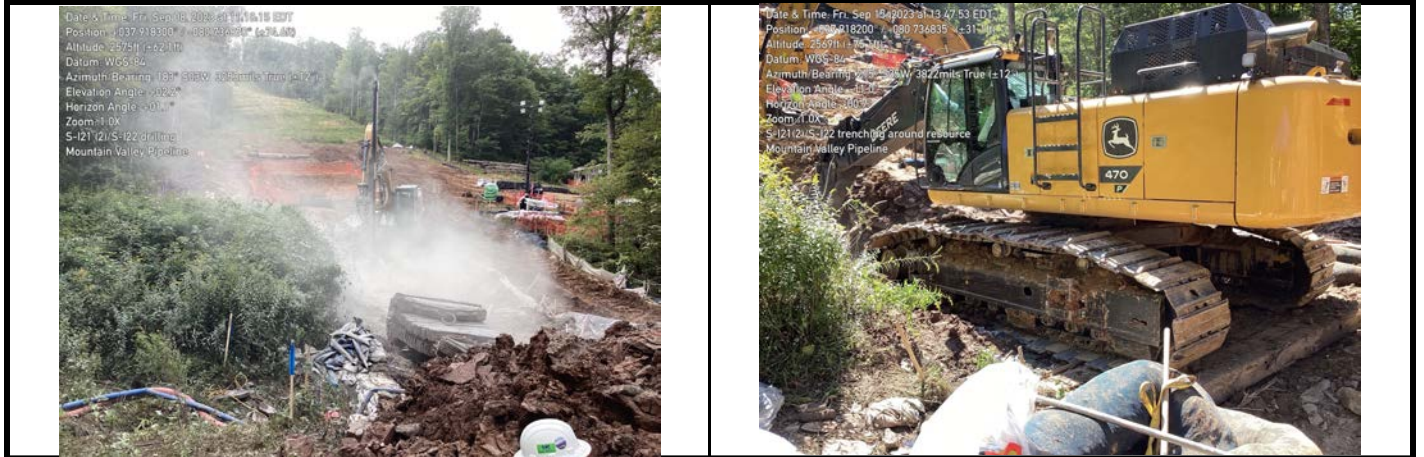
| Description | Photo 3: Drilling in aquatic resource area. | Description | Photo 4: Trenching in aquatic resources. |

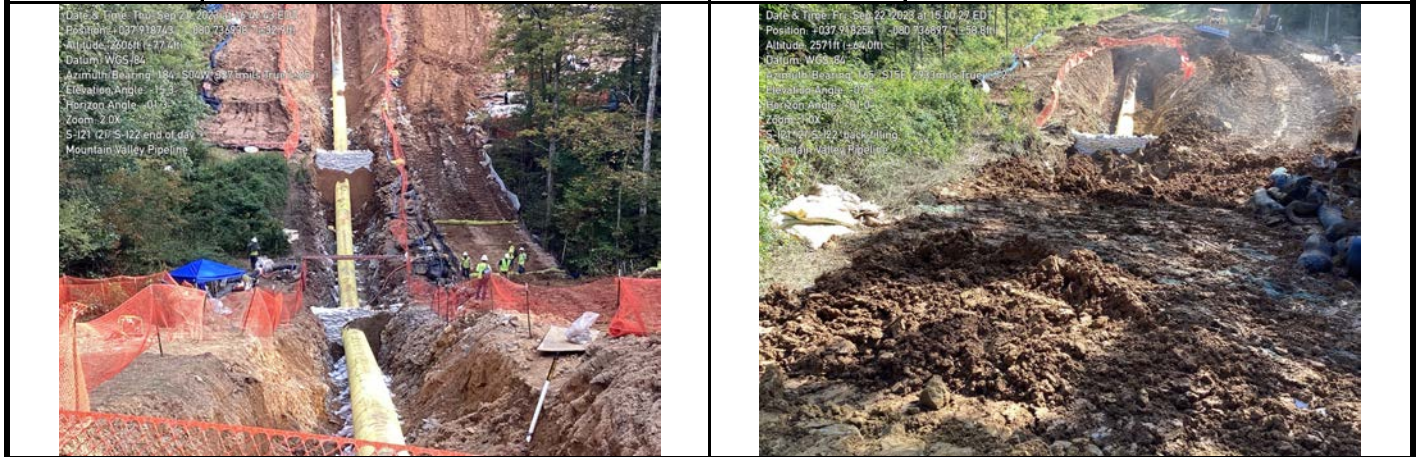
| Description | Photo 5: Trench breakers both sides of aquatic resources. | Description | Photo 6: Backfilling of aquatic resources. |

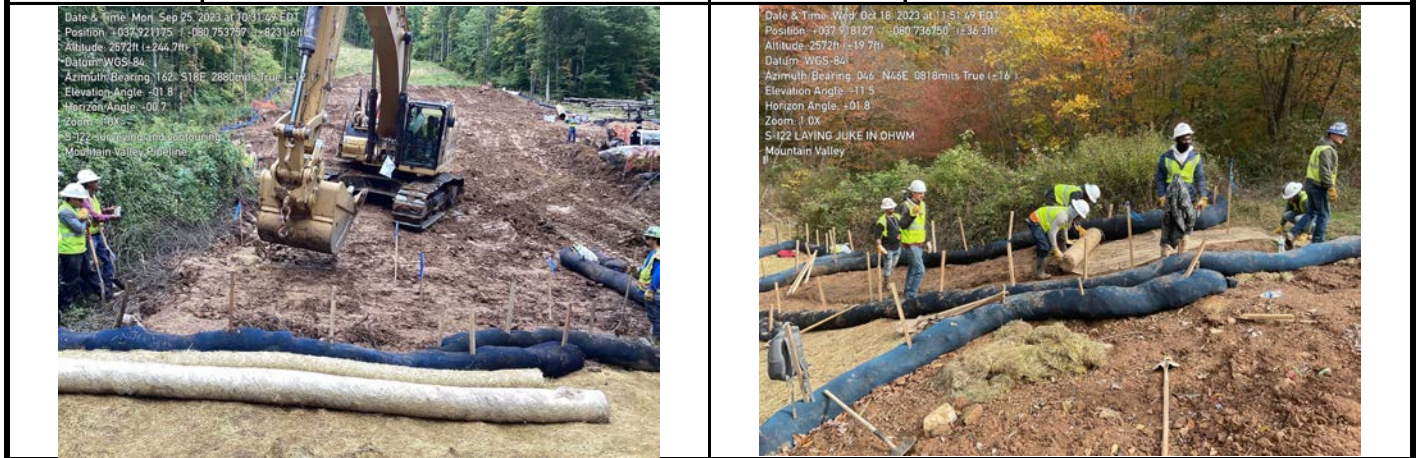
| Description | Photo 7: Survey being completed and contours being restored. | Description | Photo 8: Spreading jute matting after stream is reworked by hand. |
