# Stream Biological Conditions EA Report

<b>Project Name</b>	H-600 Pipeline Spread E	<b>AFE</b>	124300134	<b>Spread</b>	H-600 Pipeline Spread E
<b>Contractor</b>	Price Gregory	<b>Report #</b>	284		
<b>Environmental Auditor</b>	Jessica Yeager	<b>Date/Time</b>	10/9/2023 3:17 PM		
<b>Stream ID</b>	S-I25	<b>Crossing Start Date</b>	10/9/2023	<b>Crossing Completion Date</b>	11/1/2023
<b>Milepost</b>	140.94	<b>Pre-Con Assessment Date</b>	10/9/2023	<b>Post-Con Assessment Date</b>	11/1/2023
<b>Station</b>	7441+63	<b>Bankfull Width (ft.)</b>	10.2	<b>Riffle:Pool Complexes Present?</b>	No
<b>State</b>	WV	<b>Stream Classification</b>	Intermittent		
<b>County</b>	Greenbrier	<b>303(d) Impairment Listing</b>	No

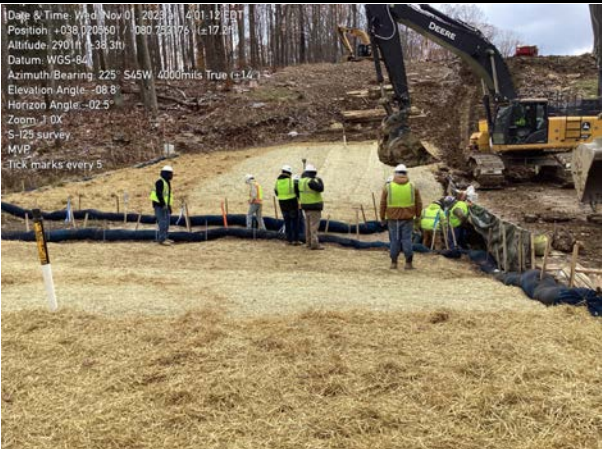
<p><small>Date &amp; Time: Wed Nov 01, 2023 at 14:01:12 EDT Position: +038.020501 / -080.753175 (-517.2ft) Altitude: 270.0ft (-82.3ft) Datum: WGS-84 Azimuth Bearing: 225° S45W 4200mils True (+14.1°) Elevation Angle: -08.8° Horizon Angle: -02.5° Zoom: 1.0X S-125 survey MVP Tick marks every 5'</small></p>	  <p><small>Date &amp; Time: Wed Nov 01, 2023 at 14:15:09 EDT Position: +038.020501 / -080.753135 (-517.3ft) Altitude: 270.0ft (-82.3m) Datum: WGS-84 Azimuth Bearing: 225° S45W 4200mils True (+14.1°) Elevation Angle: -08.8° Horizon Angle: -02.5° Zoom: 1.0X S-125 survey MVP Tick marks every 5'</small></p>		
<b>GPS Location</b>	See Photo	<b>GPS Location</b>	See Photo
<b>Description</b>	Photo 7: Overview of restoration; survey completing measurements of thalweg.	<b>Description</b>	Photo 8: Hand placement of large substrate.
