# Stream Biological Conditions EA Report

<b>Project Name</b>	H-600 Pipeline Spread D	<b>AFE</b>	124300132	<b>Spread</b>	H-600 Pipeline Spread D
<b>Contractor</b>	Precision	<b>Report #</b>	324		
<b>Environmental Auditor</b>	Todd Grant	<b>Date/Time</b>	10/27/2023 8:54 PM		
<b>Stream ID</b>	S-I36	<b>Crossing Start Date</b>	10/27/2023	<b>Crossing Completion Date</b>	11/9/2023
<b>Milepost</b>	127.04	<b>Pre-Con Assessment Date</b>	10/27/2023	<b>Post-Con Assessment Date</b>	11/11/2023
<b>Station</b>	6707+80	<b>Bankfull Width (ft.)</b>	55.0	<b>Riffle:Pool Complexes Present?</b>	Yes
<b>State</b>	WV	<b>Stream Classification</b>	Perennial		
<b>County</b>	Nicholas	<b>303(d) Impairment Listing</b>	No

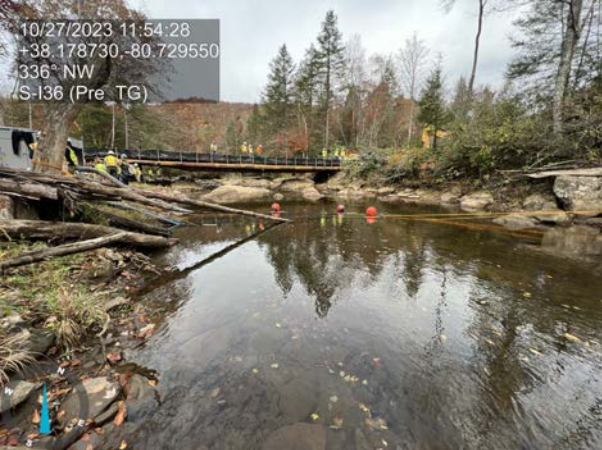
<b>GPS Location</b>	See photo above	<b>GPS Location</b>	See photo above
<b>Description</b>	Downstream view of permitted impact area during pre-construction assessment.	<b>Description</b>	Downstream view of unimpacted area during pre-construction assessment.

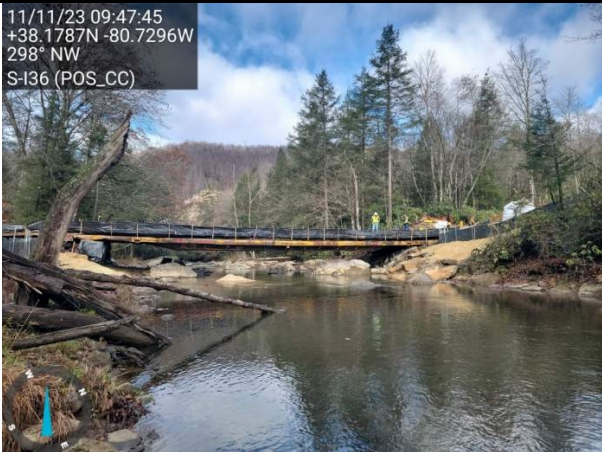
<b>GPS Location</b>	See photo above	<b>GPS Location</b>	See photo above
<b>Description</b>	Downstream view of permitted impact area during post-construction assessment.	<b>Description</b>	Downstream view of unimpacted area during post-construction assessment.

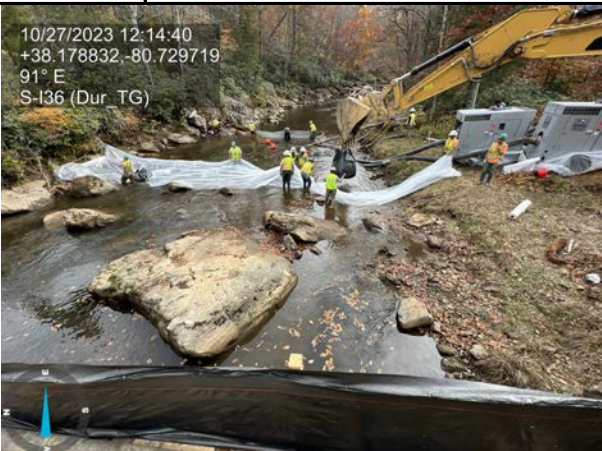
<b>GPS Location</b>	See photo above	<b>GPS Location</b>	See photo above
<b>Description</b>	View of contractor setting first super sacks of sand for dam construction. This is the #5 photo mention in the additional notes section.	<b>Description</b>	View of boulders from stream segregated on plastic in upland area.
