Stream Biological Conditions EA Report

Project Name	H-600 Pipeline Spread D	AFE	124300132	Spread	H-600 Pipeline Spread D
Contractor	Precision	Report #	315		
Environmental Auditor	Scott Wessel	Date/Time	10/25/2023 9:09 PM		
Stream ID	S-I38	Crossing Start Date	10/26/2023	Crossing Completion Date	10/29/2023
Milepost	125.68	Pre-Con Assessment Date	10/23/2023	Post-Con Assessment Date	10/29/2023
Station	6636+12	Bankfull Width (ft.)	5.0	Riffle:Pool Complexes Present?	No
State	WV	Stream Classification	Intermittent		
County	Nicholas	303(d) Impairment Listing	No

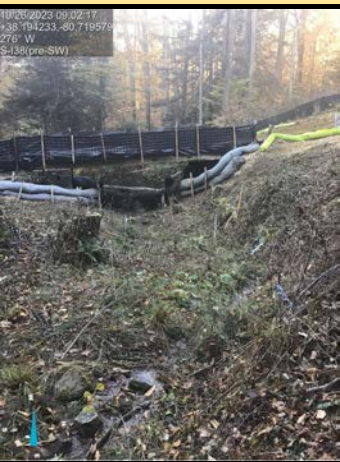
GPS Location	See GPS in above photo.
Description	Downstream view of permitted impact area during pre-construction assessment.	Description	Downstream view of unimpacted area during pre-construction assessment.

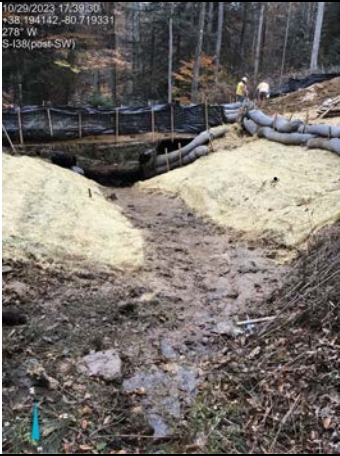
Description	Downstream view of permitted impact area during post-construction assessment.	Description	Downstream view of unimpacted area during post-construction assessment.

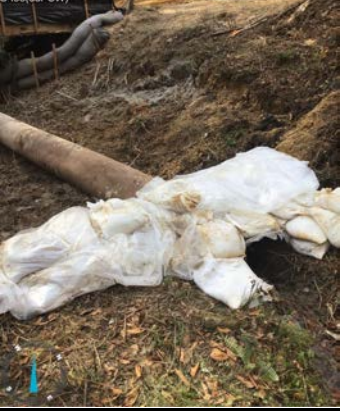
Description	Flume pipe installed for stream S-138.	Description	Substrate material for S-138 segregated in super sacks.
