Stream Biological Conditions EA Report

Project Name	H-600 Pipeline Spread D	AFE	124300132	Spread	H-600 Pipeline Spread D
Contractor	Precision	Report #	413		
Environmental Auditor	Gary Cruz	Date/Time	11/26/2023 8:00 PM		
Stream ID	S-I40	Crossing Start Date	11/16/2023	Crossing Completion Date	11/26/2023
Milepost	126.22	Pre-Con Assessment Date	11/16/2023	Post-Con Assessment Date	11/27/2023
Station	6664+61	Bankfull Width (ft.)	7.0	Riffle:Pool Complexes Present?	No
State	WV	Stream Classification	Intermittent		
County	Nicholas	303(d) Impairment Listing	No

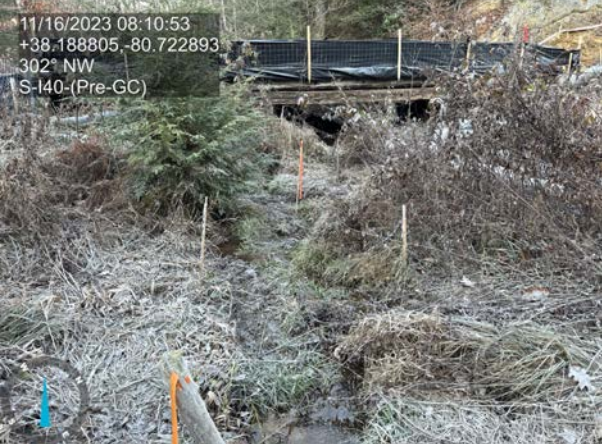
GPS Location	See photo above	GPS Location	See photo above
Description	Downstream view of permitted impact area during pre-construction assessment.	Description	Downstream view of unimpacted area during pre-construction assessment.

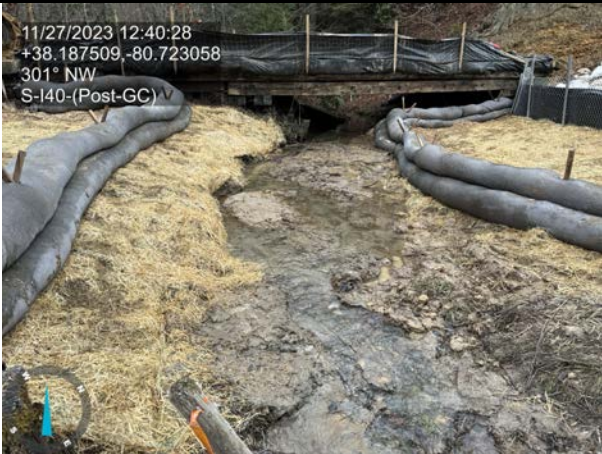
GPS Location	See photo above	GPS Location	See photo above
Description	Downstream view of permitted impact area during post-construction assessment.	Description	Downstream view of unimpacted area during post-construction assessment.

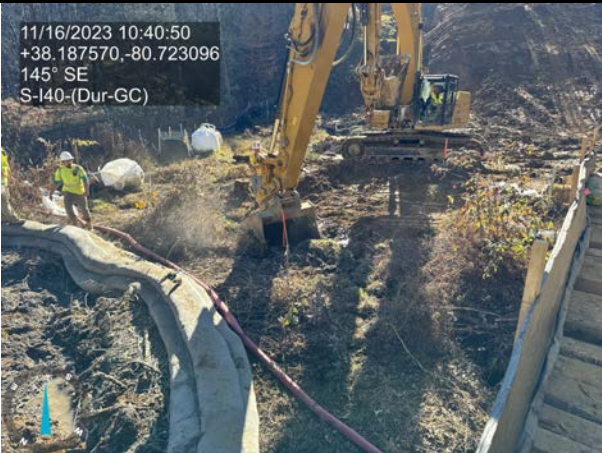
GPS Location	See photo above	GPS Location	See photo above
Description	Top 12" of substrate being removed from stream feature.	Description	Drilling holes to blast the stream and the 50' buffer zones.

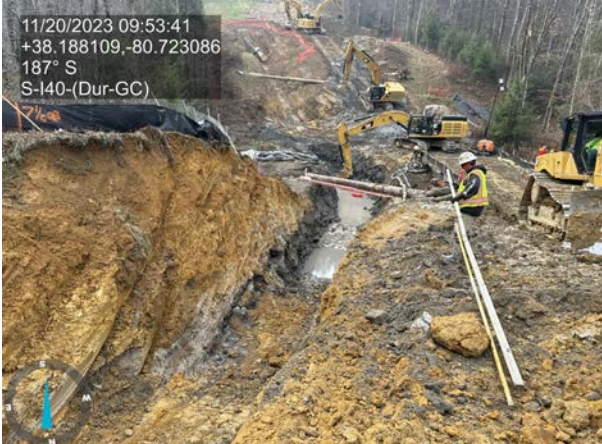
<p>11/20/2023 09:53:41 +38.188109,-80.723086 187° S S-I40-(Dur-GC)</p>

<p>11/20/2023 17:44:24 +38.187891,-80.722995 112° E S-I40-(Dur-GC)</p>
GPS Location See photo above	GPS Location See photo above
Description Ditch line for the stream has been excavated.	Description Stream section of pipe being lowered-in the trench.

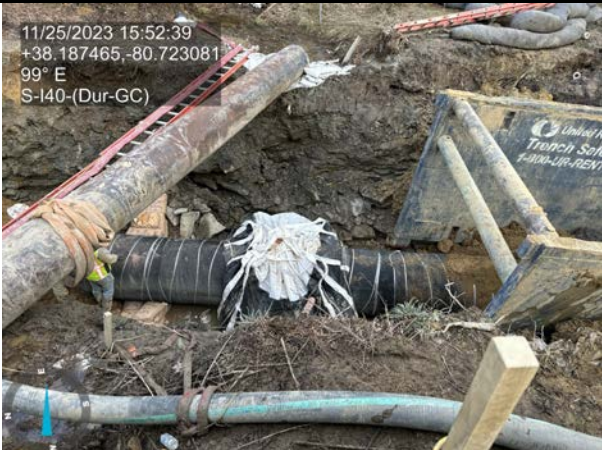
<p>11/25/2023 15:52:39 +38.187465,-80.723081 99° E S-I40-(Dur-GC)</p>	  <p>11/26/2023 10:16:23 +38.187525,-80.723022 86° E S-I40-(Dur-GC)</p>
GPS Location See photo above	GPS Location See photo above
Description River weight was installed.	Description The impervious trench breakers have been installed on the CIS and GAS of S-I40.

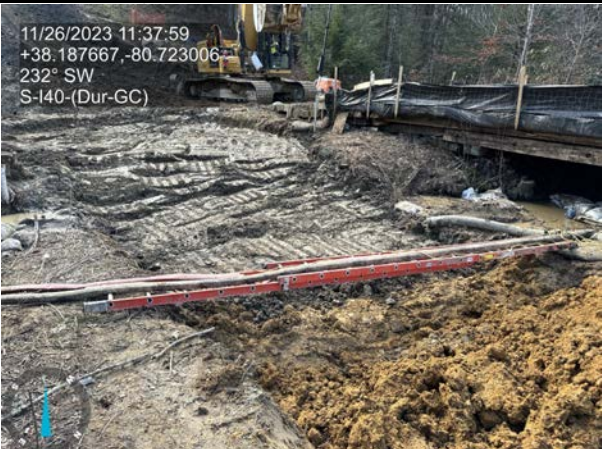
<p>11/26/2023 11:37:59 +38.187667,-80.723006 232° SW S-I40-(Dur-GC)</p>

<p>11/26/2023 13:30:19 +38.187661,-80.723410 100° E S-I40-(Dur-GC)</p>
GPS Location See photo above	GPS Location See photo above
Description Backfilling of the trench was complete using subsoil to within 12" from top of grade.	Description Survey verifying that all elevations and contours met pre-construction specifications.
