# Stream Biological Conditions EA Report

<b>Project Name</b>	H-600 Pipeline Spread D	<b>AFE</b>	124300132	<b>Spread</b>	H-600 Pipeline Spread D
<b>Contractor</b>	Precision	<b>Report #</b>	316		
<b>Environmental Auditor</b>	Todd Grant	<b>Date/Time</b>	10/26/2023 8:50 AM		
<b>Stream ID</b>	S-I41	<b>Crossing Start Date</b>	10/24/2023	<b>Crossing Completion Date</b>	11/19/2023
<b>Milepost</b>	127.01	<b>Pre-Con Assessment Date</b>	10/24/2023	<b>Post-Con Assessment Date</b>	11/20/2023
<b>Station</b>	6706+09	<b>Bankfull Width (ft.)</b>	8.0	<b>Riffle:Pool Complexes Present?</b>	No
<b>State</b>	WV	<b>Stream Classification</b>	Intermittent		
<b>County</b>	Nicholas	<b>303(d) Impairment Listing</b>	No

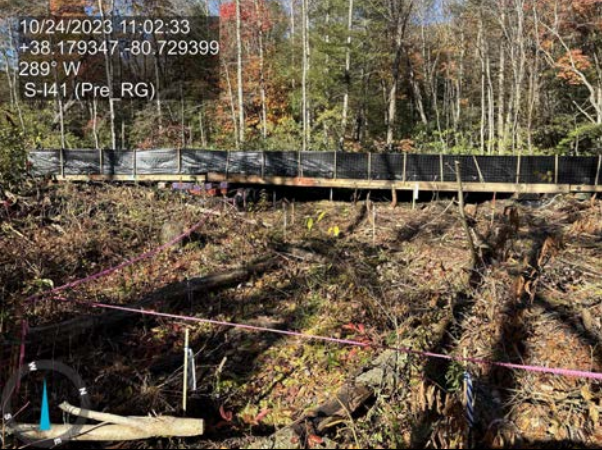
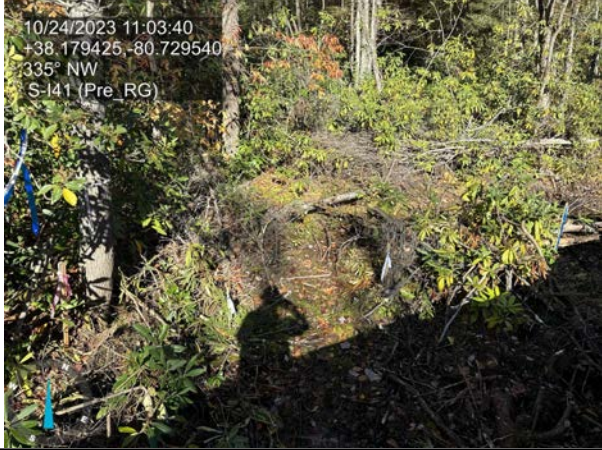
<b>GPS Location</b>	See photo above	<b>GPS Location</b>	See photo above
<b>Description</b>	Downstream view of permitted impact area during pre-construction assessment.	<b>Description</b>	Downstream view of unimpacted area during pre-construction assessment.

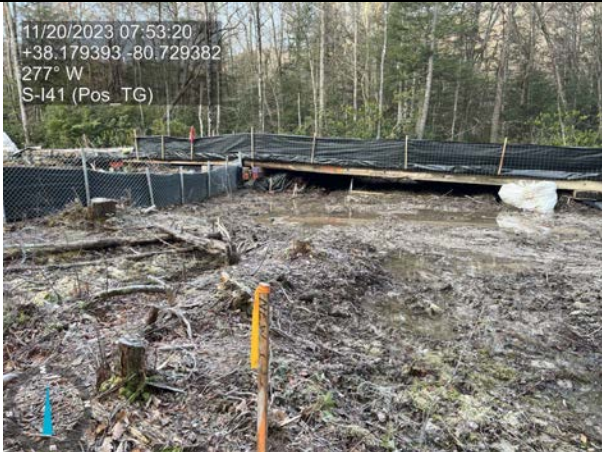
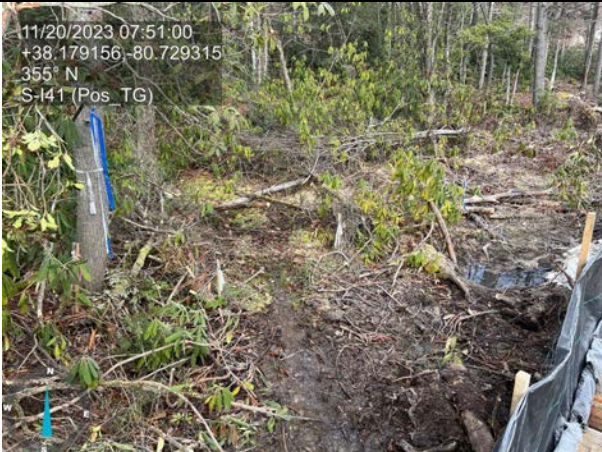
<b>GPS Location</b>	See photo above	<b>GPS Location</b>	See photo above
<b>Description</b>	Downstream view of permitted impact area during post-construction assessment.	<b>Description</b>	Downstream view of unimpacted area during post-construction assessment.

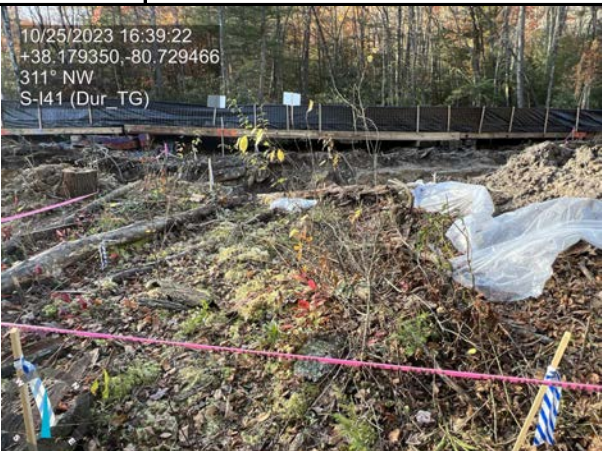
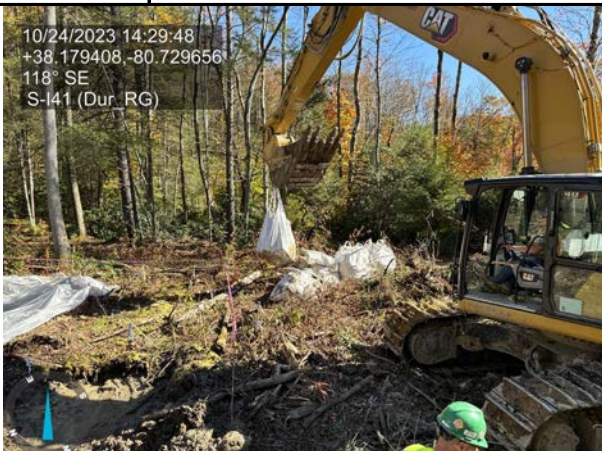
<b>GPS Location</b>	See photo above	<b>GPS Location</b>	See photo above
<b>Description</b>	View of ditch through stream S-I41 from upstream edge of ROW.	<b>Description</b>	View of the stream substrate being separated in super sacks.

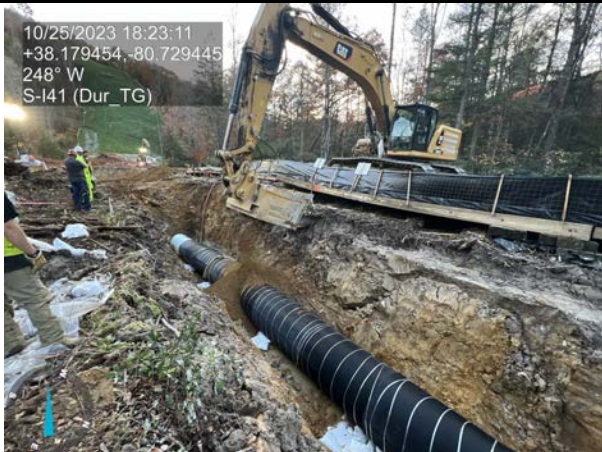
<b>GPS Location</b>	See photo above	<b>GPS Location</b>	See photo above
<b>Description</b>	View of the pipe lowered in through stream S-I41 and adjacent wetland.	<b>Description</b>	View of padding activities at stream S-I41.

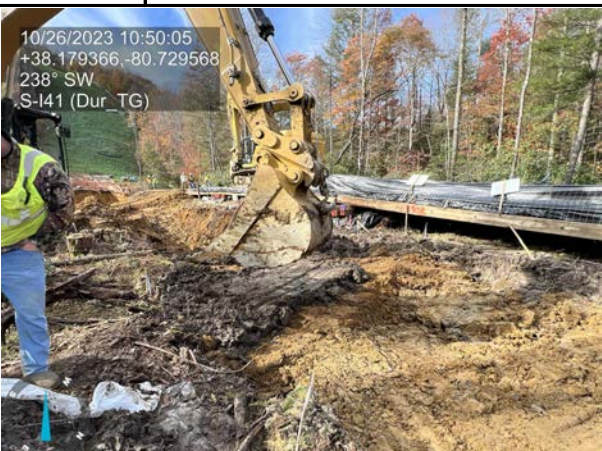
<b>GPS Location</b>	See photo above	<b>GPS Location</b>	See photo above
<b>Description</b>	View of stream S-I41 substrate being replaced.	<b>Description</b>	View of stream S-I41 substrate replaced prior to wetland topsoil replacement on both sides of the stream.
