STREAM BIOLOGICAL CONDITIONS ENVIRONMENTAL AUDITOR REPORT

Stream ID: S-II2	Crossing Start Date: 10/19/2023	Crossing Completion Date: 10/28/2023
Milepost: 263.4	Pre-Con Assessment Date: 10/18/2023	Post-Con Assessment Date: 10/30/2023
Station: 13915+82	Stream Classification: Perennial (Perennial, Intermittent, Ephemeral)	Bankfull Width (ft.): 60
County: Franklin	303(d) Impairment Listing: Impaired	Riffle:Pool Complexes Present? No

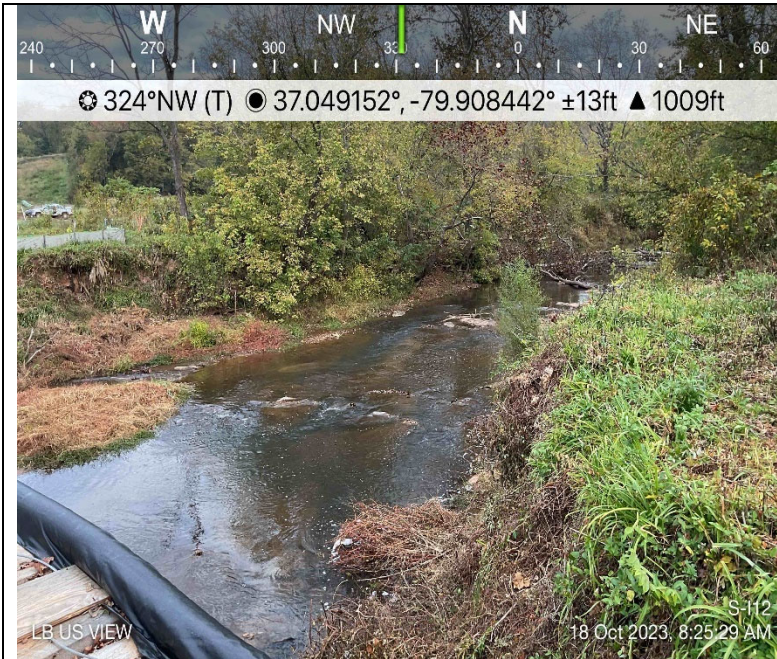
Photo Description: Upstream view of permitted impact area from left bank during pre-construction assessment.

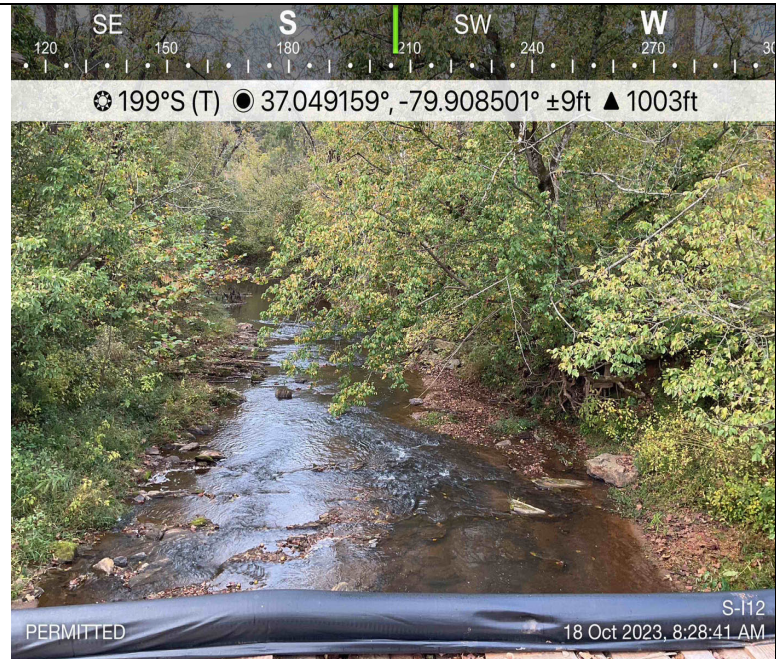
Photo Description: Conditions of the downstream area outside the ROW during pre-construction assessment.

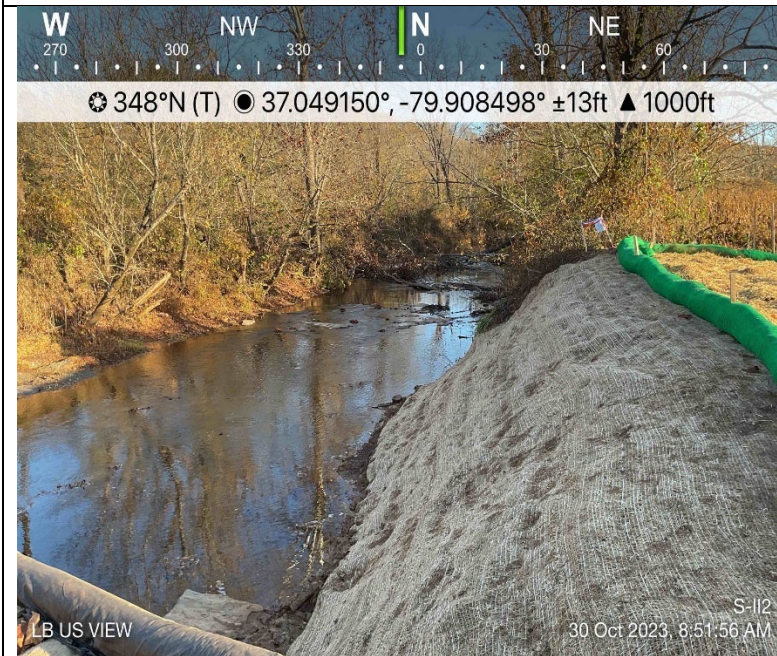
Photo Description: Upstream view of permitted impact area from left bank during post-construction assessment.

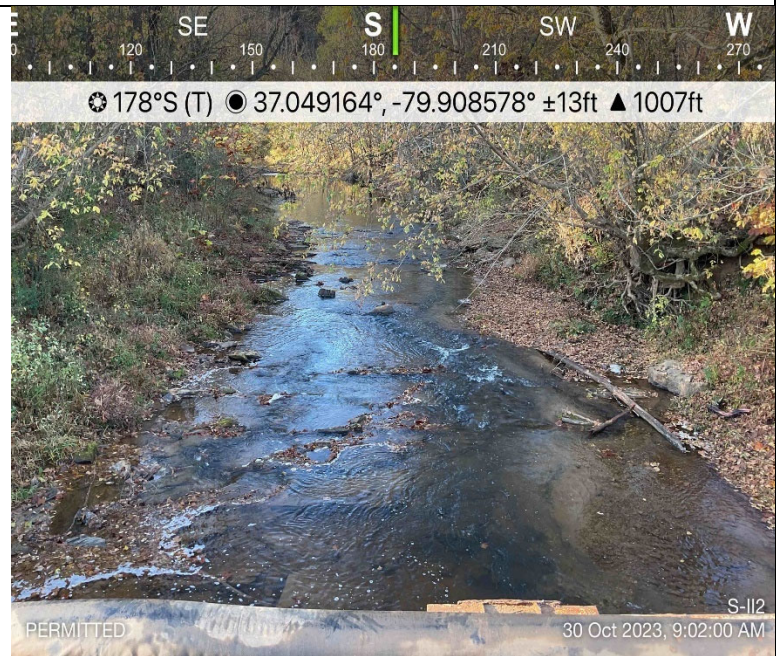
Photo Description: Conditions of the downstream area outside the ROW during post-construction assessment.

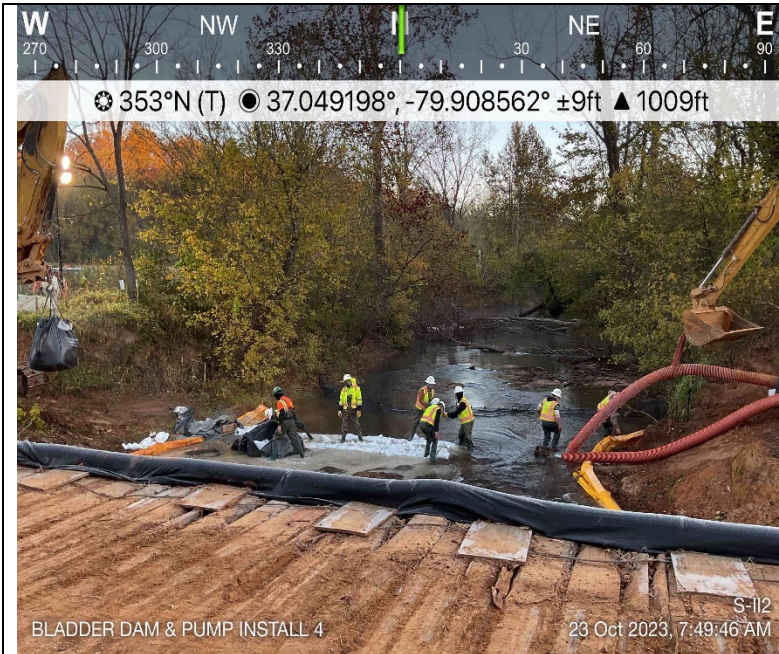
Photo Description: Bladder dam and pump installation.

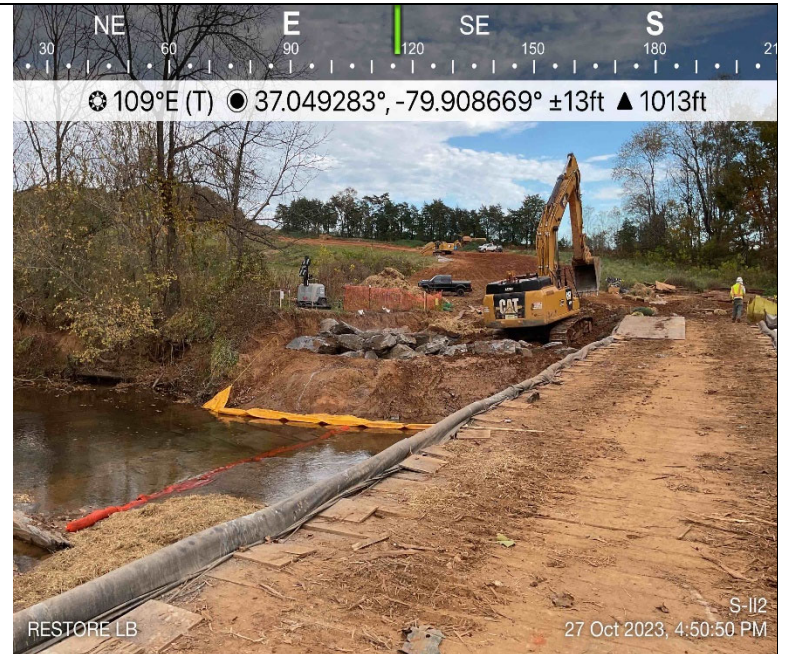
Item #10: Due to the size of the bladder dam, an excavator had to be staged on the denuded left bank while the stream flow was returned to the resource. A turbidity curtain was installed along the left bank while final restoration activities (final grade, seed, & stabilization) of the bank were completed. No adverse impacts to biological conditions were observed.

Photo Description: Item #10: Left bank was not seeded and stabilized prior to re-establishing flow. Turbidity curtain installed while LB restoration was completed. Equipment had to work from left bank to remove upstream bladder dam.

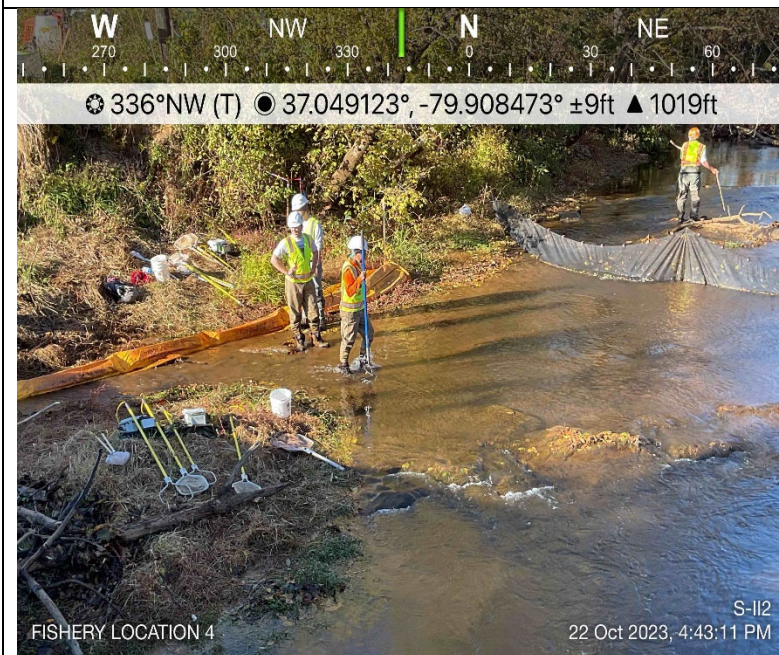
Photo Description: A crew on site to remove fish from the stream prior to construction.

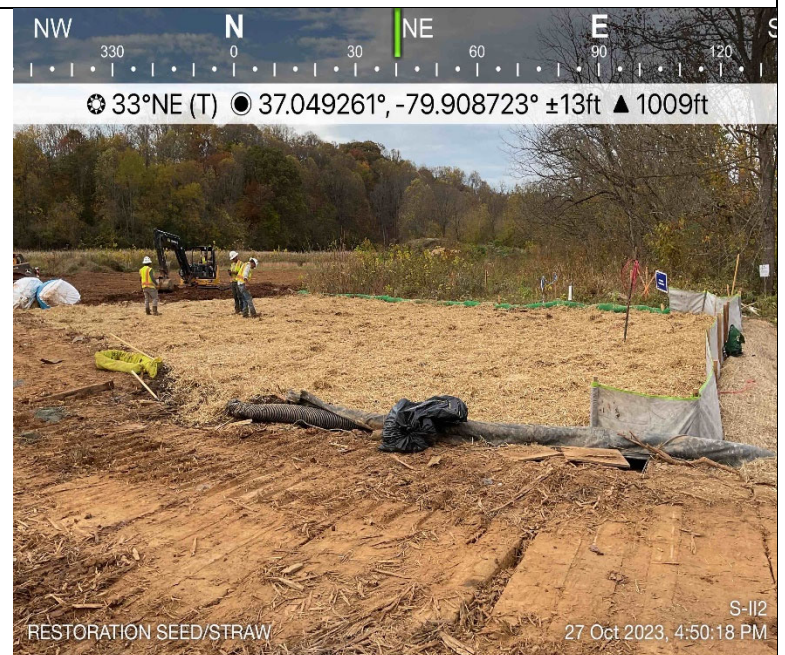
Photo Description: The application of seed and straw mulch buffer zones during site restoration.

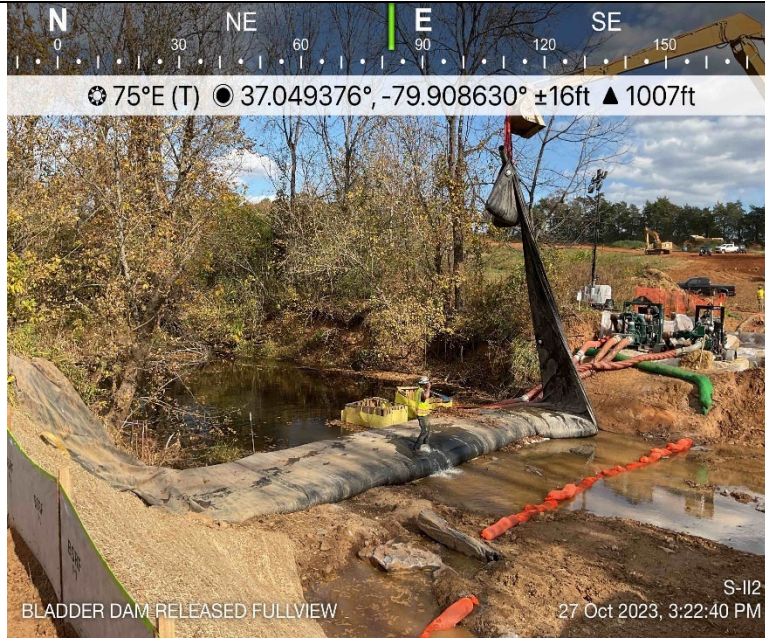
Photo Description: Bladder dam and pump removal. Item #10: Left bank was not seeded and stabilized prior to re-establishing flow. Turbidity curtain installed while stabilization applied. Equipment had to work from left bank to remove upstream bladder dam.

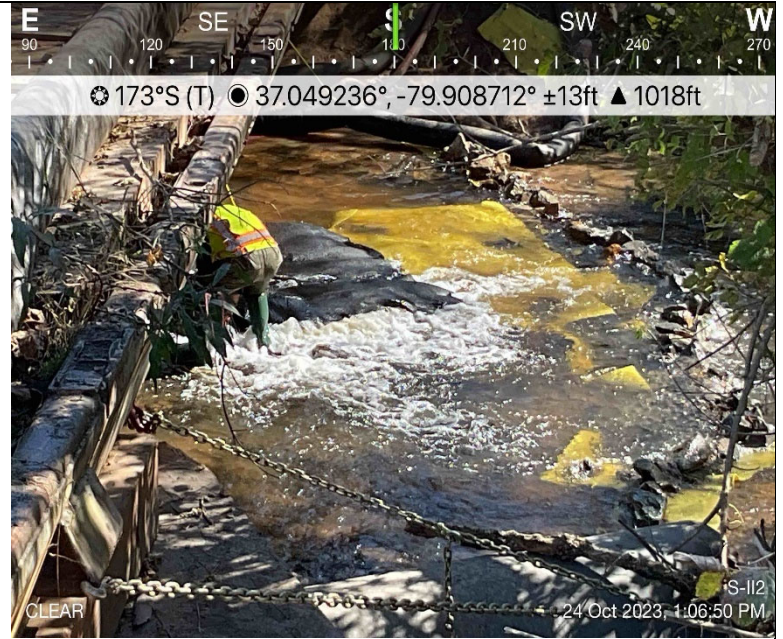
Photo Description: Discharge point for dam and pump around. Dam and pump around maintained throughout crossing activities.

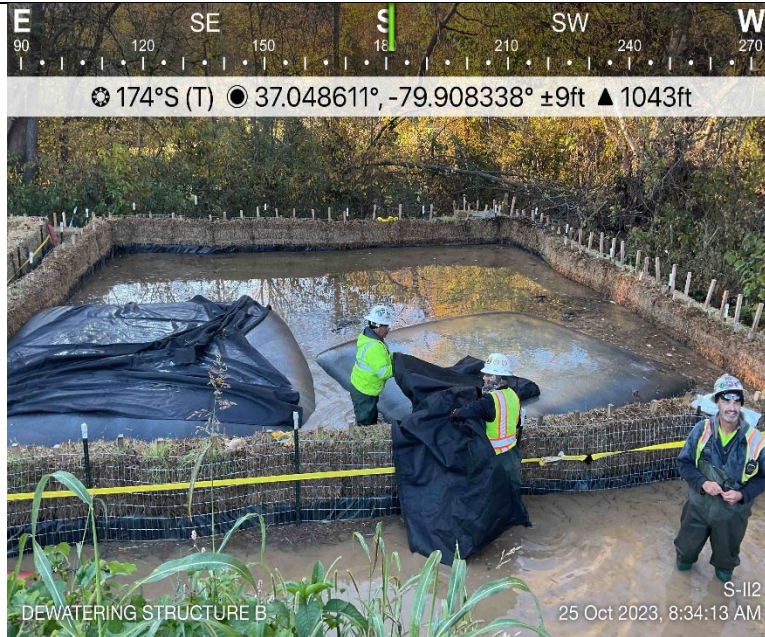
10-24-2023: The dewatering structures, pumps, and bladder dam are operational. Drilling in the stream bed continues. The crew performed another blast, and no unauthorized discharges were noted. Temporarily a small amount of turbidity was visible post-blasting but cleared and did not persist. Trench was excavated, and welding occurred with the FBE Pipe tied into CIS pipe loose end. The filter bag was observed to have failed within its containment. Turbid water was observed within the structure, but subsequently passed through additional sediment control measures. Upon further observation, there was no unauthorized discharge or accumulated material, and no adverse effect to biological conditions were observed at time of inspection. The filter bag was replaced, and another dewatering structure was installed as an additional control. All controls are installed and operational. Hoses are in place and pumps are active/operational. MVP and DEQ were onsite during the dewatering bag failure and repair. -V. Smith

Photo Description: 4 dewatering structures were used throughout crossing, and bags were changed out daily as required. One filter bag failed during crossing, but water was still filtered by secondary controls prior to leaving the LOD.

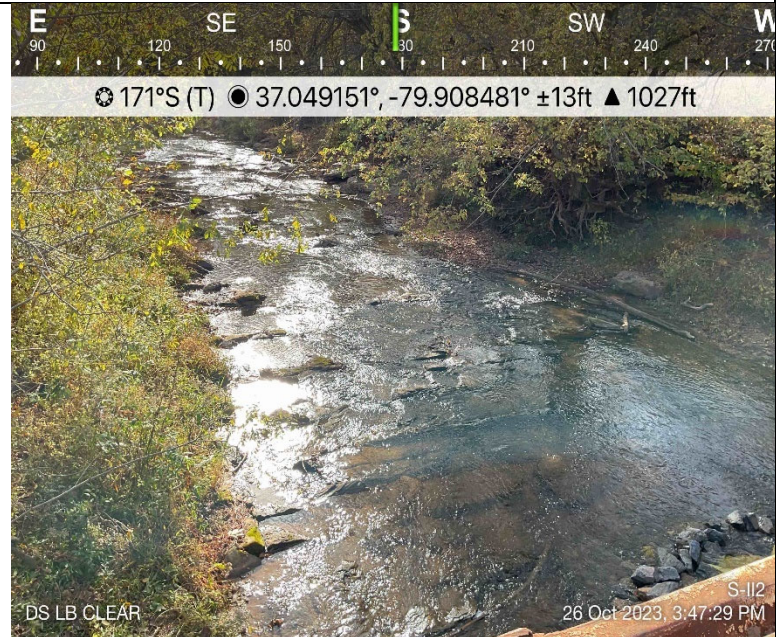
Photo Description: Off-site downstream conditions of resource during construction. No significant increase in turbidity from dam and pump around was observed.
