Stream Biological Conditions EA Report

Project Name	H-600 Pipeline Spread F	AFE	124300135	Spread	H-600 Pipeline Spread F
Contractor	Price Gregory	Report #	302		
Environmental Auditor	Kristin Duty	Date/Time	10/22/2023 9:18 PM		
Stream ID	S-J13(2)	Crossing Start Date	11/9/2023	Crossing Completion Date	11/15/2023
Milepost	160.40	Pre-Con Assessment Date	10/23/2023	Post-Con Assessment Date	11/15/2023
Station	8469+12	Bankfull Width (ft.)	3.8	Riffle:Pool Complexes Present?	No
State	WV	Stream Classification	Ephemeral		
County	Summers	303(d) Impairment Listing	No

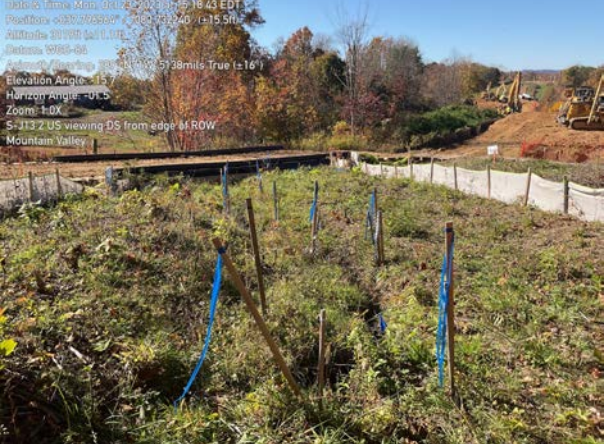
GPS Location See Photo	GPS Location See Photo
Description Downstream view of permitted impact area during pre-construction assessment.	Description Downstream view of unimpacted area during pre-construction assessment.

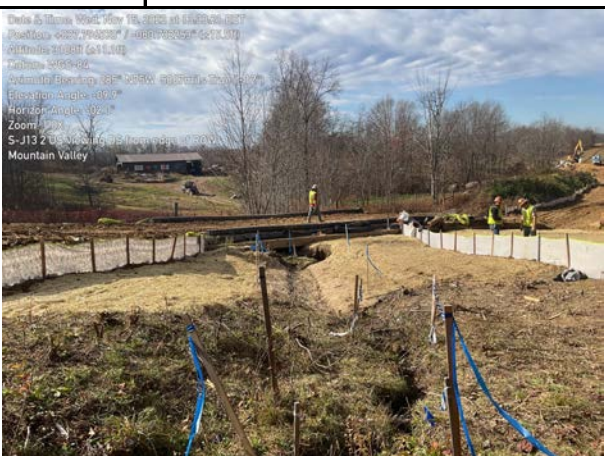
GPS Location See Photo	GPS Location See Photo
Description Downstream view of permitted impact area during post-construction assessment.	Description Downstream view of unimpacted area during post-construction assessment.

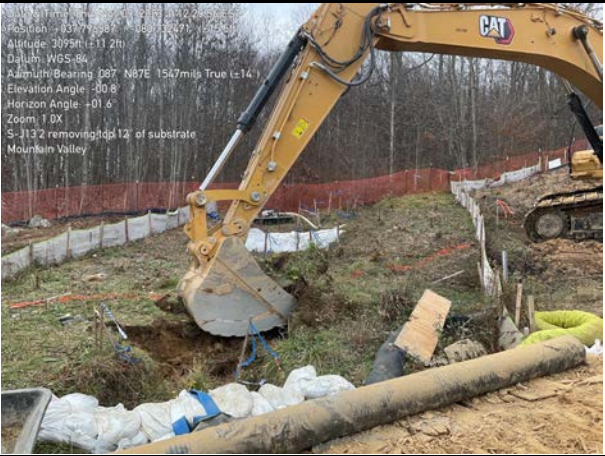
GPS Location See Photo	GPS Location See Photo
Description Photo 1: Excavation of top 12 inches of stream substrate.	Description Photo 2: Segregated stream substrate stored in work area.
