Stream Biological Conditions EA Report

Project Name	H-600 Pipeline Spread D	AFE	124300132	Spread	H-600 Pipeline Spread D
Contractor	Precision	Report #	320		
Environmental Auditor	Gary Cruz	Date/Time	10/26/2023 2:55 PM		
Stream ID	S-J22	Crossing Start Date	10/23/2023	Crossing Completion Date	11/1/2023
Milepost	122.48	Pre-Con Assessment Date	10/23/2023	Post-Con Assessment Date	11/1/2023
Station	6466+86	Bankfull Width (ft.)	3.0	Riffle:Pool Complexes Present?	No
State	WV	Stream Classification	Intermittent		
County	Nicholas	303(d) Impairment Listing	No

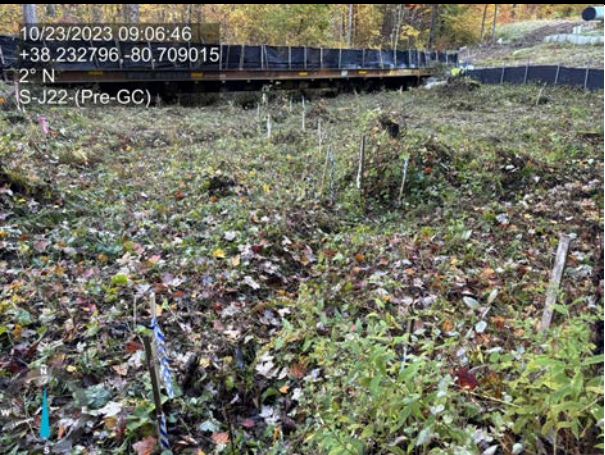
GPS Location See photo above		GPS Location See photo above			
Description Downstream view of permitted impact area during pre-construction assessment.		Description Downstream view of unimpacted area during pre-construction assessment.

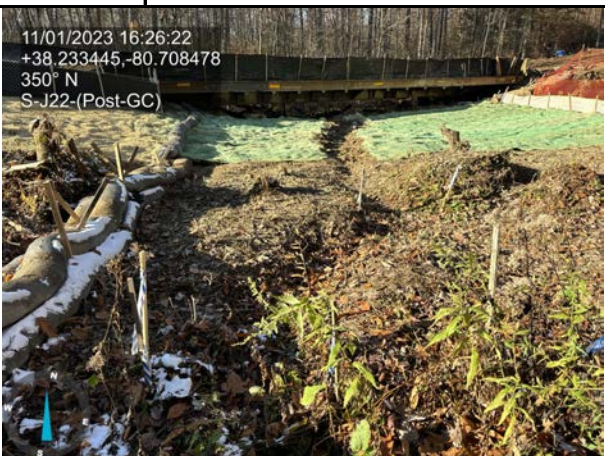
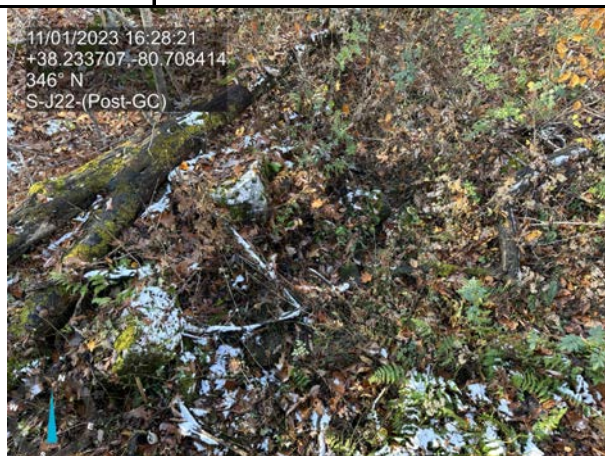
GPS Location See photo above		GPS Location See photo above			
Description Downstream view of permitted impact area during post-construction assessment.		Description Downstream view of unimpacted area during post-construction assessment.
