# Stream Biological Conditions EA Report

<b>Project Name</b>	H-600 Pipeline Spread D	<b>AFE</b>	124300132	<b>Spread</b>	H-600 Pipeline Spread D
<b>Contractor</b>	Precision	<b>Report #</b>	311		
<b>Environmental Auditor</b>	Gary Cruz	<b>Date/Time</b>	10/20/2023 2:34 PM		
<b>Stream ID</b>	S-J24n	<b>Crossing Start Date</b>	10/17/2023	<b>Crossing Completion Date</b>	10/24/2023
<b>Milepost</b>	120.45	<b>Pre-Con Assessment Date</b>	10/17/2023	<b>Post-Con Assessment Date</b>	10/25/2023
<b>Station</b>	6359+62	<b>Bankfull Width (ft.)</b>	15.0	<b>Riffle:Pool Complexes Present?</b>	No
<b>State</b>	WV	<b>Stream Classification</b>	Perennial		
<b>County</b>	Nicholas	<b>303(d) Impairment Listing</b>	pH

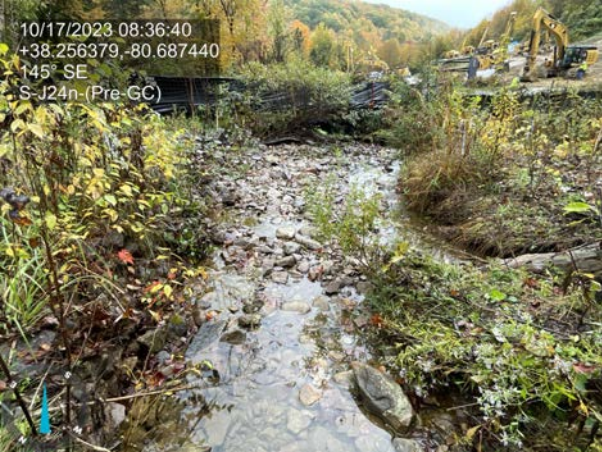
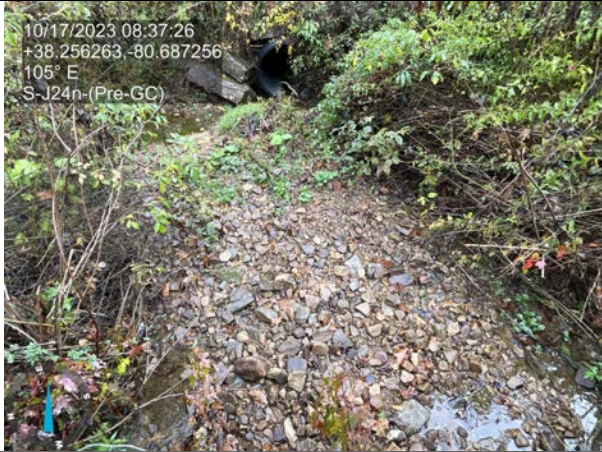
<b>GPS Location</b>	See photo above	<b>GPS Location</b>	See photo above
<b>Description</b>	Downstream view of permitted impact area during pre-construction assessment.	<b>Description</b>	Downstream view of unimpacted area during pre-construction assessment.

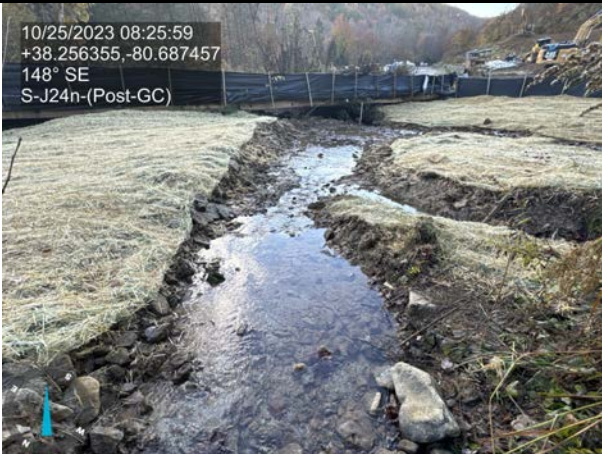
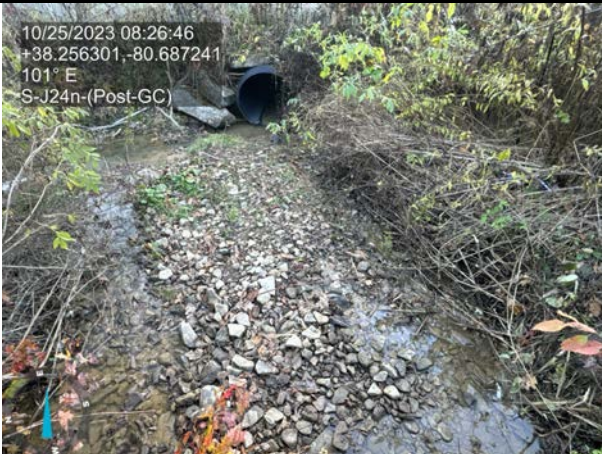
<b>GPS Location</b>	See photo above	<b>GPS Location</b>	See photo above
<b>Description</b>	Downstream view of permitted impact area during post-construction assessment.	<b>Description</b>	Downstream view of unimpacted area during post-construction assessment.

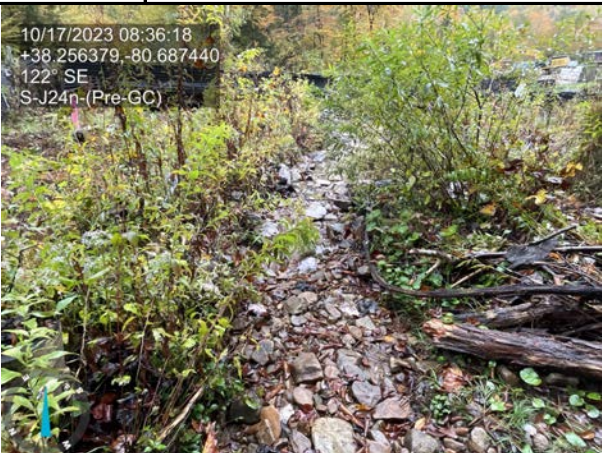
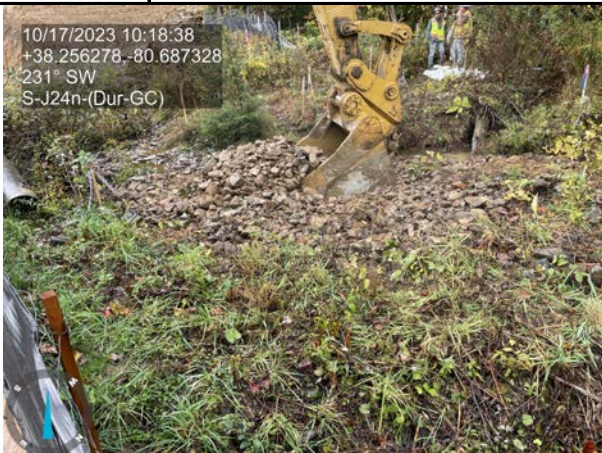
<b>GPS Location</b>	See photo above	<b>GPS Location</b>	See photo above
<b>Description</b>	Downstream view of permitted impacted area during pre-construction assessment.	<b>Description</b>	Contractor removing the surface rock from the stream bed.

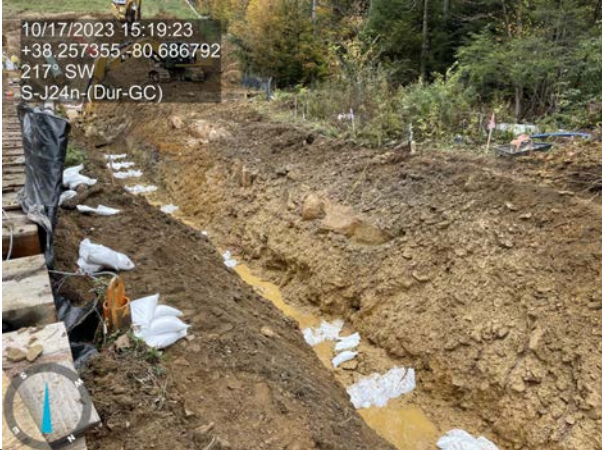
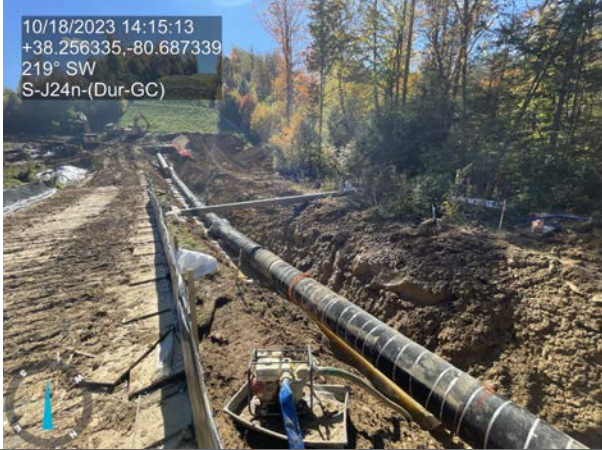
<b>GPS Location</b>	See photo above	<b>GPS Location</b>	See photo above
<b>Description</b>	Ditch line excavated through the feature.	<b>Description</b>	Lowered-in section of pipe for the stream.

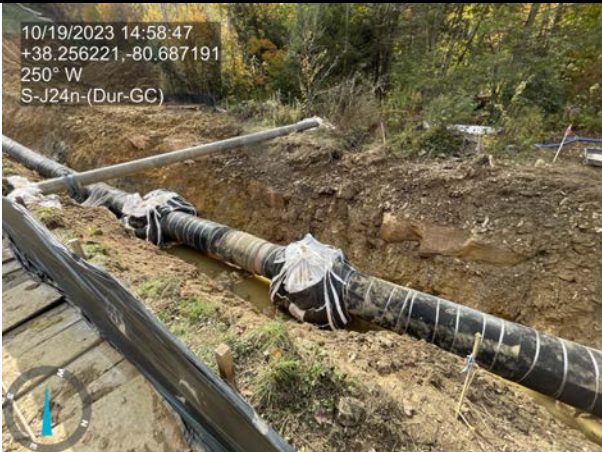
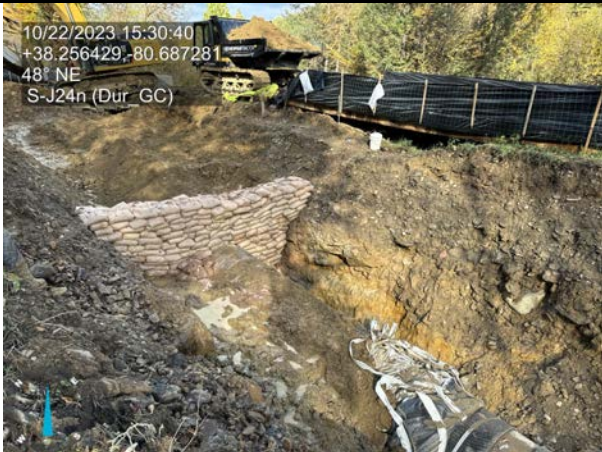
<b>GPS Location</b>	See photo above	<b>GPS Location</b>	See photo above
<b>Description</b>	Installed river weights.	<b>Description</b>	The impervious trench breakers on coming in side of the stream.

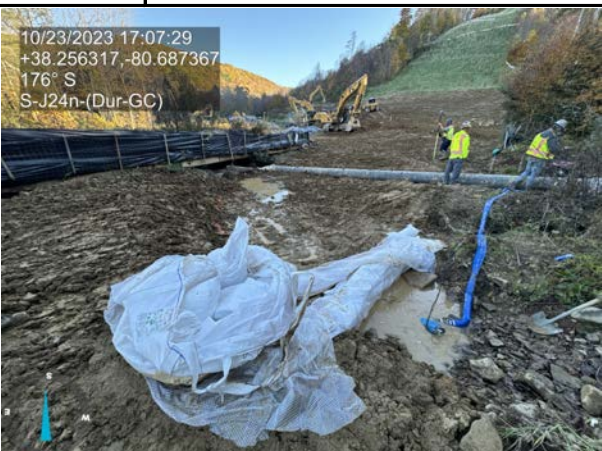
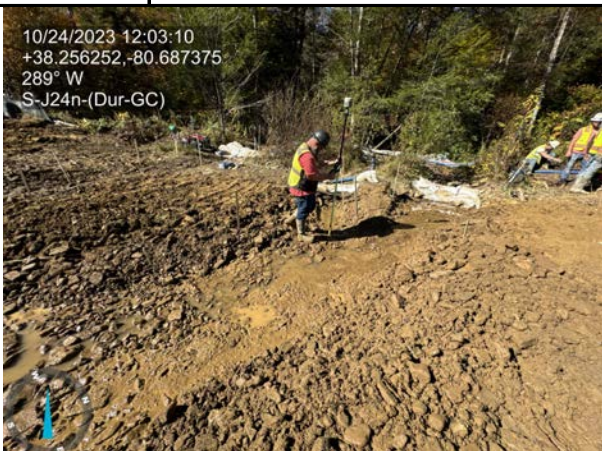
<b>GPS Location</b>	See photo above	<b>GPS Location</b>	See photo above
<b>Description</b>	Contractor backfilled trench with subsoil within 12" from top of grade.	<b>Description</b>	Survey verifying that all elevations and contours met pre-construction specifications.
