# Stream Biological Conditions EA Report

<b>Project Name</b>	H-600 Pipeline Spread D	<b>AFE</b>	124300132	<b>Spread</b>	H-600 Pipeline Spread D
<b>Contractor</b>	Precision	<b>Report #</b>	309		
<b>Environmental Auditor</b>	Gary Cruz	<b>Date/Time</b>	10/20/2023 2:39 PM		
<b>Stream ID</b>	S-J24s	<b>Crossing Start Date</b>	10/17/2023	<b>Crossing Completion Date</b>	10/24/2023
<b>Milepost</b>	120.45	<b>Pre-Con Assessment Date</b>	10/17/2023	<b>Post-Con Assessment Date</b>	10/25/2023
<b>Station</b>	6359+62	<b>Bankfull Width (ft.)</b>	15.0	<b>Riffle:Pool Complexes Present?</b>	No
<b>State</b>	WV	<b>Stream Classification</b>	Perennial		
<b>County</b>	Nicholas	<b>303(d) Impairment Listing</b>	pH

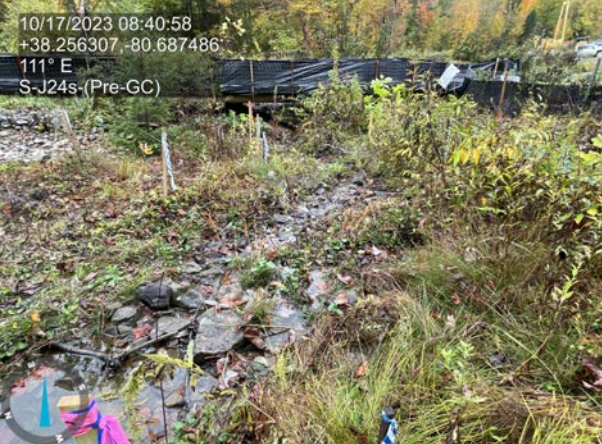
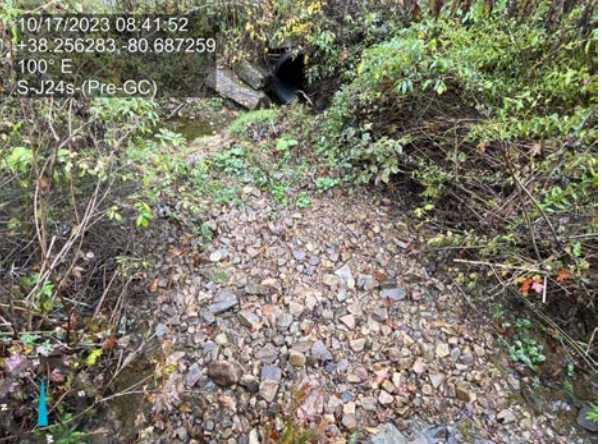
<b>GPS Location</b>	See photo above	<b>GPS Location</b>	See photo above
<b>Description</b>	Downstream view of permitted impact area during pre-construction assessment.	<b>Description</b>	Downstream view of unimpacted area during pre-construction assessment.

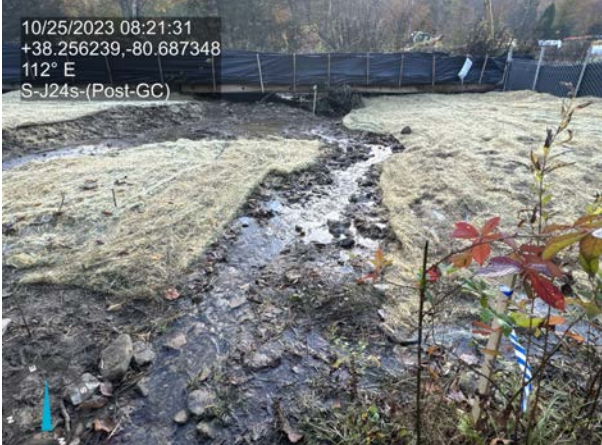
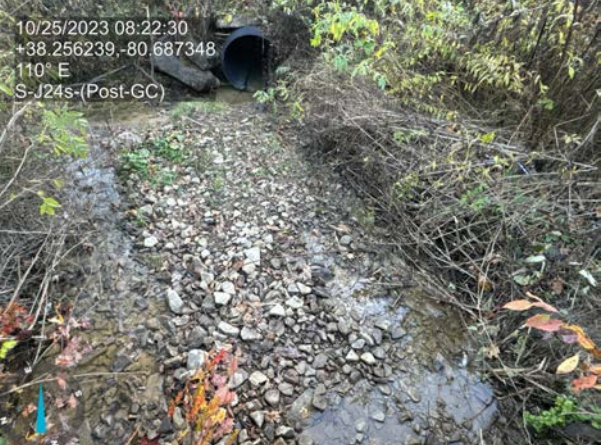
<b>GPS Location</b>	See photo above	<b>GPS Location</b>	See photo above
<b>Description</b>	Downstream view of permitted impact area during post-construction assessment.	<b>Description</b>	Downstream view of unimpacted area during post-construction assessment.

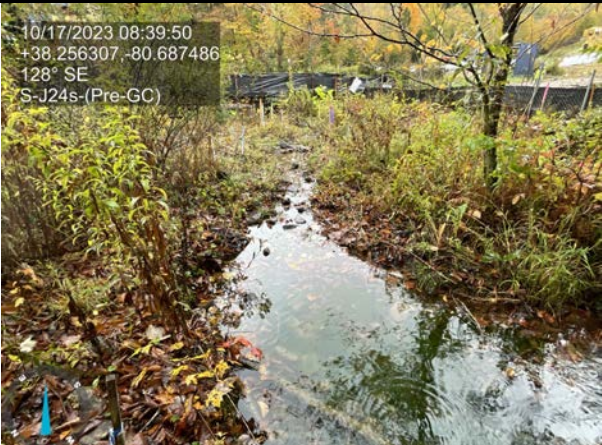
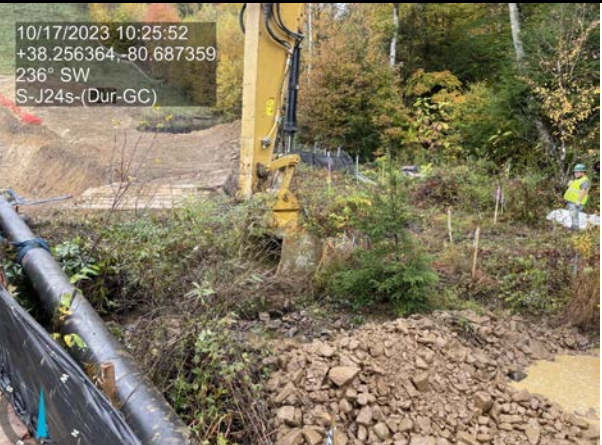
<b>GPS Location</b>	See photo above	<b>GPS Location</b>	See photo above
<b>Description</b>	Downstream view of permitted impacted area during pre-construction assessment.	<b>Description</b>	Contractor removing the top 12" of substrate.

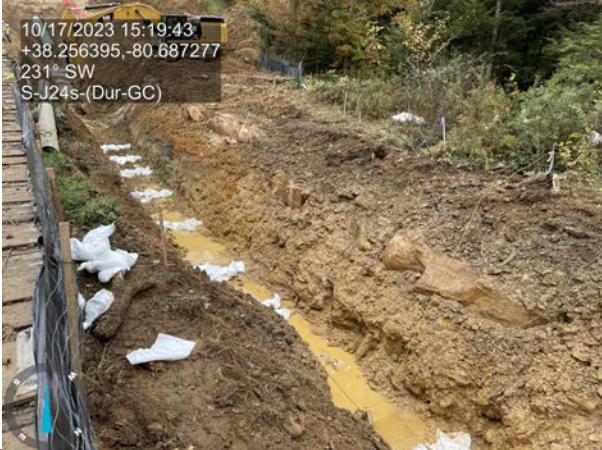
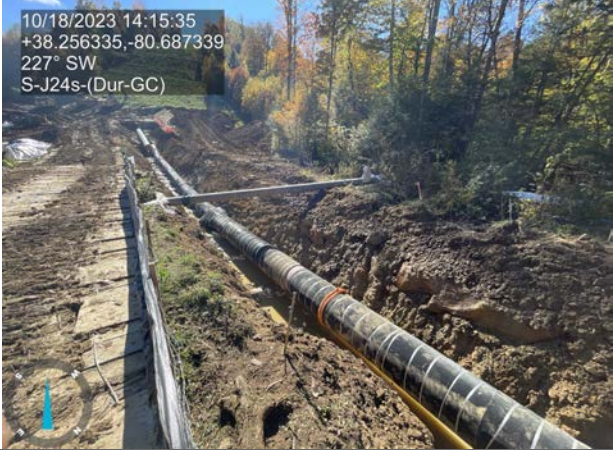
<b>GPS Location</b>	See photo above	<b>GPS Location</b>	See photo above
<b>Description</b>	Ditch line of stream feature excavated.	<b>Description</b>	Section of pipe for the stream lowered-in.

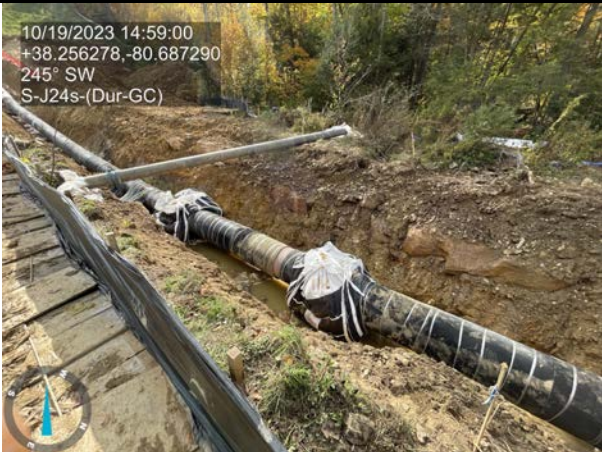
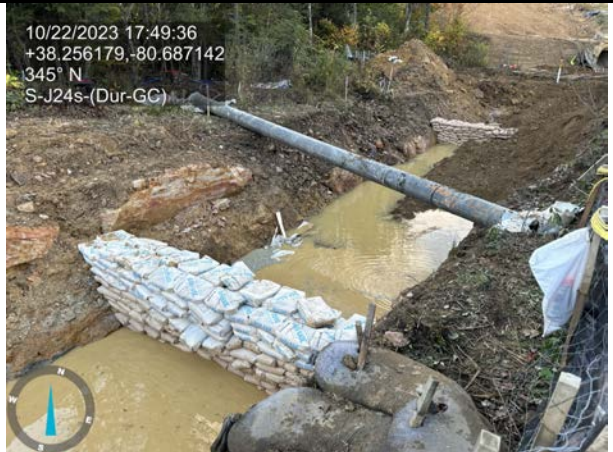
<b>GPS Location</b>	See photo above	<b>GPS Location</b>	See photo above
<b>Description</b>	Contractor installed the river weights for stream.	<b>Description</b>	Impervious trench breakers were installed.

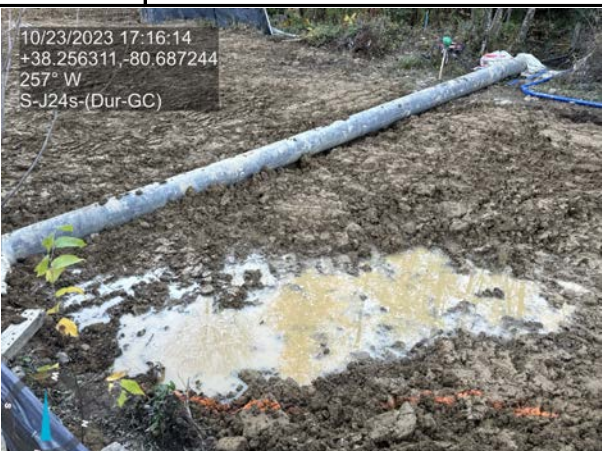
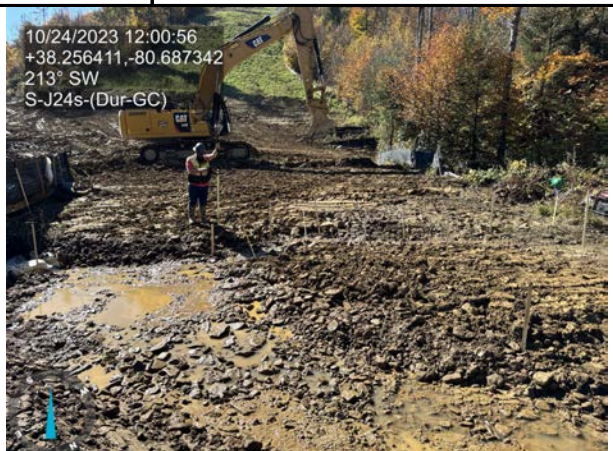
<b>GPS Location</b>	See photo above	<b>GPS Location</b>	See photo above
<b>Description</b>	Contractor backfilled trench with subsoil within 12" from top of grade.	<b>Description</b>	Survey verifying that all elevations and contours met pre-construction specifications.
