# Stream Biological Conditions EA Report

<b>Project Name</b>	H-600 Pipeline Spread D	<b>AFE</b>	124300132	<b>Spread</b>	H-600 Pipeline Spread D
<b>Contractor</b>	Precision	<b>Report #</b>	312		
<b>Environmental Auditor</b>	Gary Cruz	<b>Date/Time</b>	10/12/2023 7:42 PM		
<b>Stream ID</b>	S-J25	<b>Crossing Start Date</b>	10/12/2023	<b>Crossing Completion Date</b>	10/24/2023
<b>Milepost</b>	120.42	<b>Pre-Con Assessment Date</b>	10/12/2023	<b>Post-Con Assessment Date</b>	10/25/2023
<b>Station</b>	6358+09	<b>Bankfull Width (ft.)</b>	3.2	<b>Riffle:Pool Complexes Present?</b>	No
<b>State</b>	WV	<b>Stream Classification</b>	Ephemeral		
<b>County</b>	Nicholas	<b>303(d) Impairment Listing</b>	No

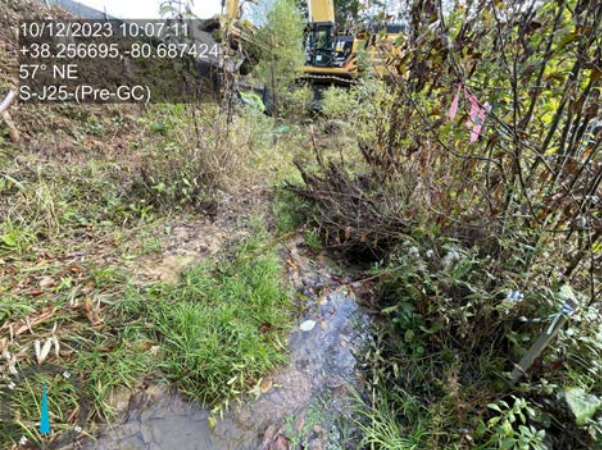
<b>GPS Location</b>	See photo above	<b>GPS Location</b>	See photo above
<b>Description</b>	Downstream view of permitted impact area during pre-construction assessment.	<b>Description</b>	Downstream view of unimpacted area during pre-construction assessment.

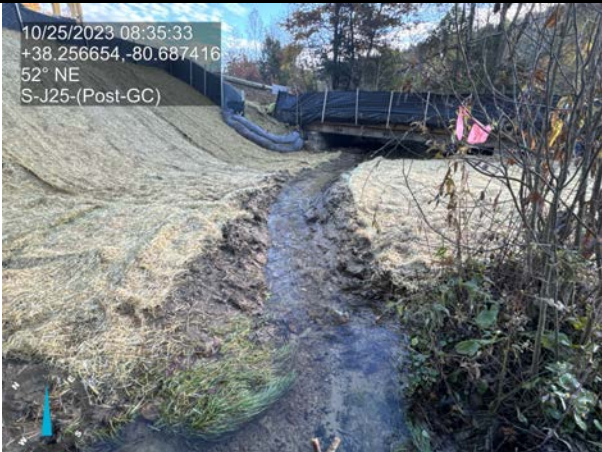
<b>GPS Location</b>	See photo above	<b>GPS Location</b>	See photo above
<b>Description</b>	Downstream view of permitted impact area during post-construction assessment.	<b>Description</b>	Downstream view of unimpacted area during post-construction assessment.

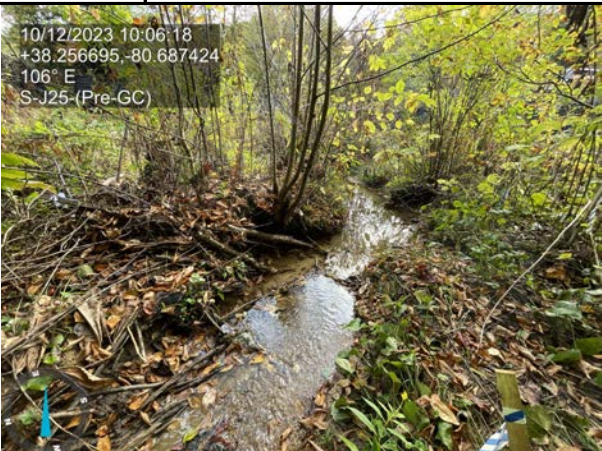
<b>GPS Location</b>	See photo above	<b>GPS Location</b>	See photo above
<b>Description</b>	Downstream view of permitted impacted area during pre-construction assessment.	<b>Description</b>	Upstream view of contractor removing top 12" of substrate.
