Stream Biological Conditions EA Report

Project Name	H-600 Pipeline Spread B	AFE	124300130	Spread	H-600 Pipeline Spread B
Contractor	Precision	Report #	332		
Environmental Auditor	Samantha Felix	Date/Time	10/17/2023 10:30 AM		
Stream ID	S-J44	Crossing Start Date	10/24/2023	Crossing Completion Date	11/11/2023
Milepost	21.77	Pre-Con Assessment Date	10/17/2023	Post-Con Assessment Date	11/14/2023
Station	1149+20	Bankfull Width (ft.)	5.0	Riffle:Pool Complexes Present?	No
State	WV	Stream Classification	Perennial		
County	Lewis	303(d) Impairment Listing	No

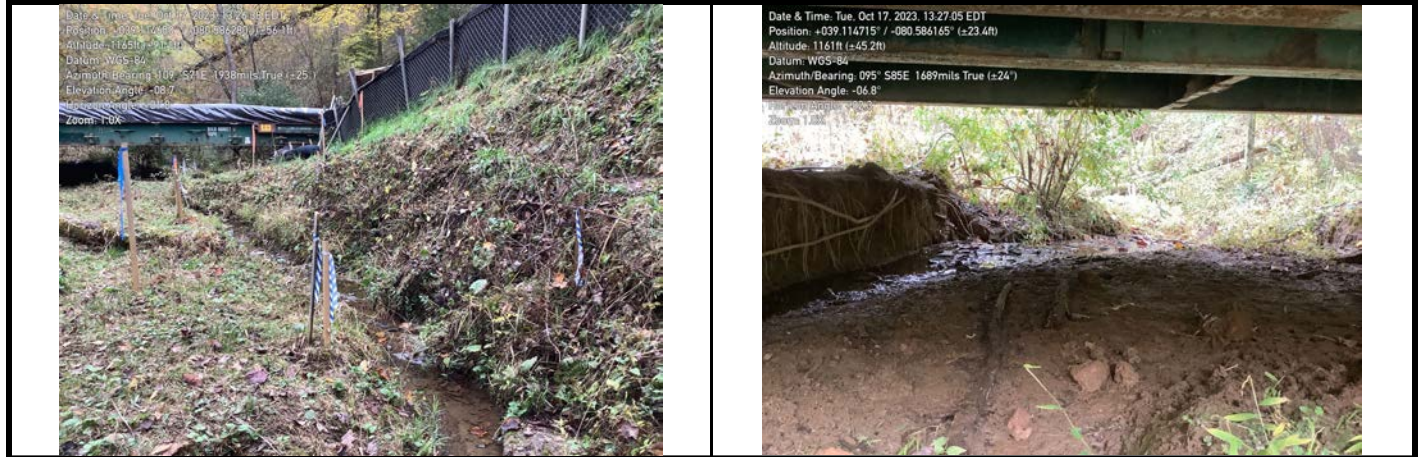
GPS Location	See above	GPS Location	See above
Description	Downstream view of permitted impact area during pre-construction assessment.	Description	Downstream view of unimpacted area during pre-construction assessment.

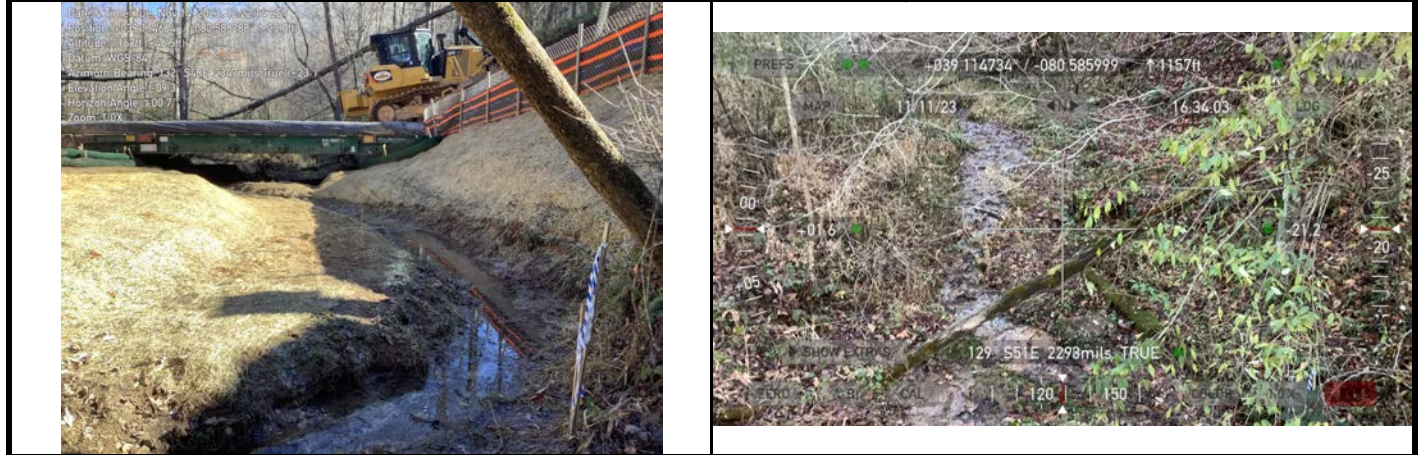
GPS Location	See above	GPS Location	See above
Description	Downstream view of permitted impact area during post-construction assessment.	Description	Downstream view of unimpacted area during post-construction assessment.

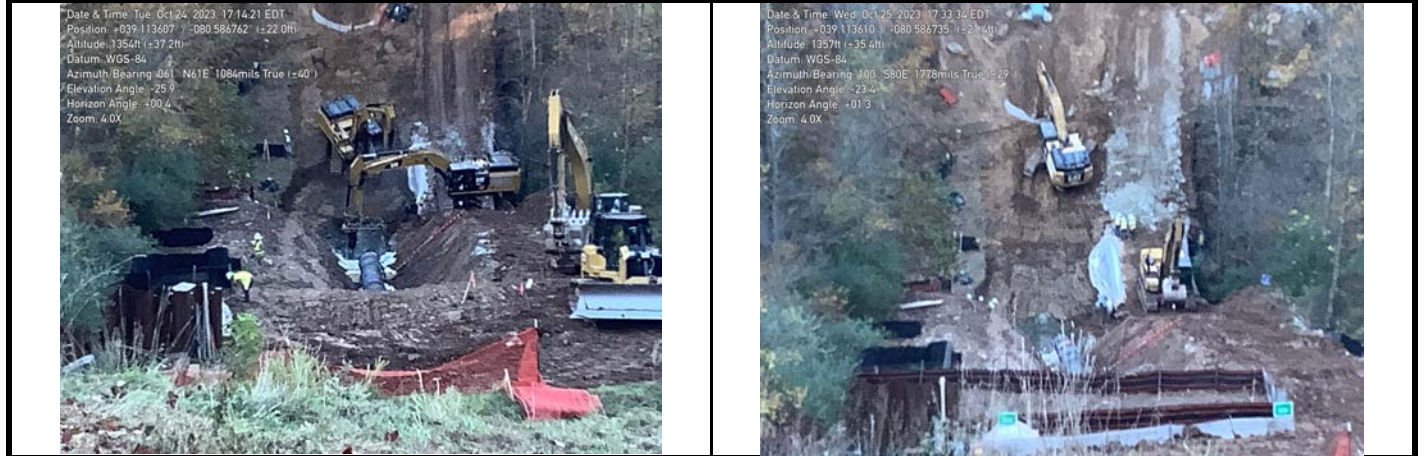
GPS Location	See above.	GPS Location	See above.
Description	Removing streambed material.	Description	The crew started drilling rock.

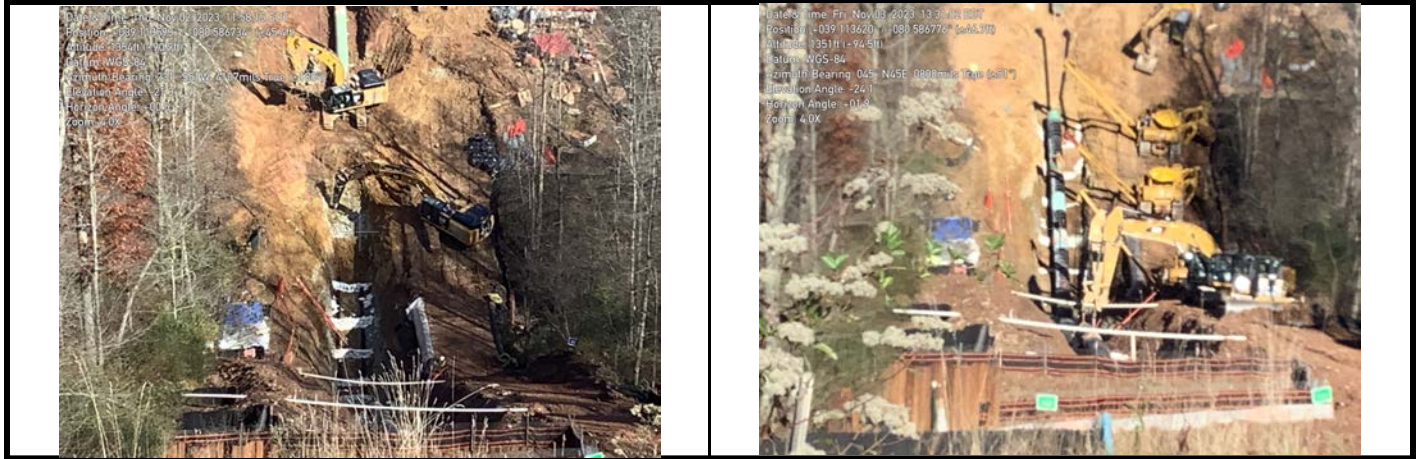
GPS Location	See above.	GPS Location	See above.
Description	The crew finishing up drilling the rock.	Description	The crew setting the pipe in the ground.

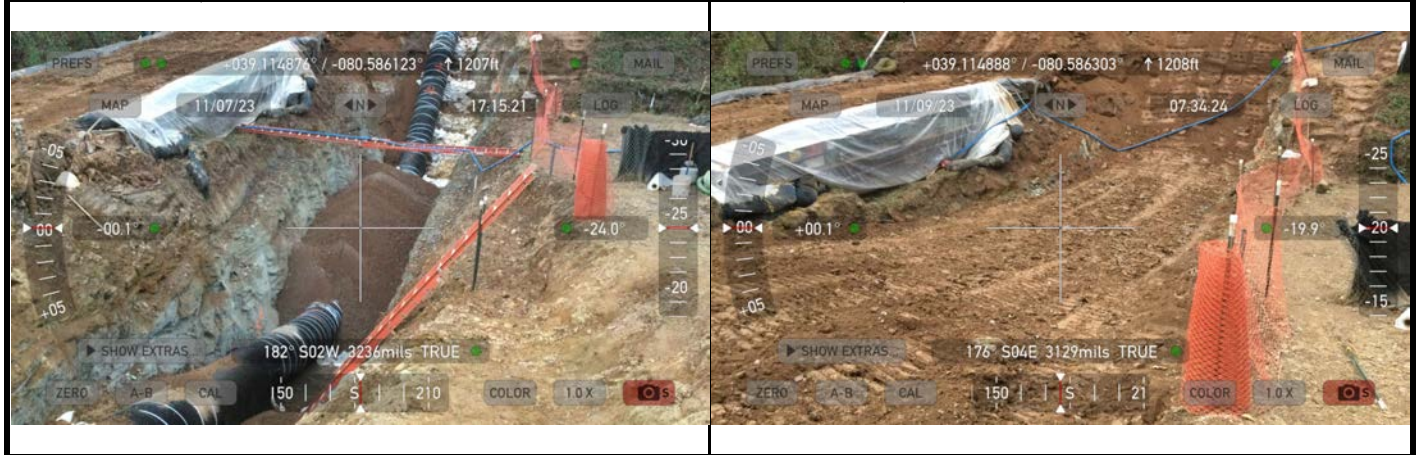
GPS Location	See above	GPS Location	See above
Description	Initial backfilling of stream crossing.	Description	Backfilling progress in stream crossing by 11/09/2023.

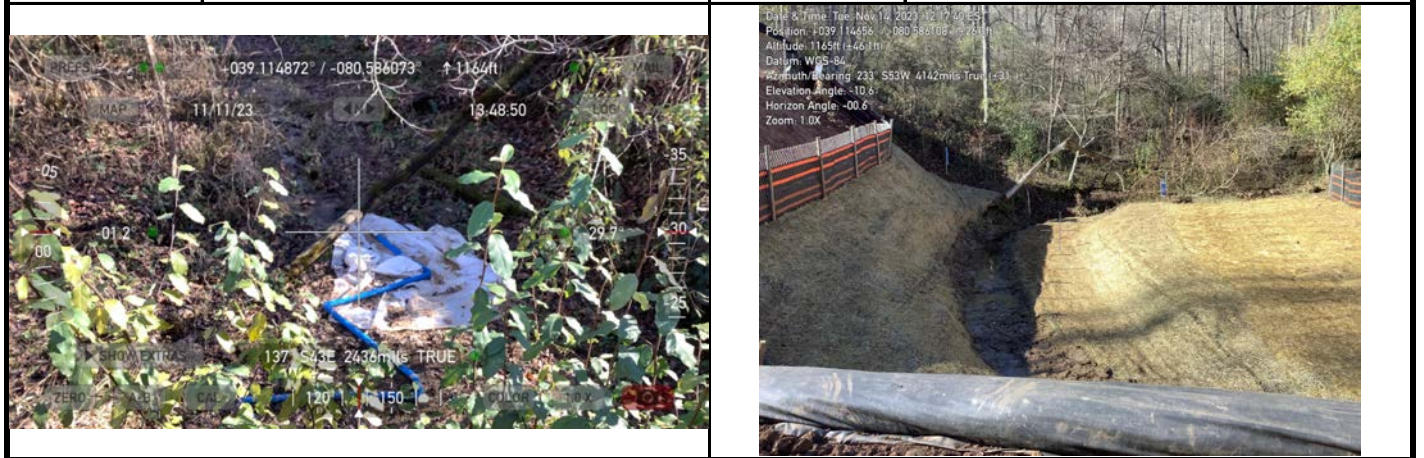
GPS Location	See above	GPS Location	See above
Description	Downstream discharge for dam and pump on 11/11/2023.	Description	Restored crossing on 11/14/2023.
