Stream Biological Conditions EA Report

Project Name	H-600 Pipeline Spread F	AFE		Spread	H-600 Pipeline Spread F
Contractor	Price Gregory	Report #	296		
Environmental Auditor	Luke Fultz	Date/Time	10/23/2023 9:45 AM		
Stream ID	S-K17	Crossing Start Date	10/23/2023	Crossing Completion Date	11/1/2023
Milepost	155.06	Pre-Con Assessment Date	10/18/2023	Post-Con Assessment Date	11/1/2023
Station	B187+17	Bankfull Width (ft.)	13.1	Riffle:Pool Complexes Present?	No
State	WV	Stream Classification	Perennial		
County	Greenbrier	303(d) Impairment Listing	No

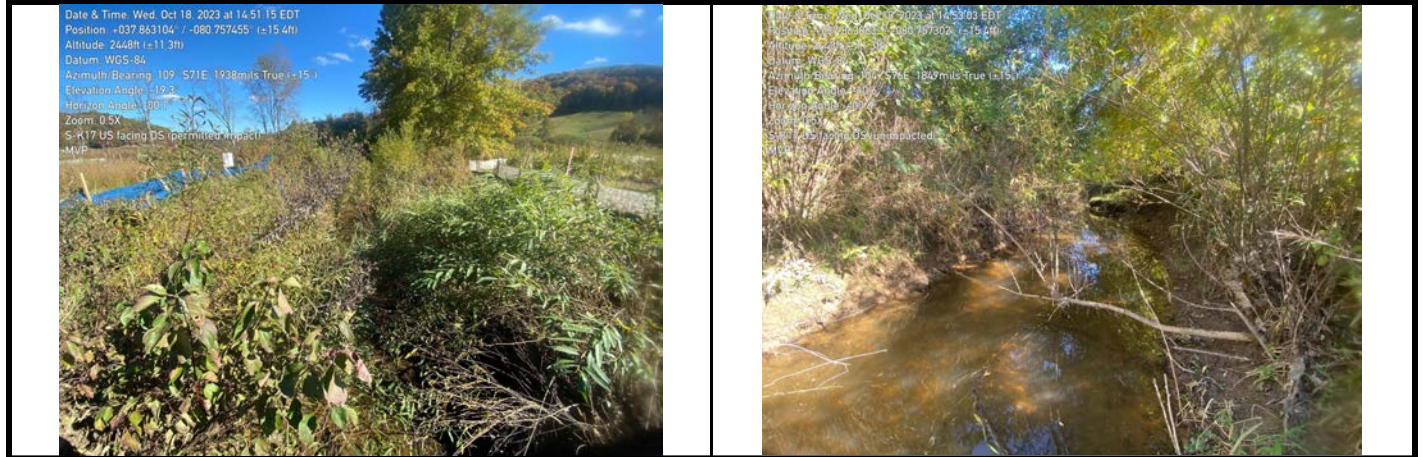
GPS Location See Photo	GPS Location See Photo
Description Downstream view of permitted impact area during pre-construction assessment.	Description Downstream view of unimpacted area during pre-construction assessment.

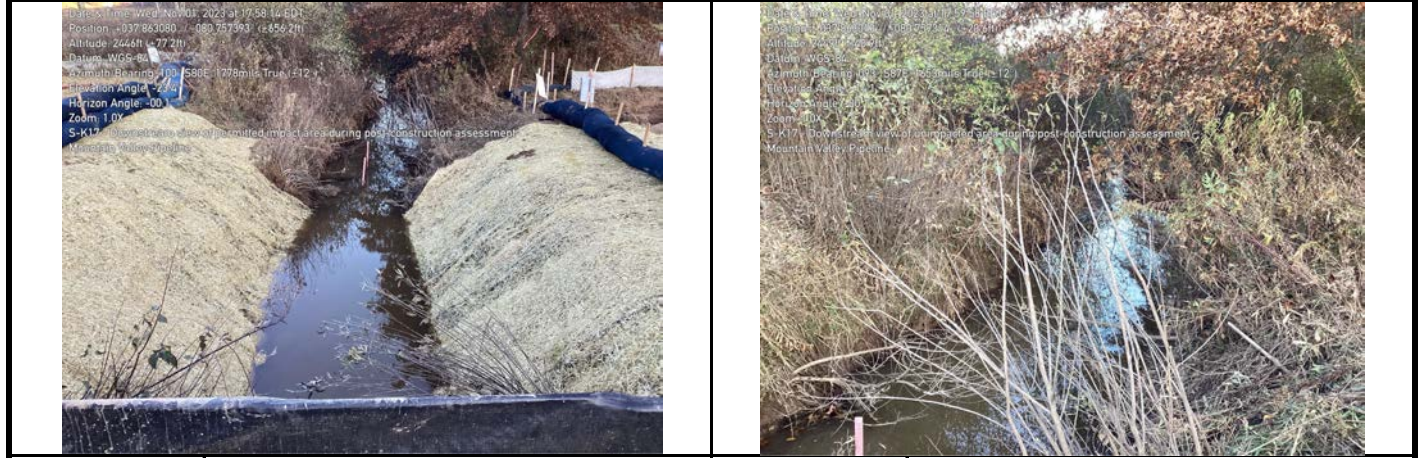
GPS Location See Photo	GPS Location See Photo
Description Downstream view of permitted impact area during post-construction assessment.	Description Downstream view of unimpacted area during post-construction assessment.

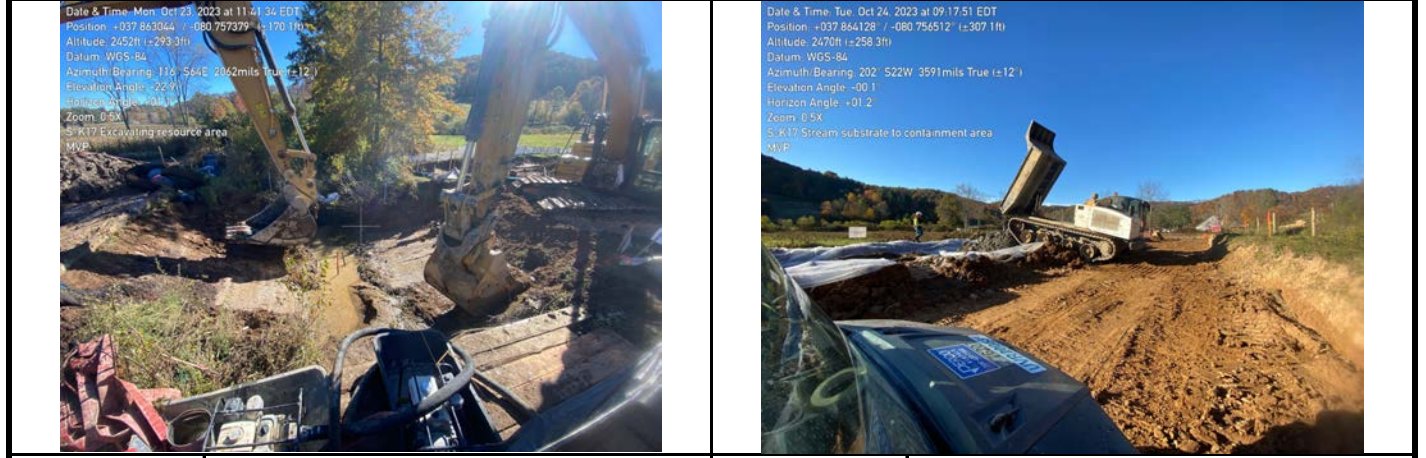
GPS Location See Photo	GPS Location See Photo
Description Photo 1: Stream substrate removed.	Description Photo 2: Placement of substrate

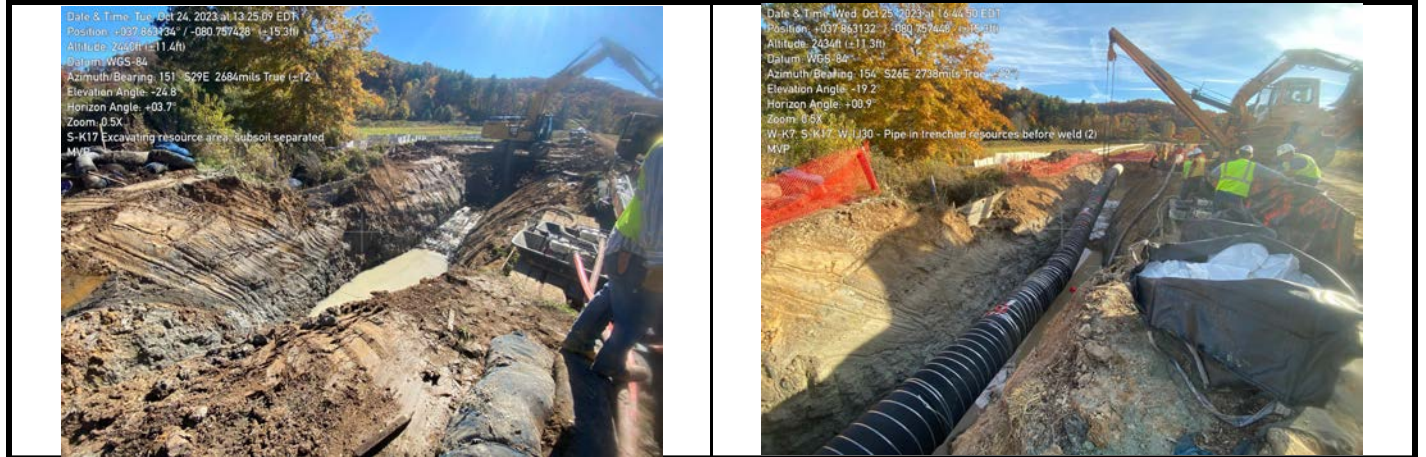
GPS Location	See Photo	GPS Location	See Photo
Description	Photo 3: Excavating through aquatic resource and upland area.	Description	Photo 4: Staging of pipe through aquatic resource.

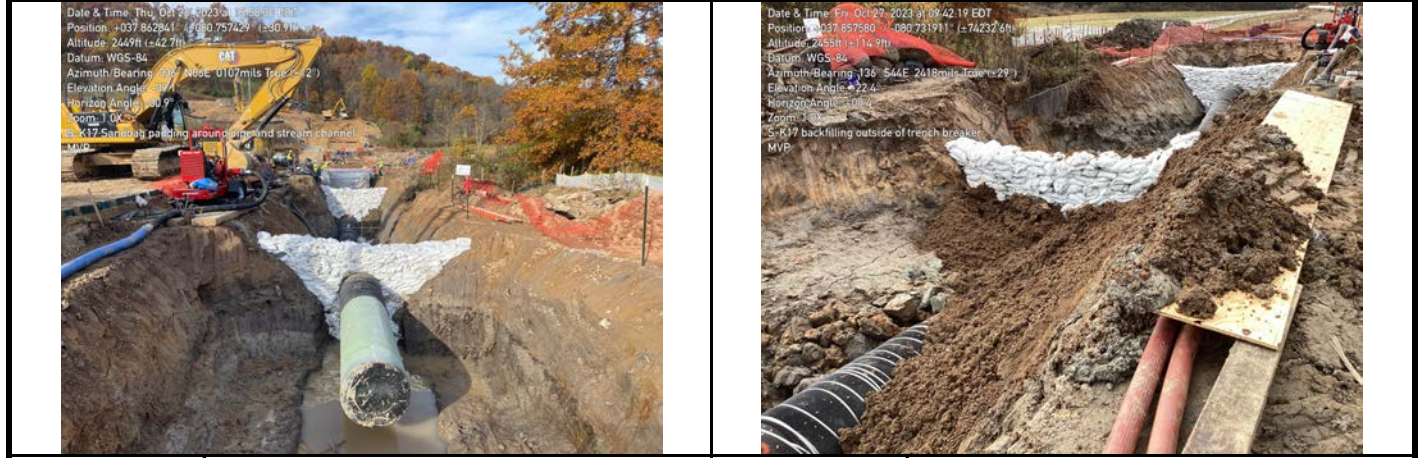
GPS Location	See Photo	GPS Location	See Photo
Description	Photo 5: Trench breakers being constructed around aquatic resource.	Description	Photo 6: Filling trench.

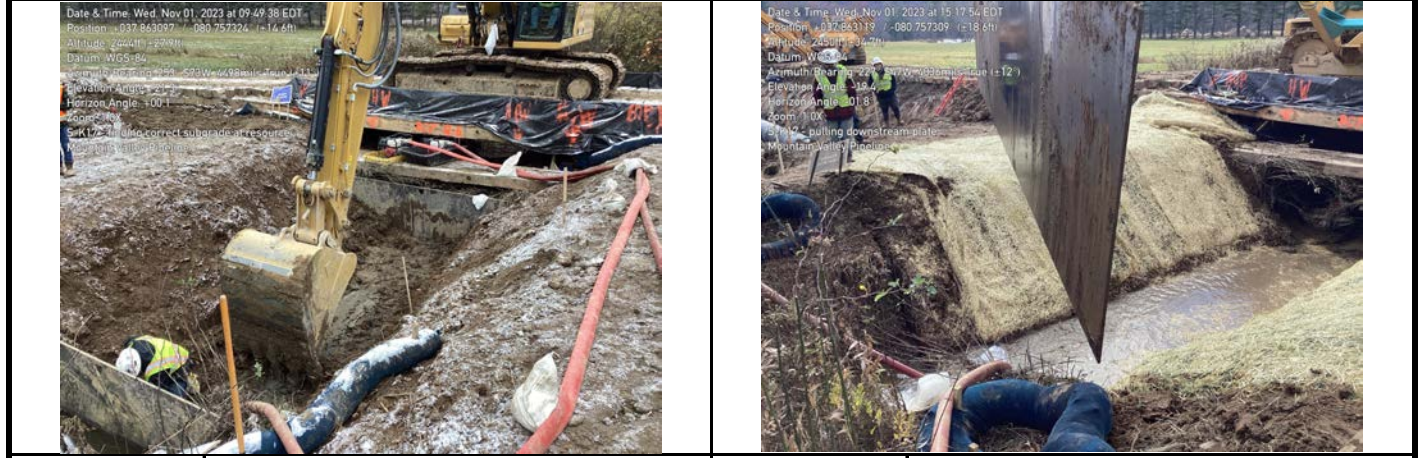
GPS Location	See Photo	GPS Location	See Photo
Description	Photo 7. Contouring and achieving correct subgrade.	Description	Photo 8. Removing of steel plates and restoring flow.
