Stream Biological Conditions EA Report

Project Name	H-600 Pipeline Spread A	AFE	124300129	Spread	H-600 Pipeline Spread A
Contractor	Precision	Report #	237		
Environmental Auditor	Devin Jen	Date/Time	9/18/2023 11:10 AM		
Stream ID	S-K73	Crossing Start Date	9/21/2023	Crossing Completion Date	10/26/2023
Milepost	31.41	Pre-Con Assessment Date	9/18/2023	Post-Con Assessment Date	10/26/2023
Station	1658+47	Bankfull Width (ft.)	5.0	Riffle:Pool Complexes Present?	Yes
State	WV	Stream Classification	Perennial		
County	Harrison	303(d) Impairment Listing	Biological, Fecal, Iron

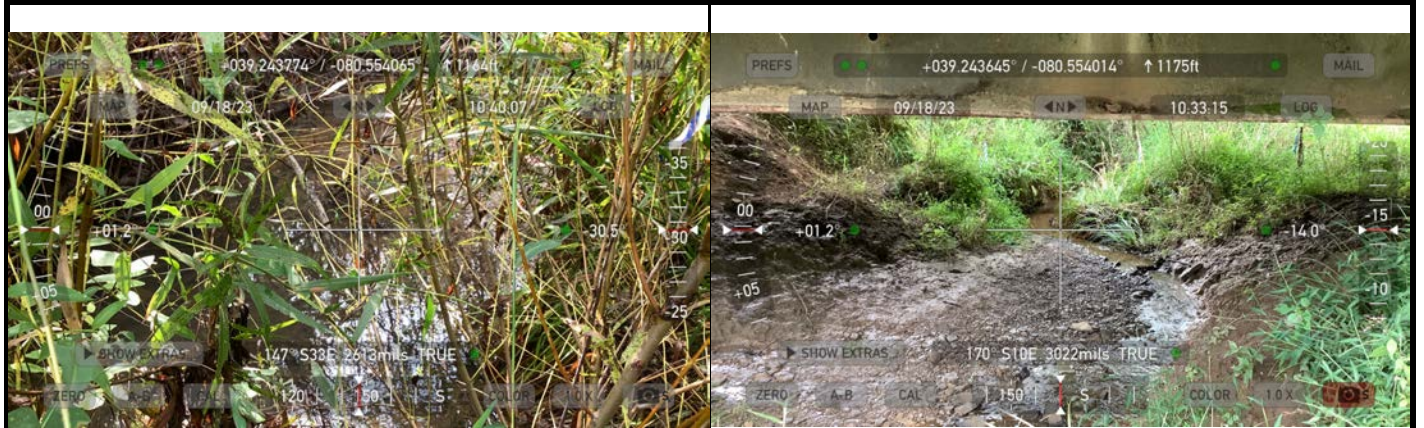
GPS Location	See photo.	GPS Location	See photo.
Description	Downstream view of permitted impact area during pre-construction assessment.	Description	Downstream view of unimpacted area during pre-construction assessment.

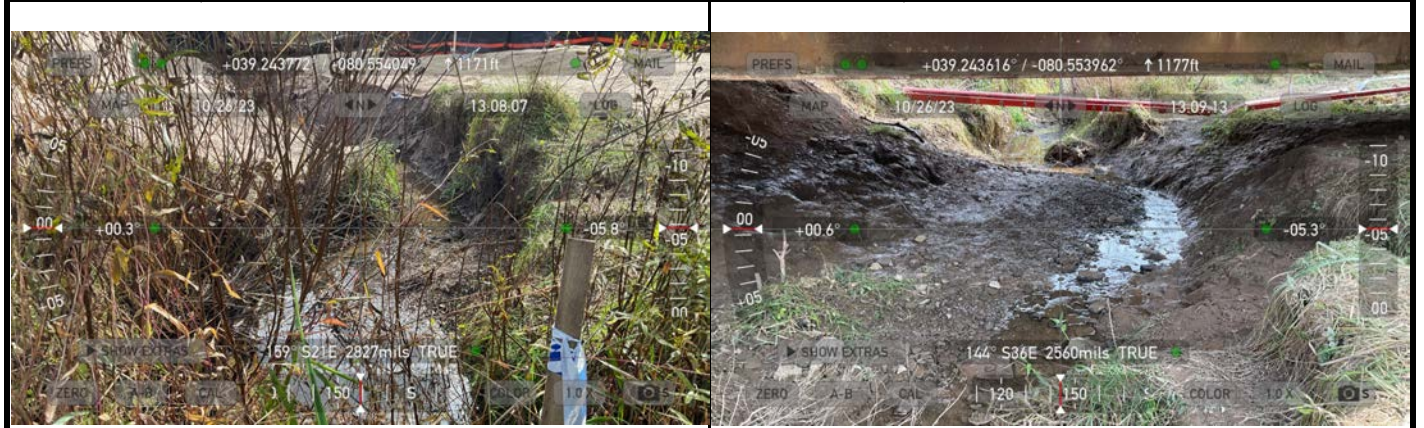
GPS Location	See photo	GPS Location	See photo
Description	Downstream view of permitted impact area during post-construction assessment.	Description	Downstream view of unimpacted area during post-construction assessment.

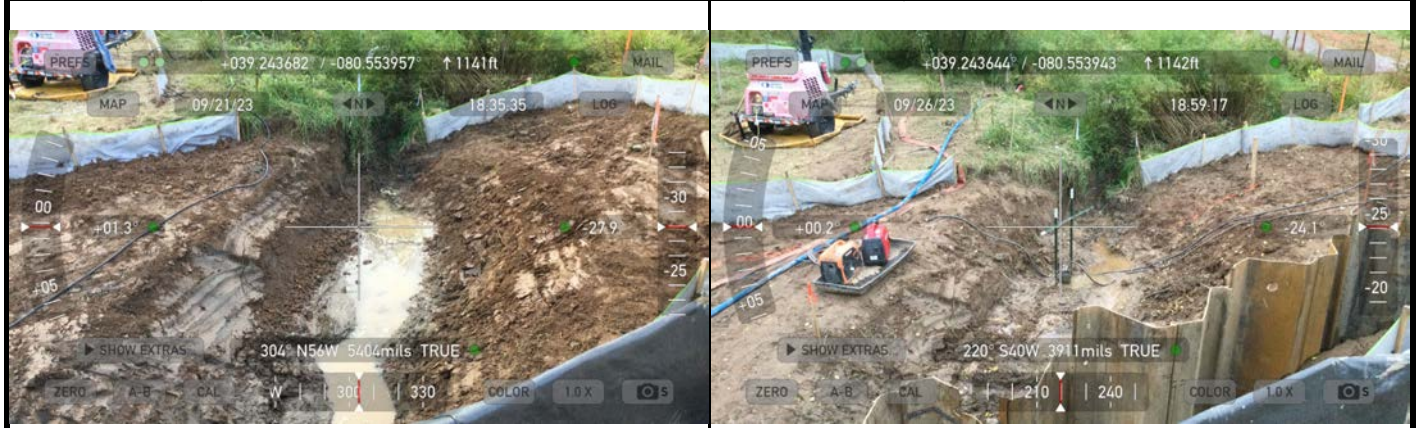
GPS Location	See photo	GPS Location	See photo
Description	This photo shows the stream following removal of the stream substrate	Description	This photo shows sheet piling installed in the stream crossing

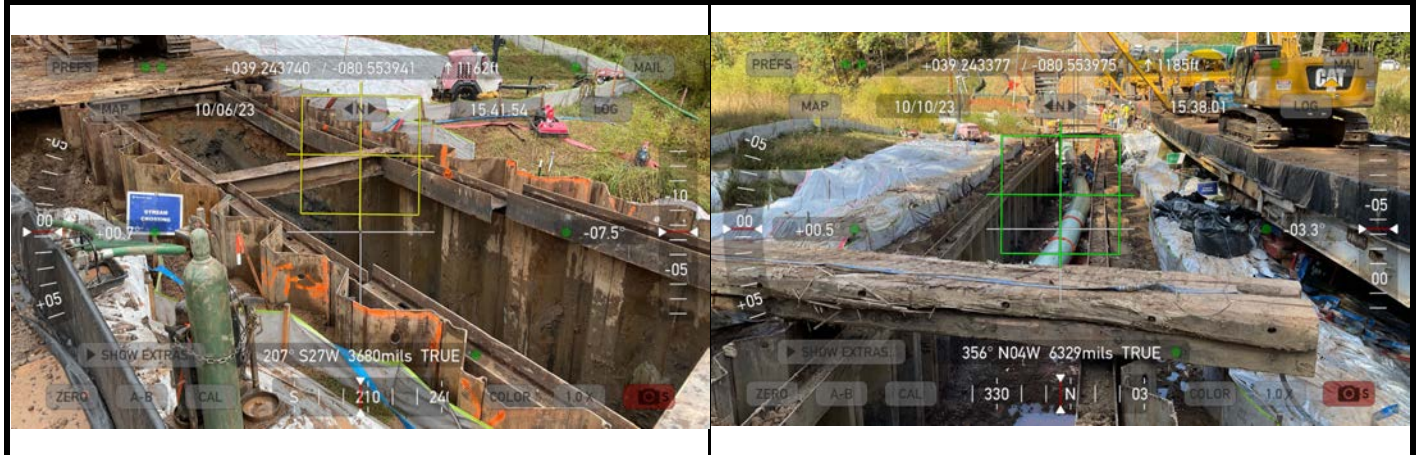
GPS Location See photo	GPS Location See photo
Description This photo shows the trench excavated through the stream crossing	Description This photo shows the pipe installed in the stream crossing

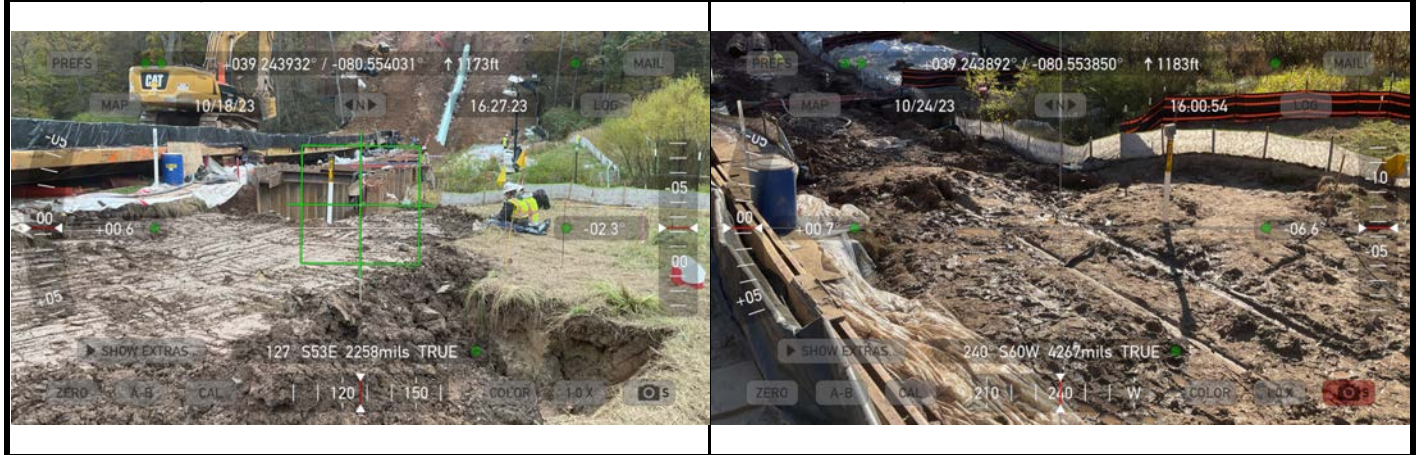
GPS Location See photo	GPS Location See photo
Description This photo shows the contractor working on backfilling the trench	Description This photo shows the contractor working on removing sheet piling

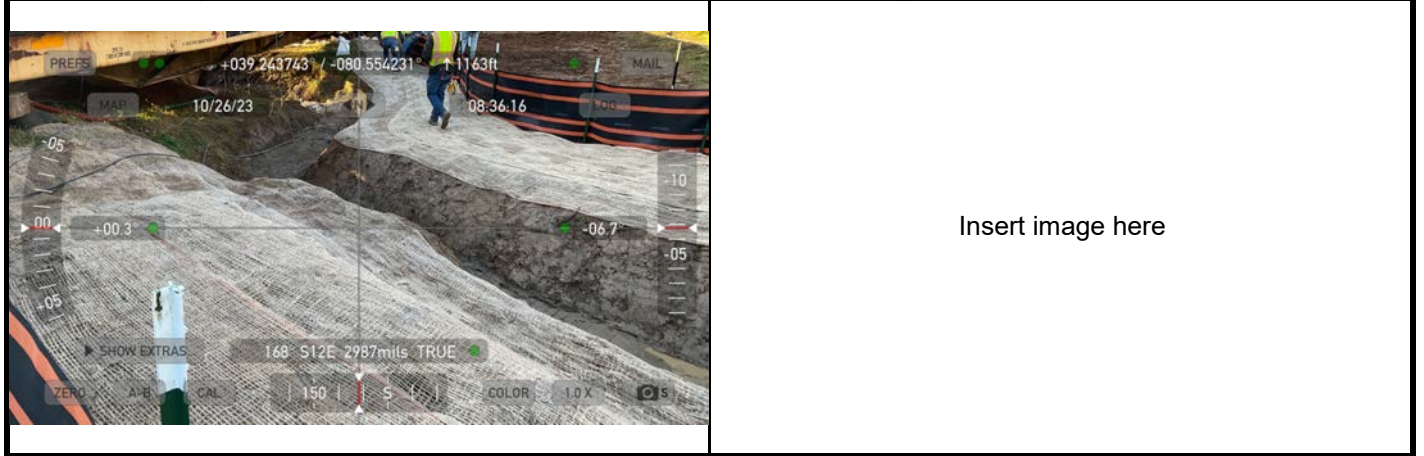
GPS Location See photo	GPS Location
Description This photo shows the restored stream crossing	Description
