Stream Biological Conditions EA Report

Project Name	H-600 Pipeline Spread A	AFE	124300129	Spread	H-600 Pipeline Spread A
Contractor	Precision	Report #	239		
Environmental Auditor	Devin Jen	Date/Time	9/18/2023 11:33 AM		
Stream ID	S-K75	Crossing Start Date	9/21/2023	Crossing Completion Date	10/26/2023
Milepost	31.42	Pre-Con Assessment Date	9/18/2023	Post-Con Assessment Date	10/26/2023
Station	1658+98	Bankfull Width (ft.)	3.0	Riffle:Pool Complexes Present?	No
State	WV	Stream Classification	Intermittent		
County	Harrison	303(d) Impairment Listing	N/A

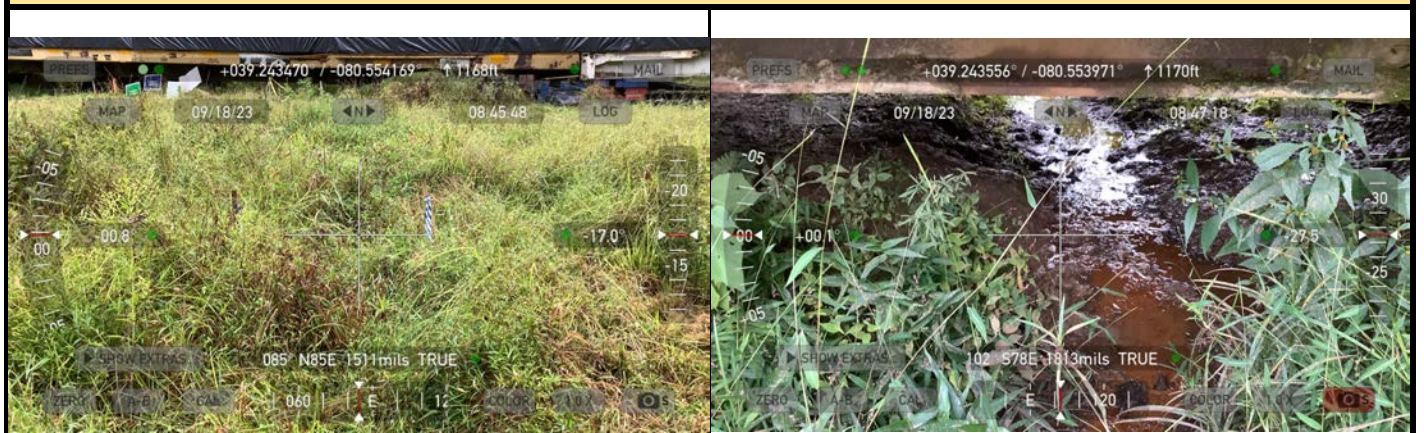
GPS Location	See photo	GPS Location	See photo
Description	Downstream view of permitted impact area during pre-construction assessment.	Description	Downstream view of unimpacted area during pre-construction assessment.

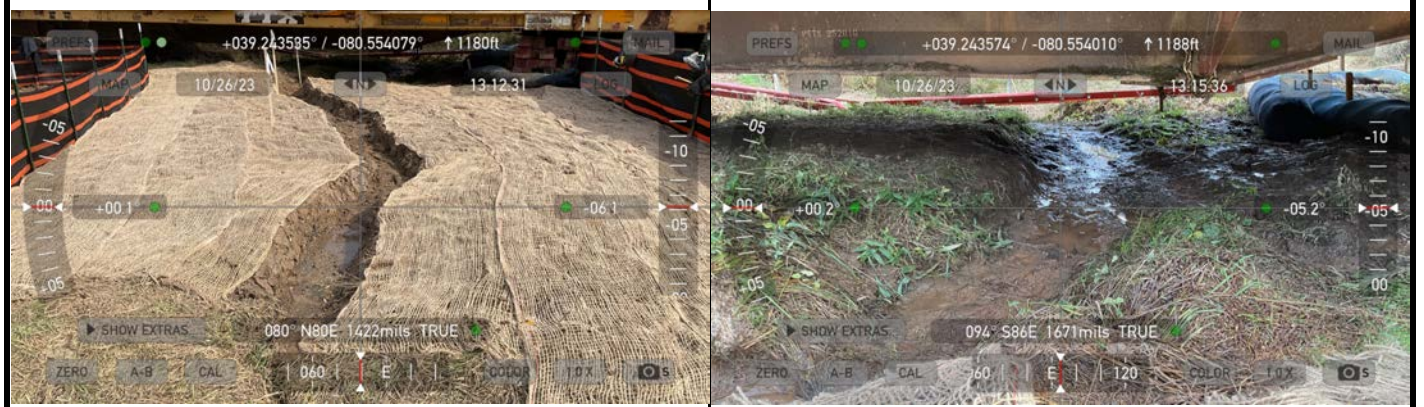
GPS Location	See photo	GPS Location	See photo
Description	Downstream view of permitted impact area during post-construction assessment.	Description	Downstream view of unimpacted area during post-construction assessment.

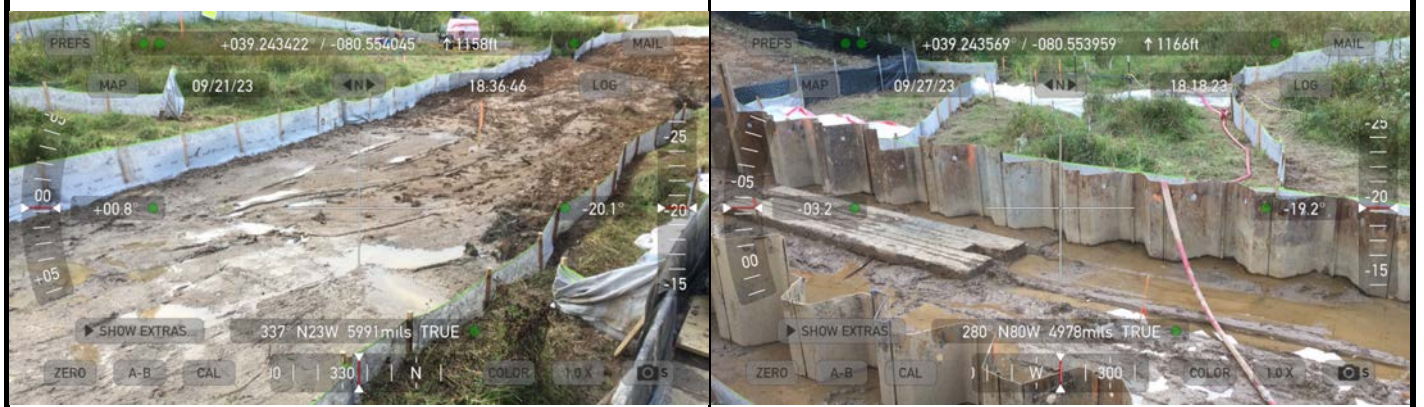
GPS Location	See photo	GPS Location	See photo
Description	This photo shows the topsoil removed from the stream/wetland complex	Description	This photo shows sheetpiling installed in the stream crossing

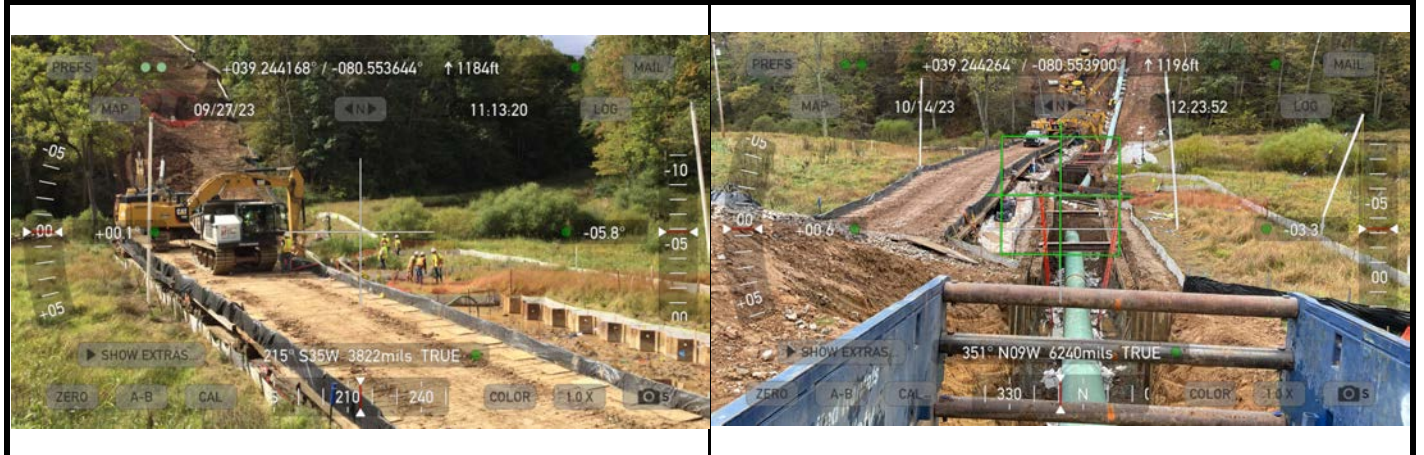
GPS Location	See photo	GPS Location	See photo
Description	This photo shows additional topsoil being removed from the stream/wetland complex prior to being stockpiled in a designated area	Description	This photo shows the contractor working on welding the pipe

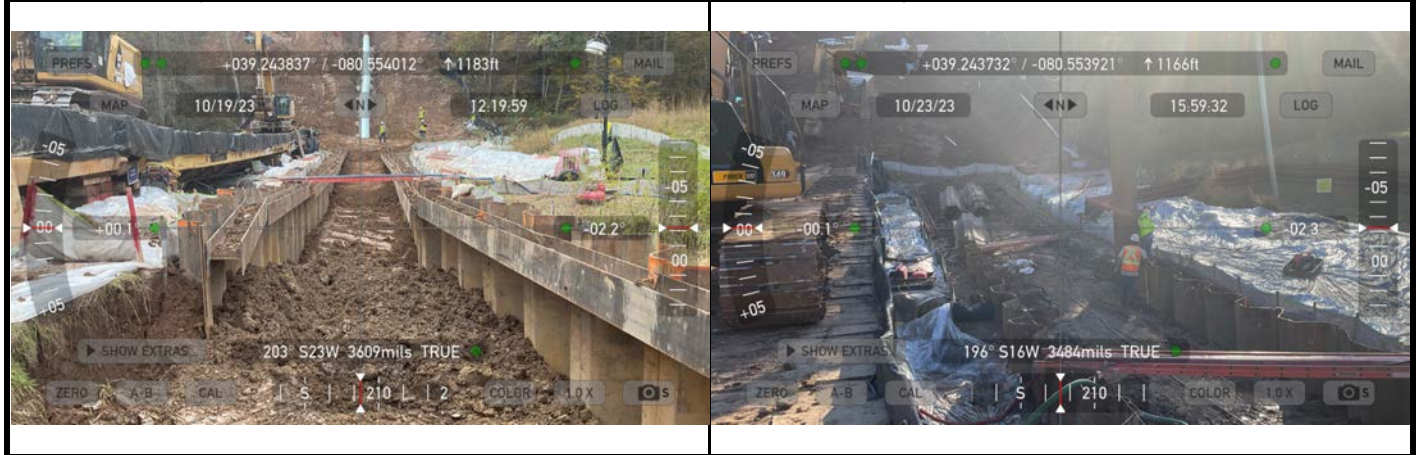
GPS Location	See photo	GPS Location	See photo
Description	This photo shows the partially backfilled trench in the stream/wetland complex	Description	This photo shows the contractor working on removing sheet piling from the stream/wetland complex

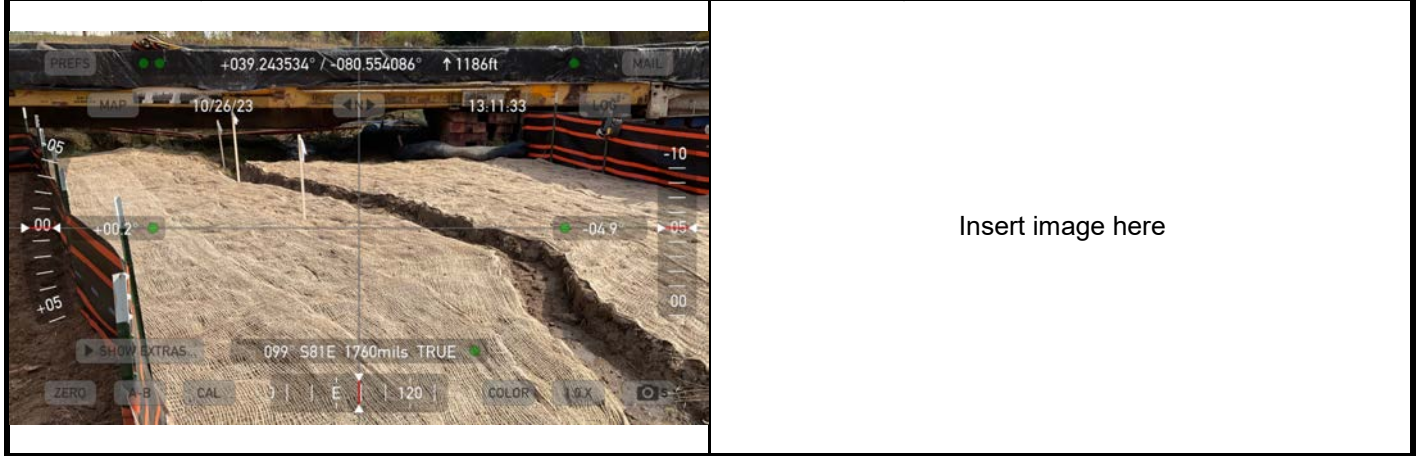
GPS Location	See photo	GPS Location	
Description	This photo shows the restored stream and stabilized banks	Description
