Stream Biological Conditions EA Report

Project Name	H-600 Pipeline Spread A	AFE	124300129	Spread	H-600 Pipeline Spread A
Contractor	Precision	Report #	306		
Environmental Auditor	Danielle Payne	Date/Time	10/17/2023 8:34 PM		
Stream ID	S-K94	Crossing Start Date	10/23/2023	Crossing Completion Date	10/27/2023
Milepost	38.18	Pre-Con Assessment Date	10/17/2023	Post-Con Assessment Date	10/27/2023
Station	2015+74	Bankfull Width (ft.)	20.0	Riffle:Pool Complexes Present?	No
State	WV	Stream Classification	Perennial		
County	Lewis	303(d) Impairment Listing	Fecal, Iron

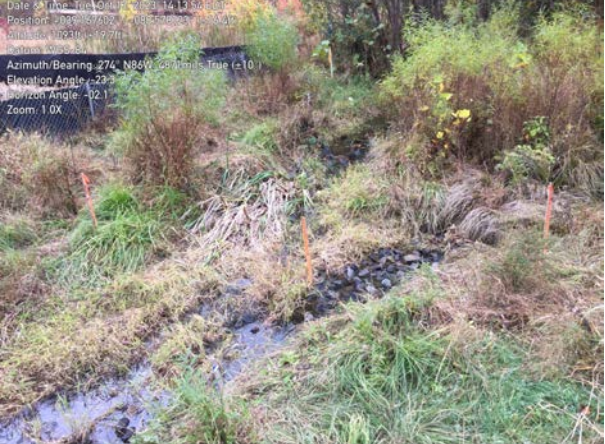
<p><small>Date & Time: Fri, Oct 13, 2023, 14:34 EDT Position: +039.167507, -080.578194 (+16.4h) Altitude: 1102ft (+34m) Datum: WGS-84 Azimuth/Bearing: 122° S58E 216mils True (+10°) Elevation Angle: +09.7 Horizon Angle: +01.7 Zoom: 1.0X</small></p>
GPS Location See above photo.	GPS Location See above photo.
Description Downstream view of permitted impact area during pre-construction assessment. Downstream view of the permitted impact area during pre-construction assessment.	Description Downstream view of unimpacted area during pre-construction assessment. Downstream view of unimpacted area during pre-construction assessment.

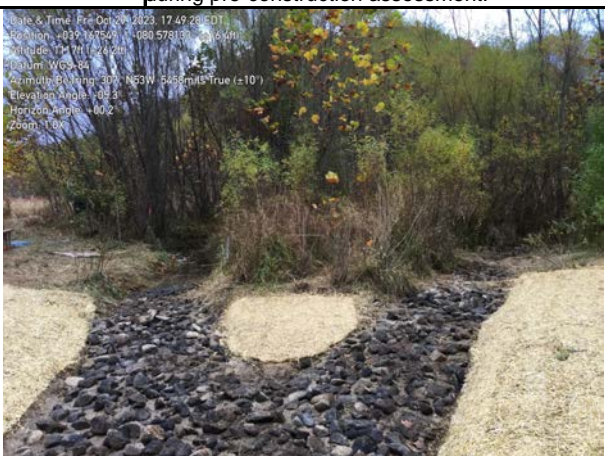
GPS Location See above photo.	GPS Location See above photo.
Description Downstream view of permitted impact area during post-construction assessment. Downstream view of the permitted impact area during post-construction assessment.	Description Downstream view of unimpacted area during post-construction assessment. Downstream view of unimpacted area during post-construction assessment.

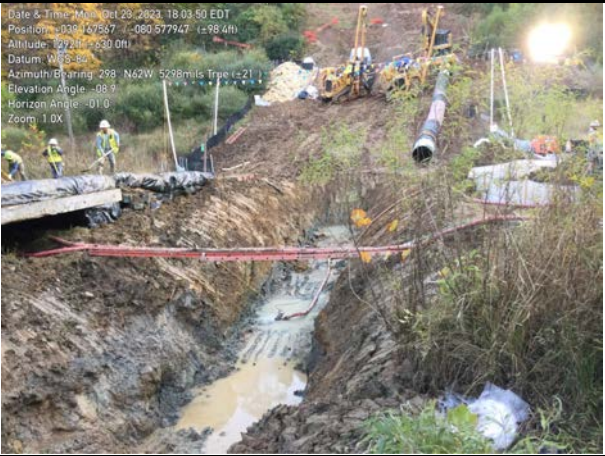
Description View of trench excavation.	Description View of resource during construction and downstream dam(s)

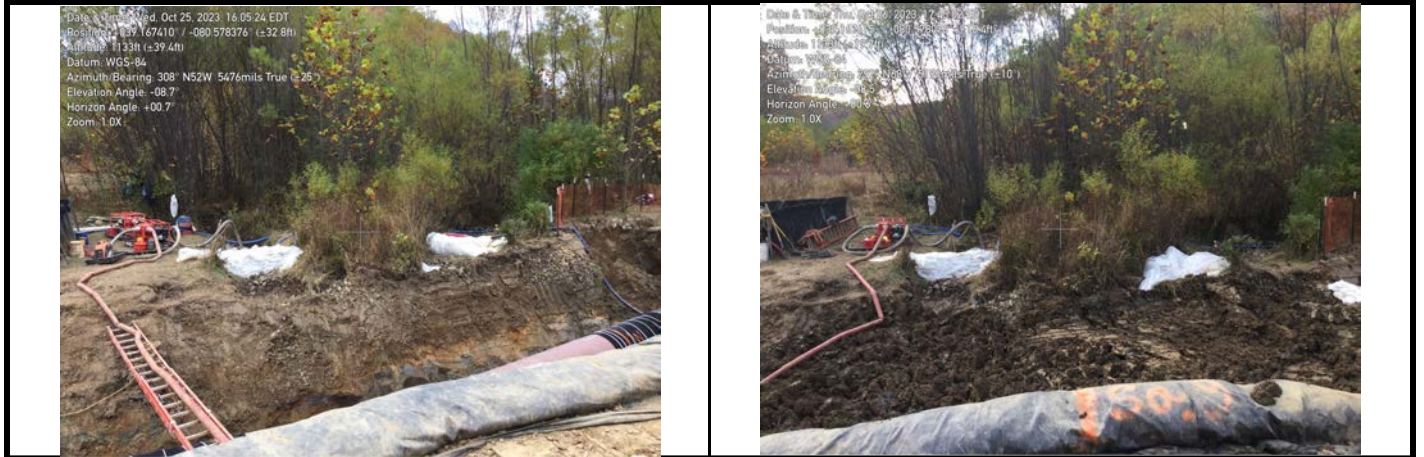
Description	View of resource as construction continued.	Description	View of resource as backfilling progressed.
--------------------	---	--------------------	---
